# Quick report of preliminary reconnaissance of the 2024 Noto-hanto Earthquake in Japan —No.2—

Masakatsu Miyajima (Professor Emeritus, Kanazawa University)

Takao Hashimoto (Specially Appointed Professor, Kokushikan University)

Survey Period: 2024.1.12-1.15

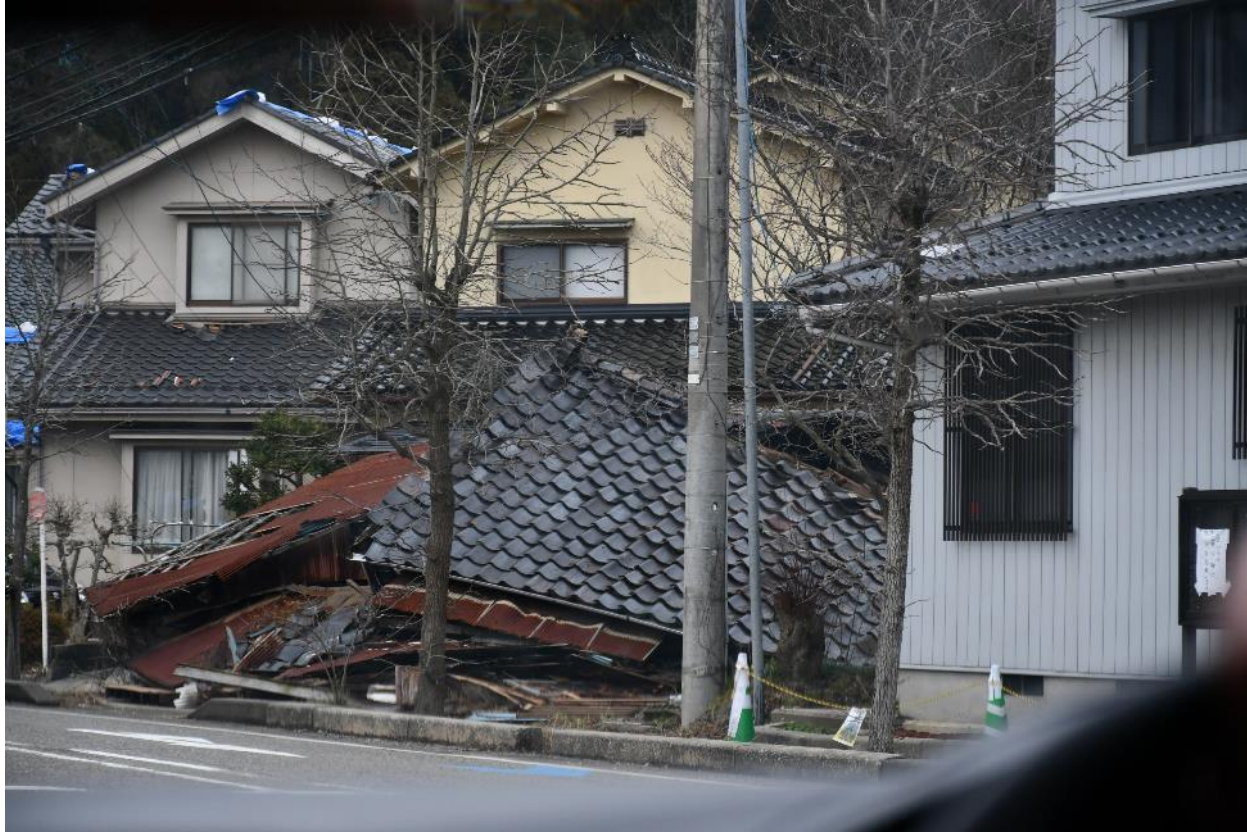
Collapse of wooden house (Map ①)

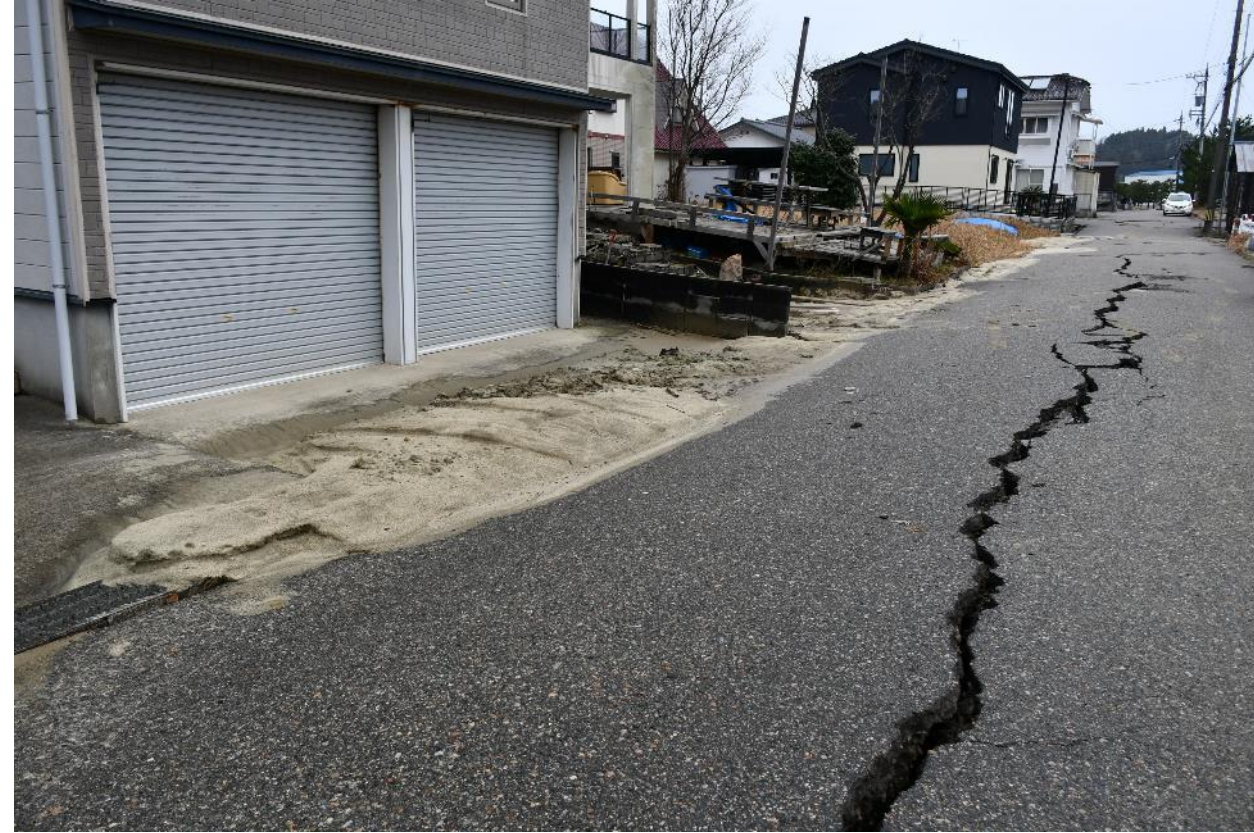
Road cracks and ejected sand due to liquefaction (Map②)

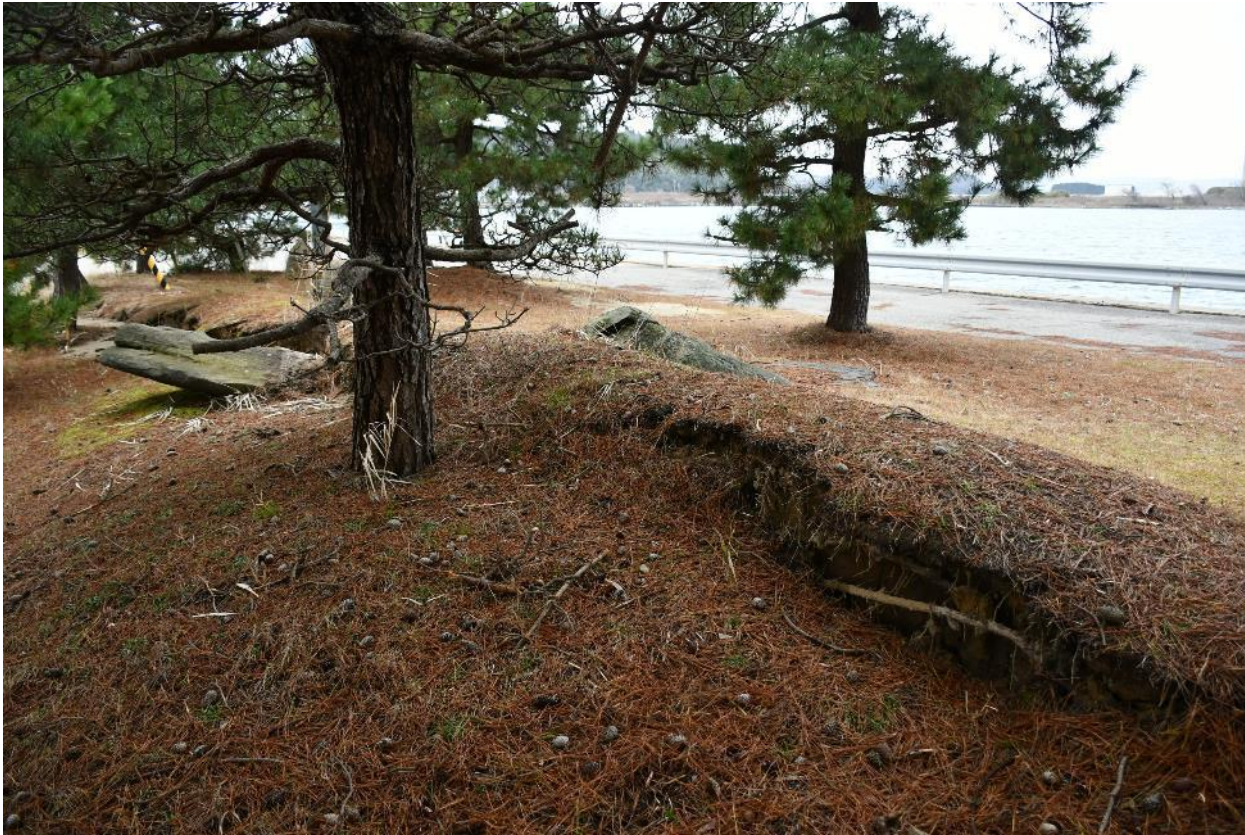
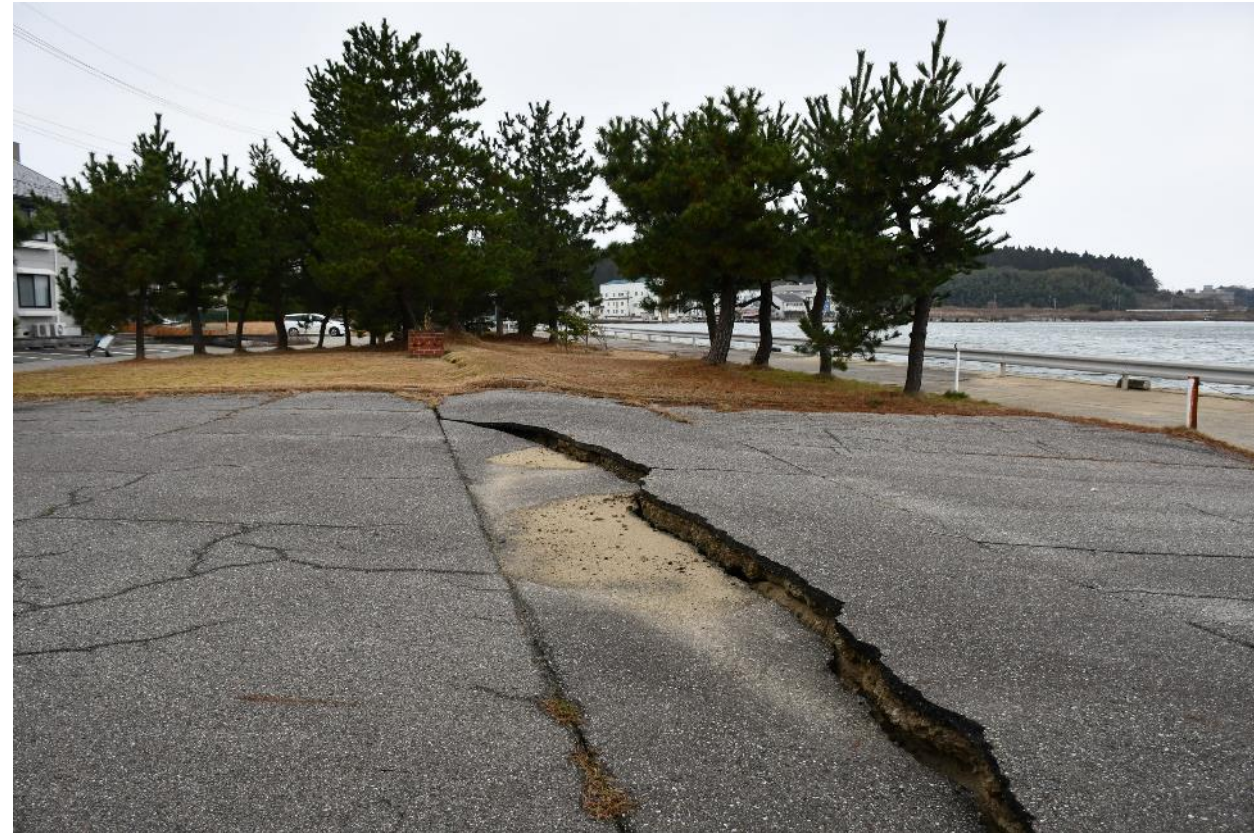
Uplift and depression of the ground due to lateral flow of liquefied ground (Map②)

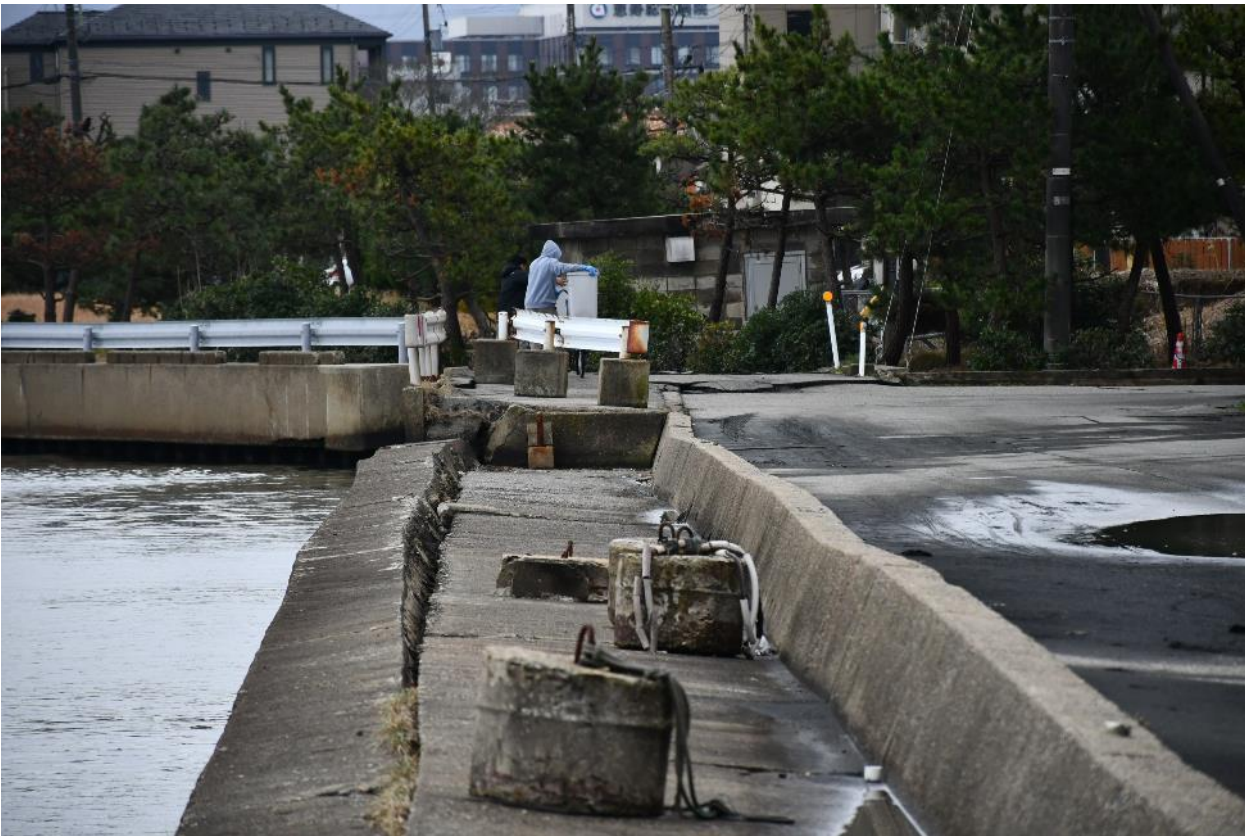
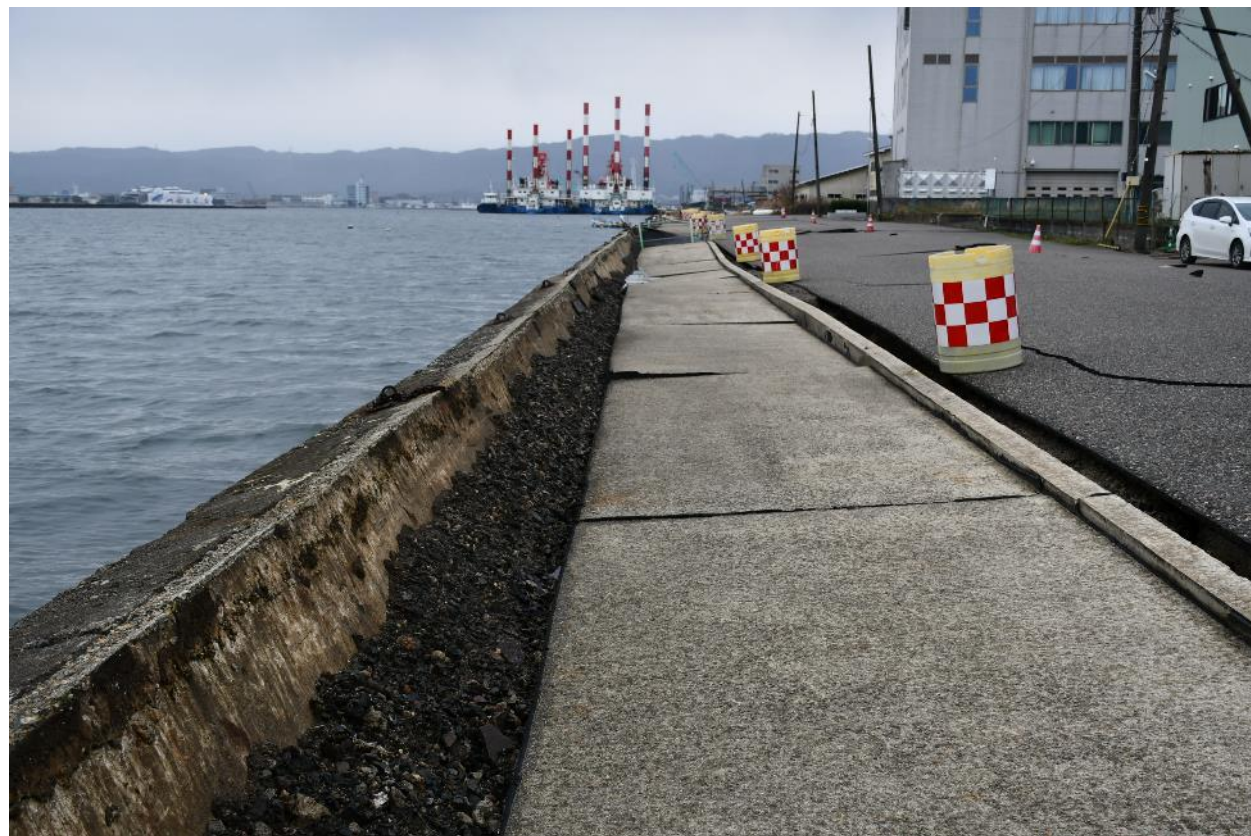
Curved quay (Map③)

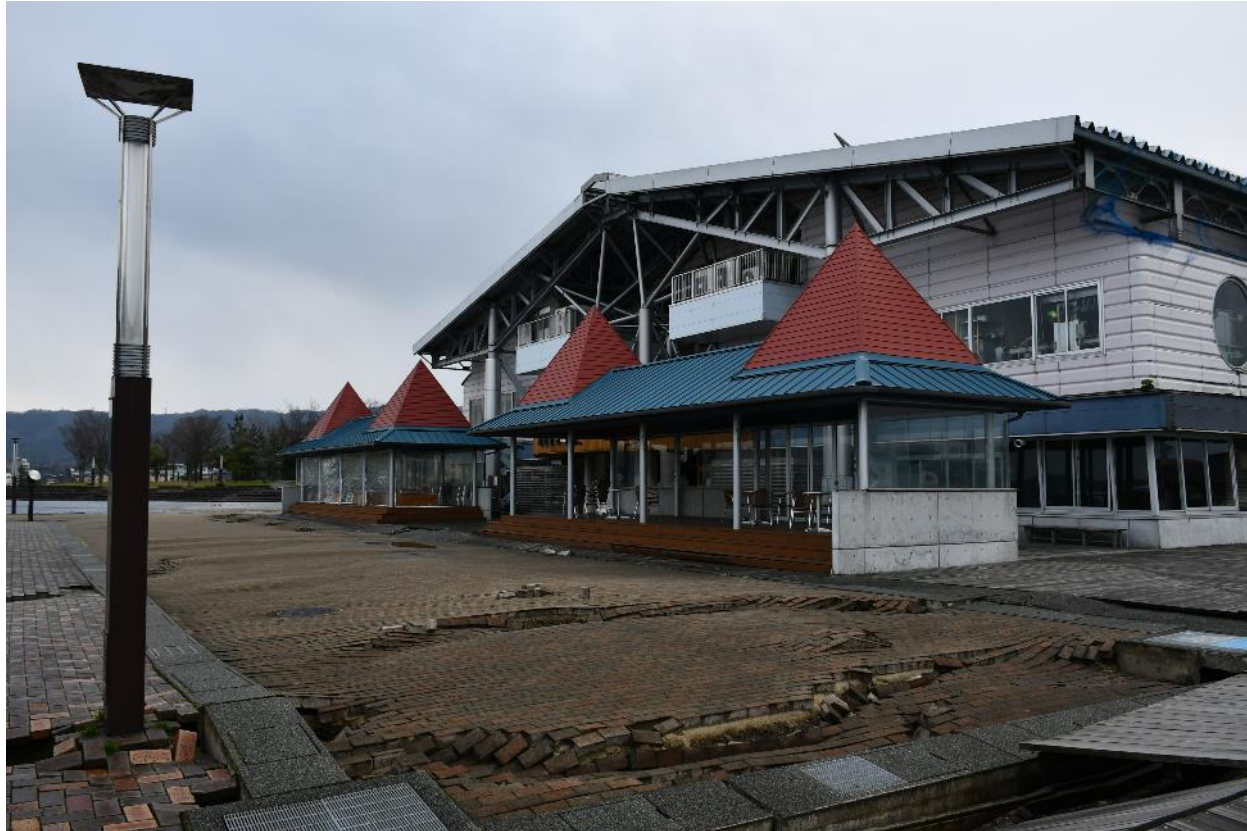
Damage of “ Food Festival Market”  
induced by liquefaction (Map④)

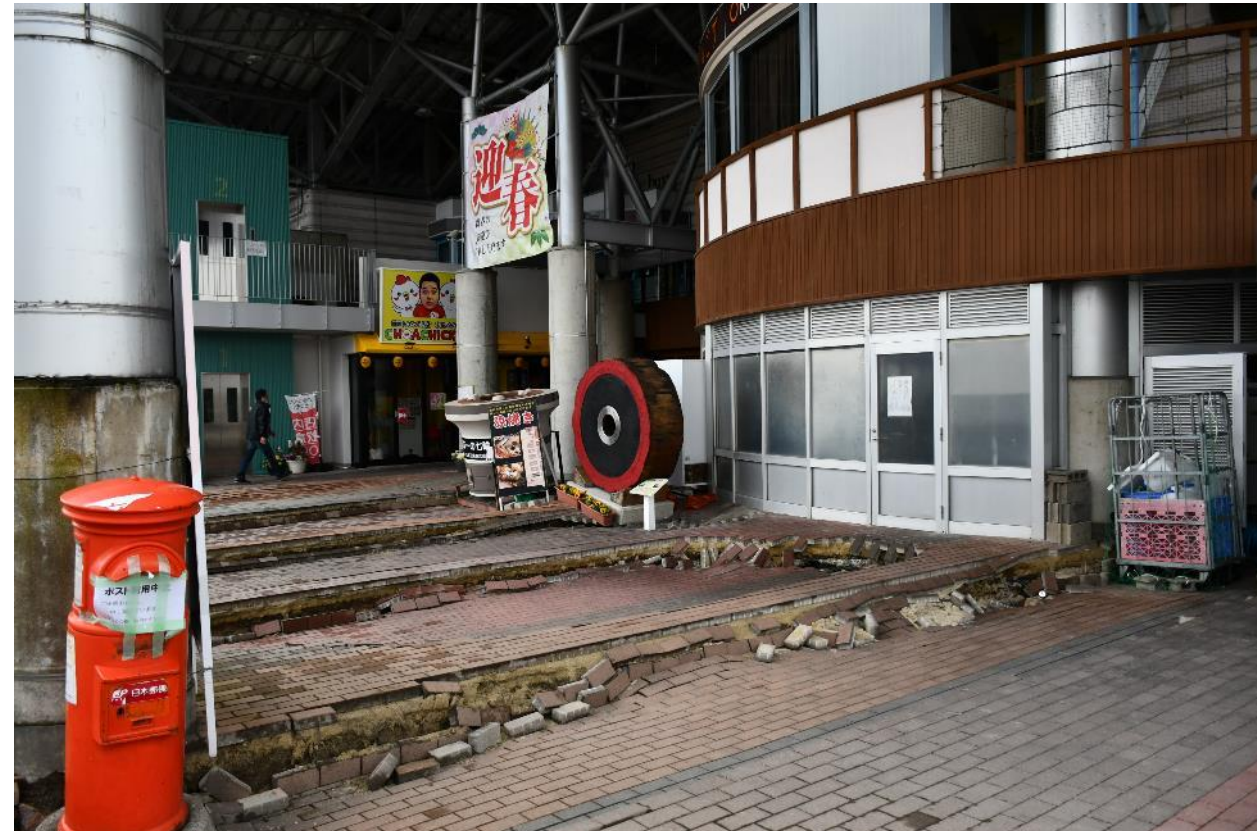
Subsidence of the entrance approach (Map④)

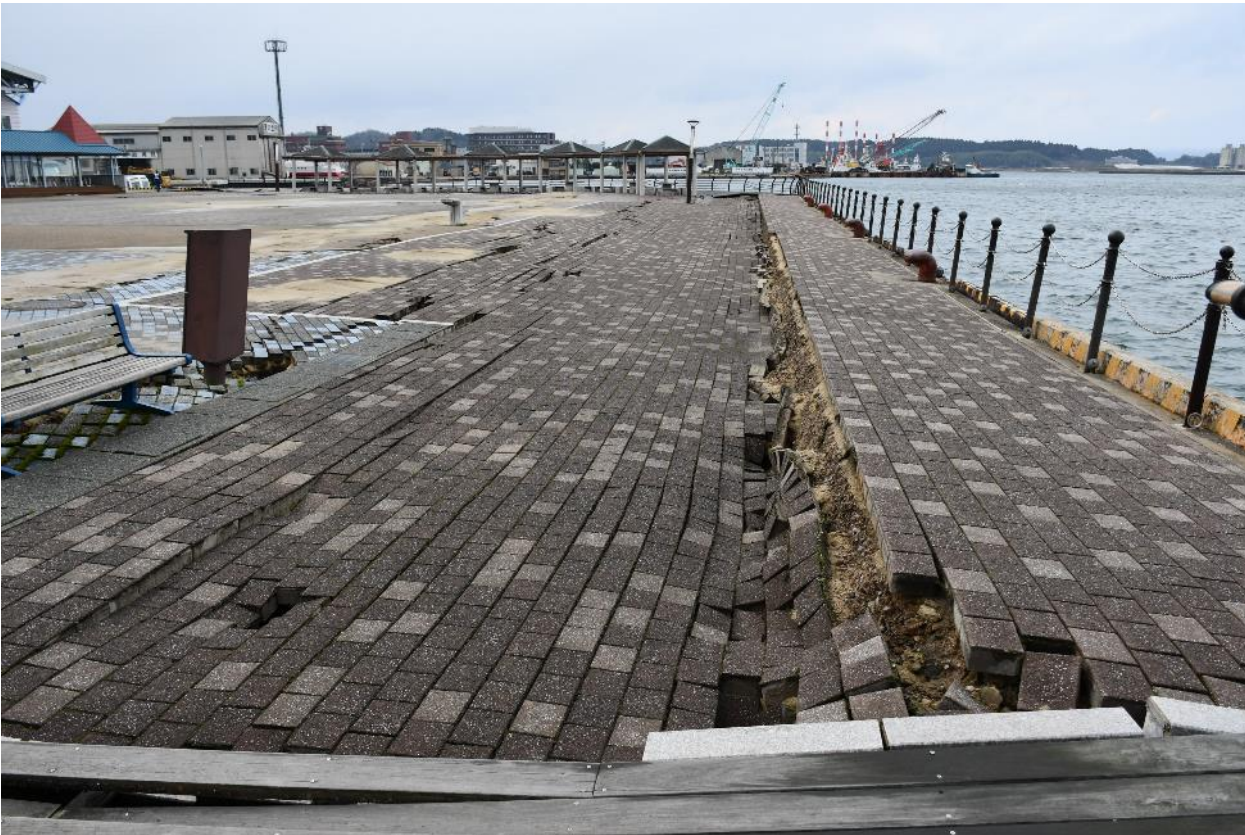
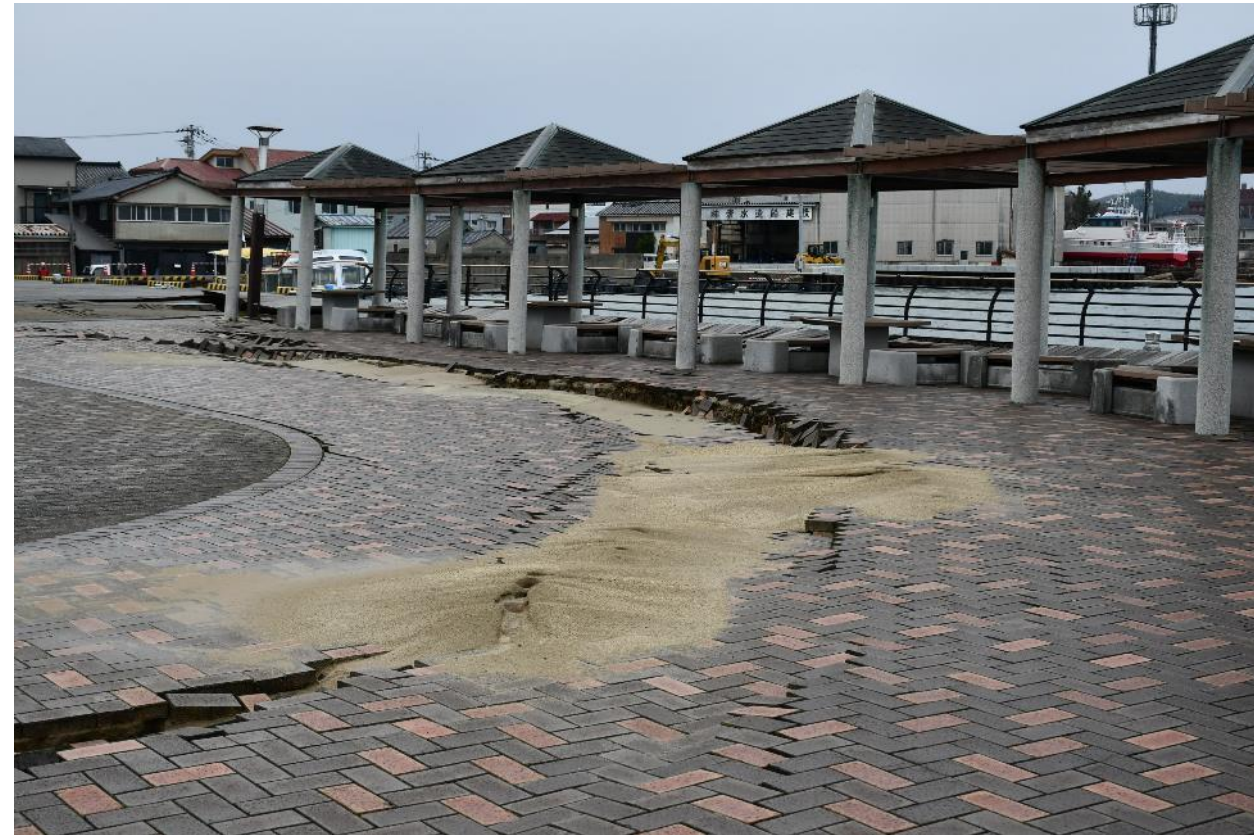
Subsidence and ejected sand due to liquefaction (Map④)

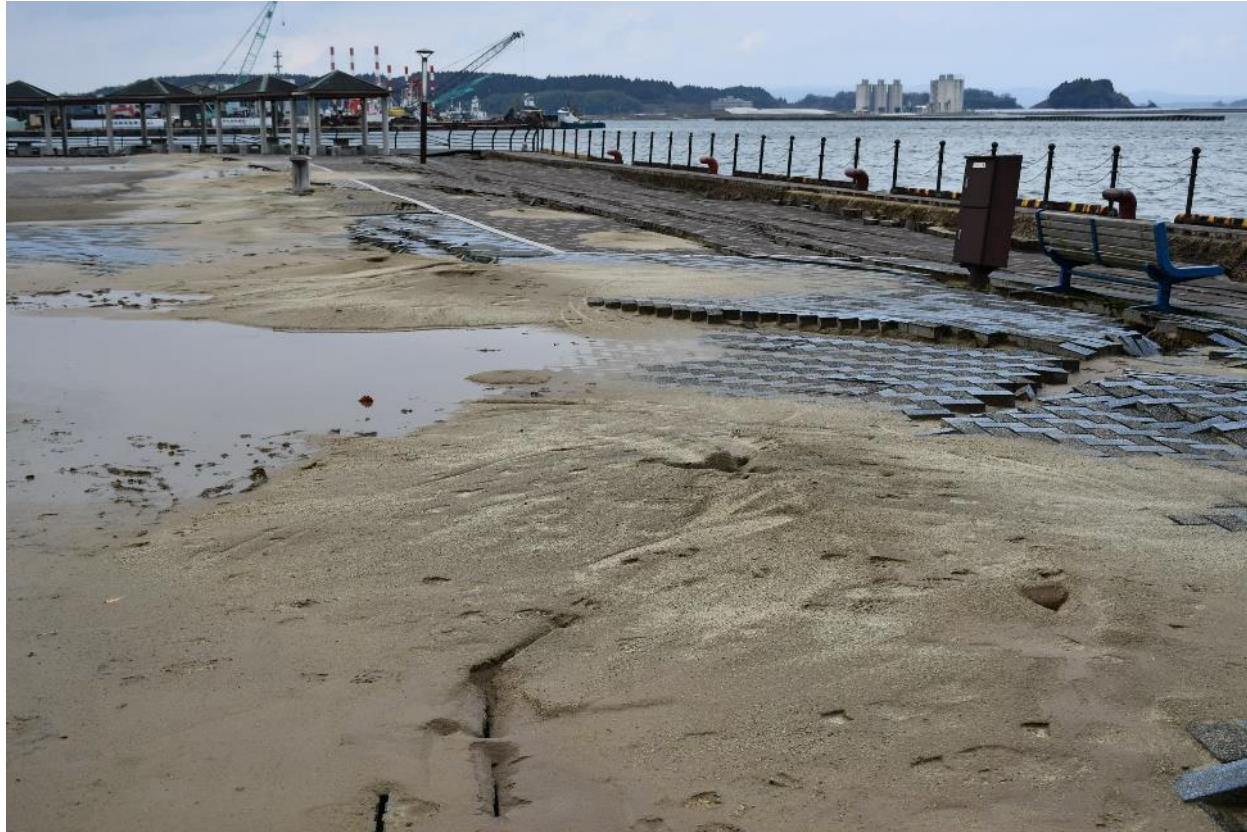
Subsidence and ejected sand due to liquefaction (Map④)

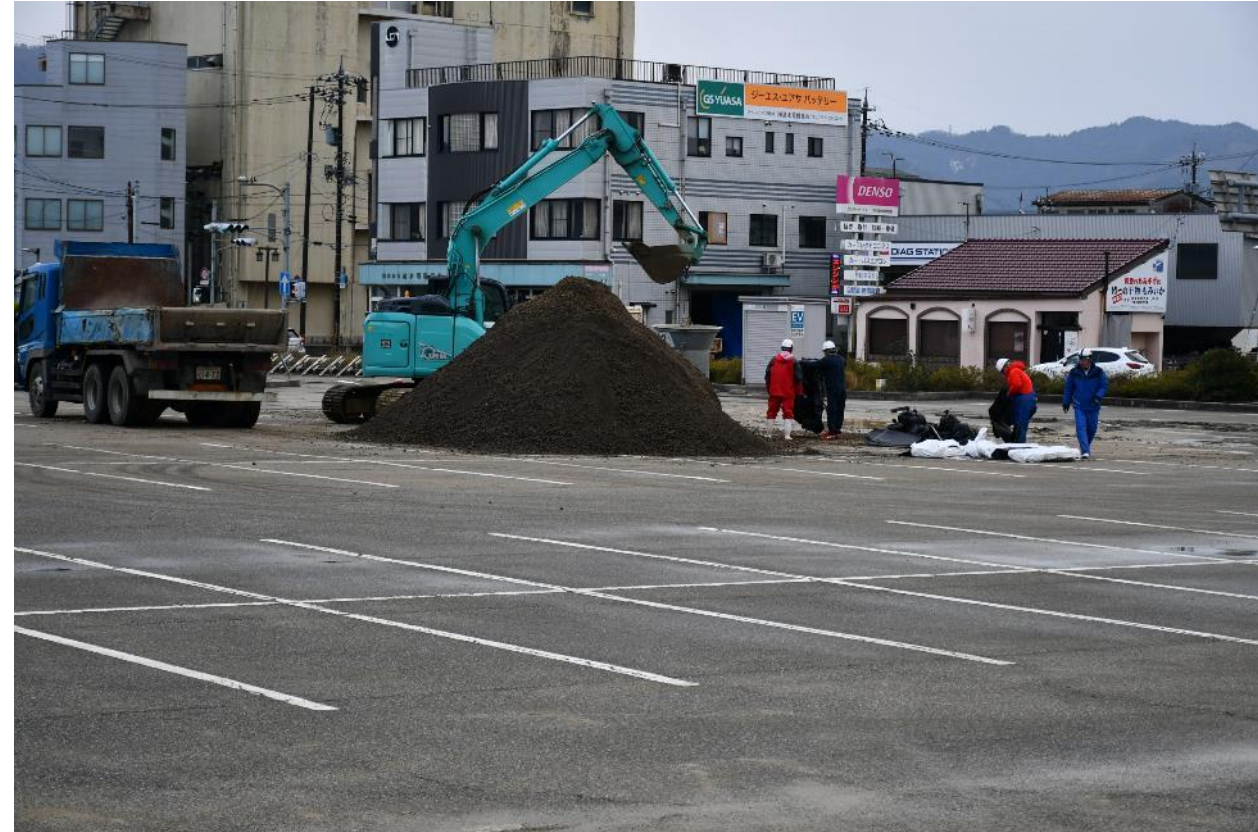
Removal of a large amount of ejected sand in the parking lot (Map④)

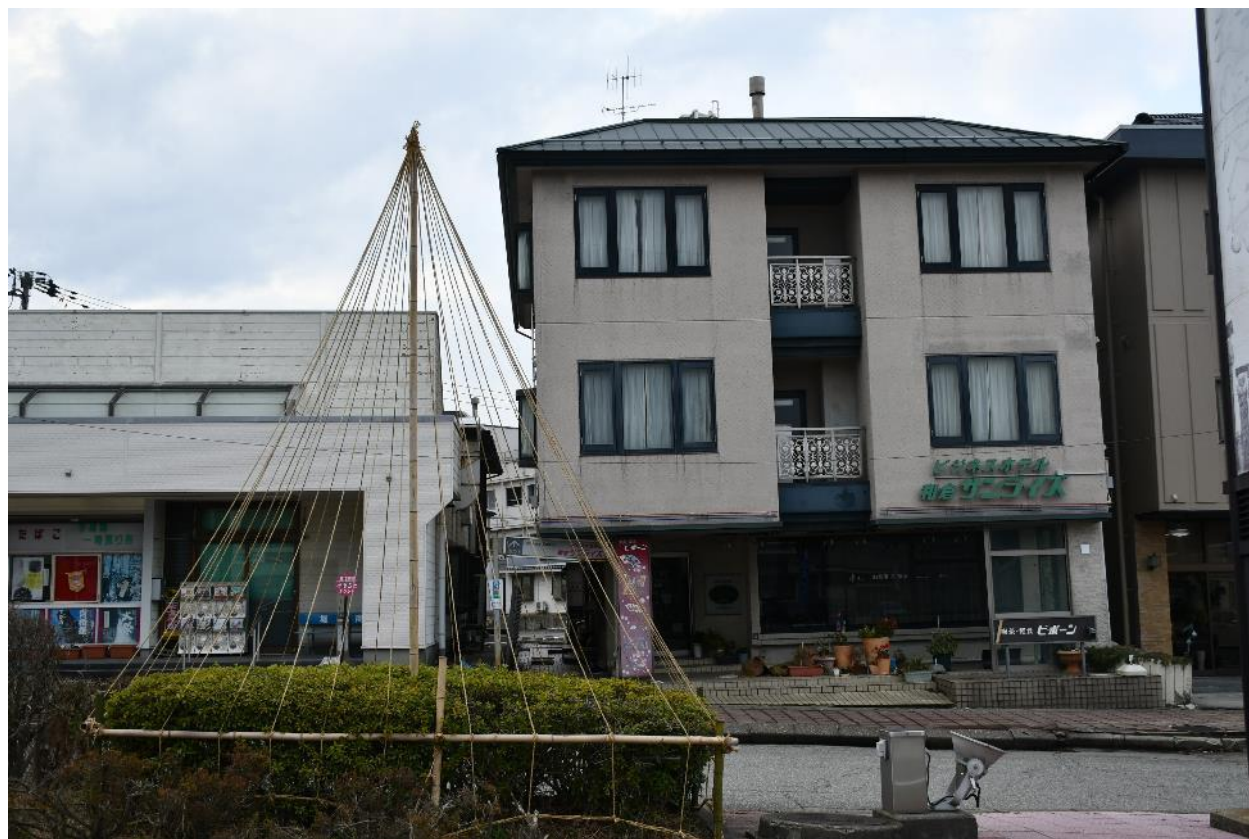
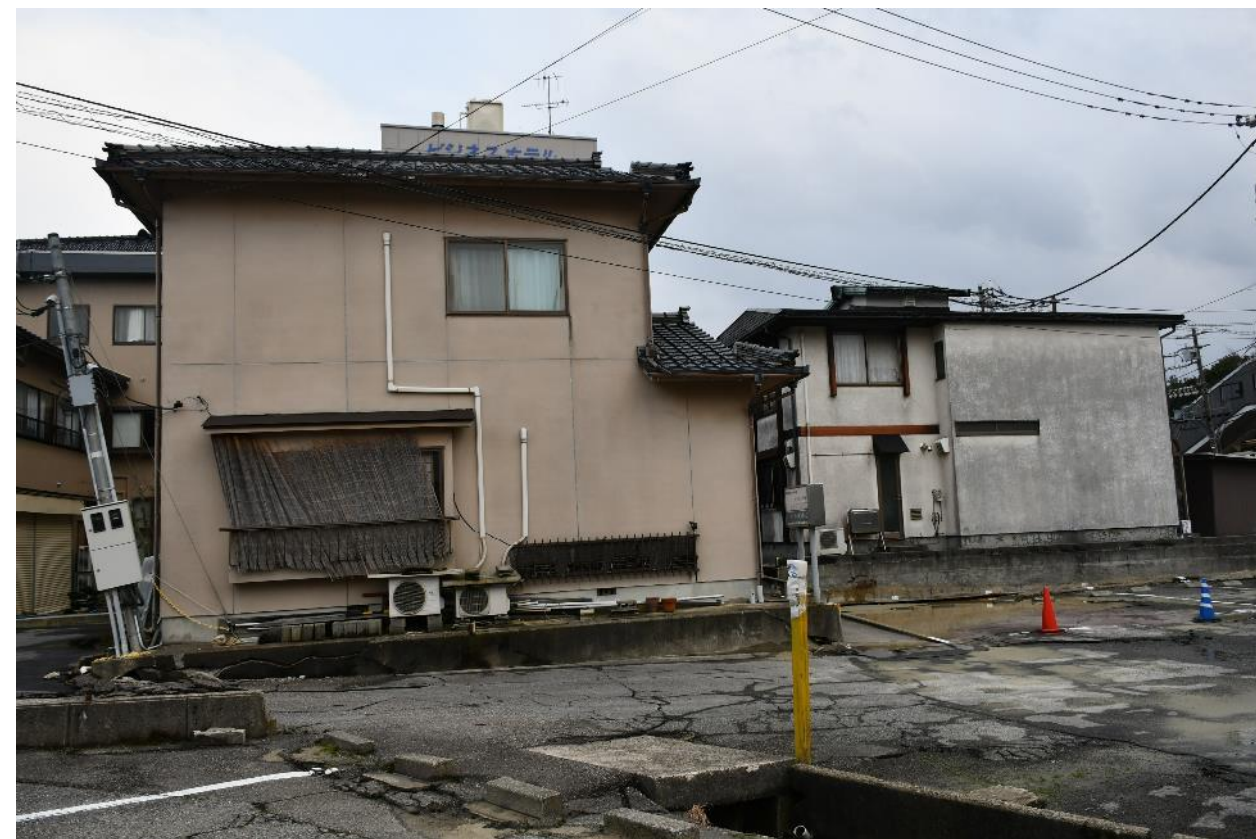
Inclination of the buildings in front of Wakura Onsen Station due to liquefaction (Map⑤)

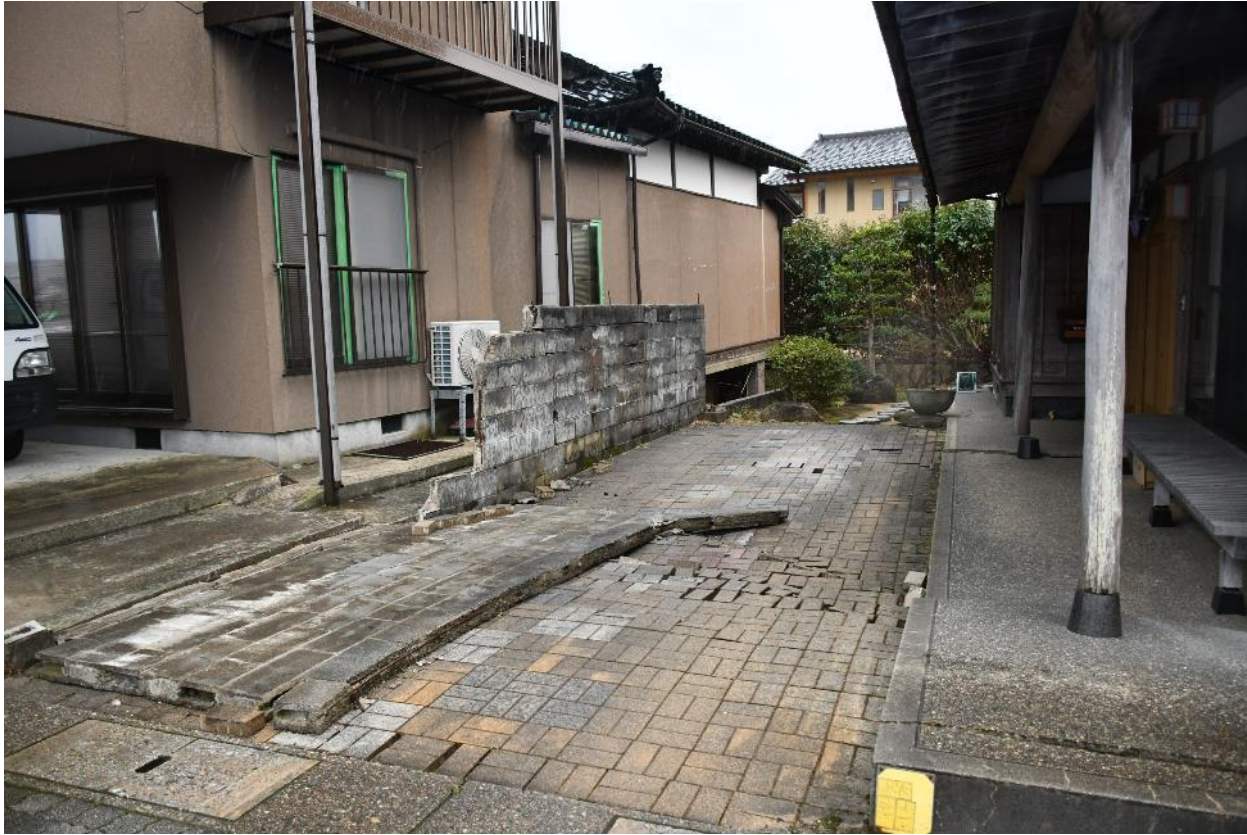
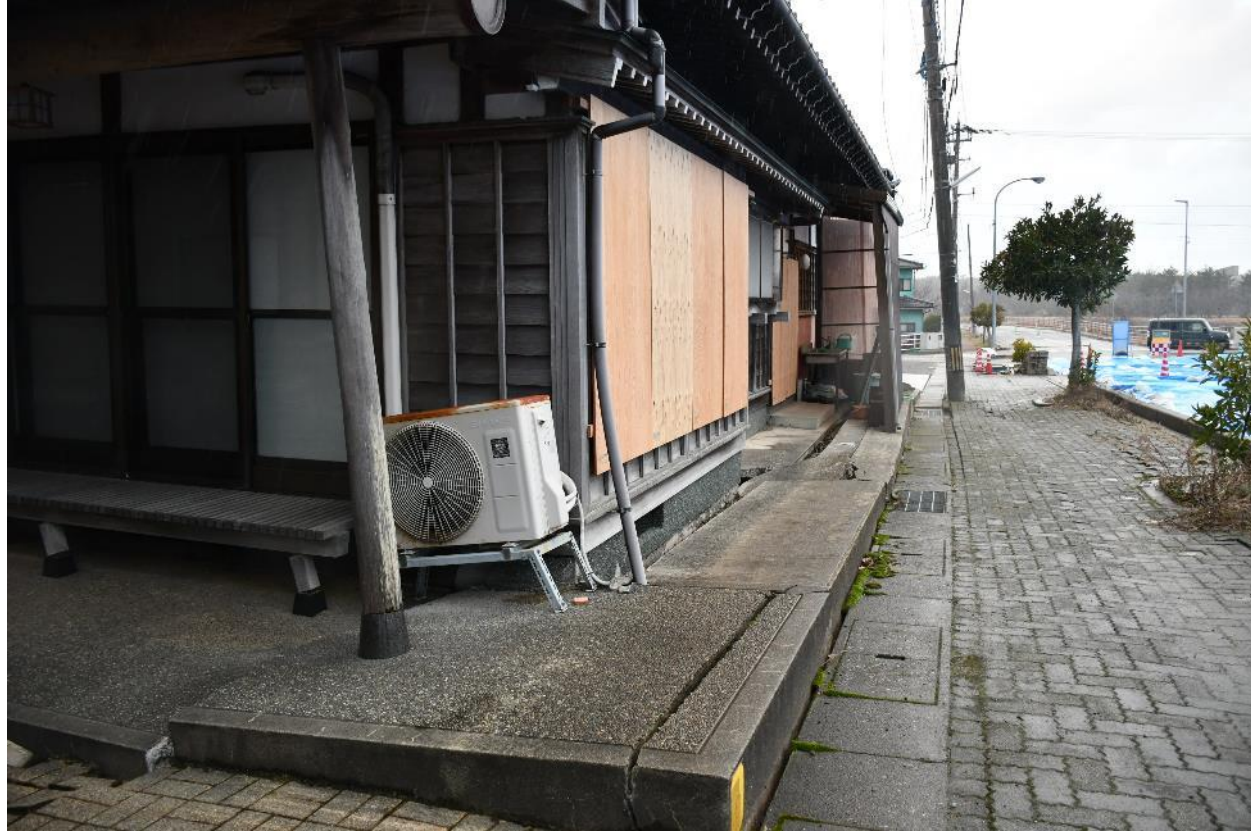
Subsidence and inclination of houses due to liquefaction (Map①)

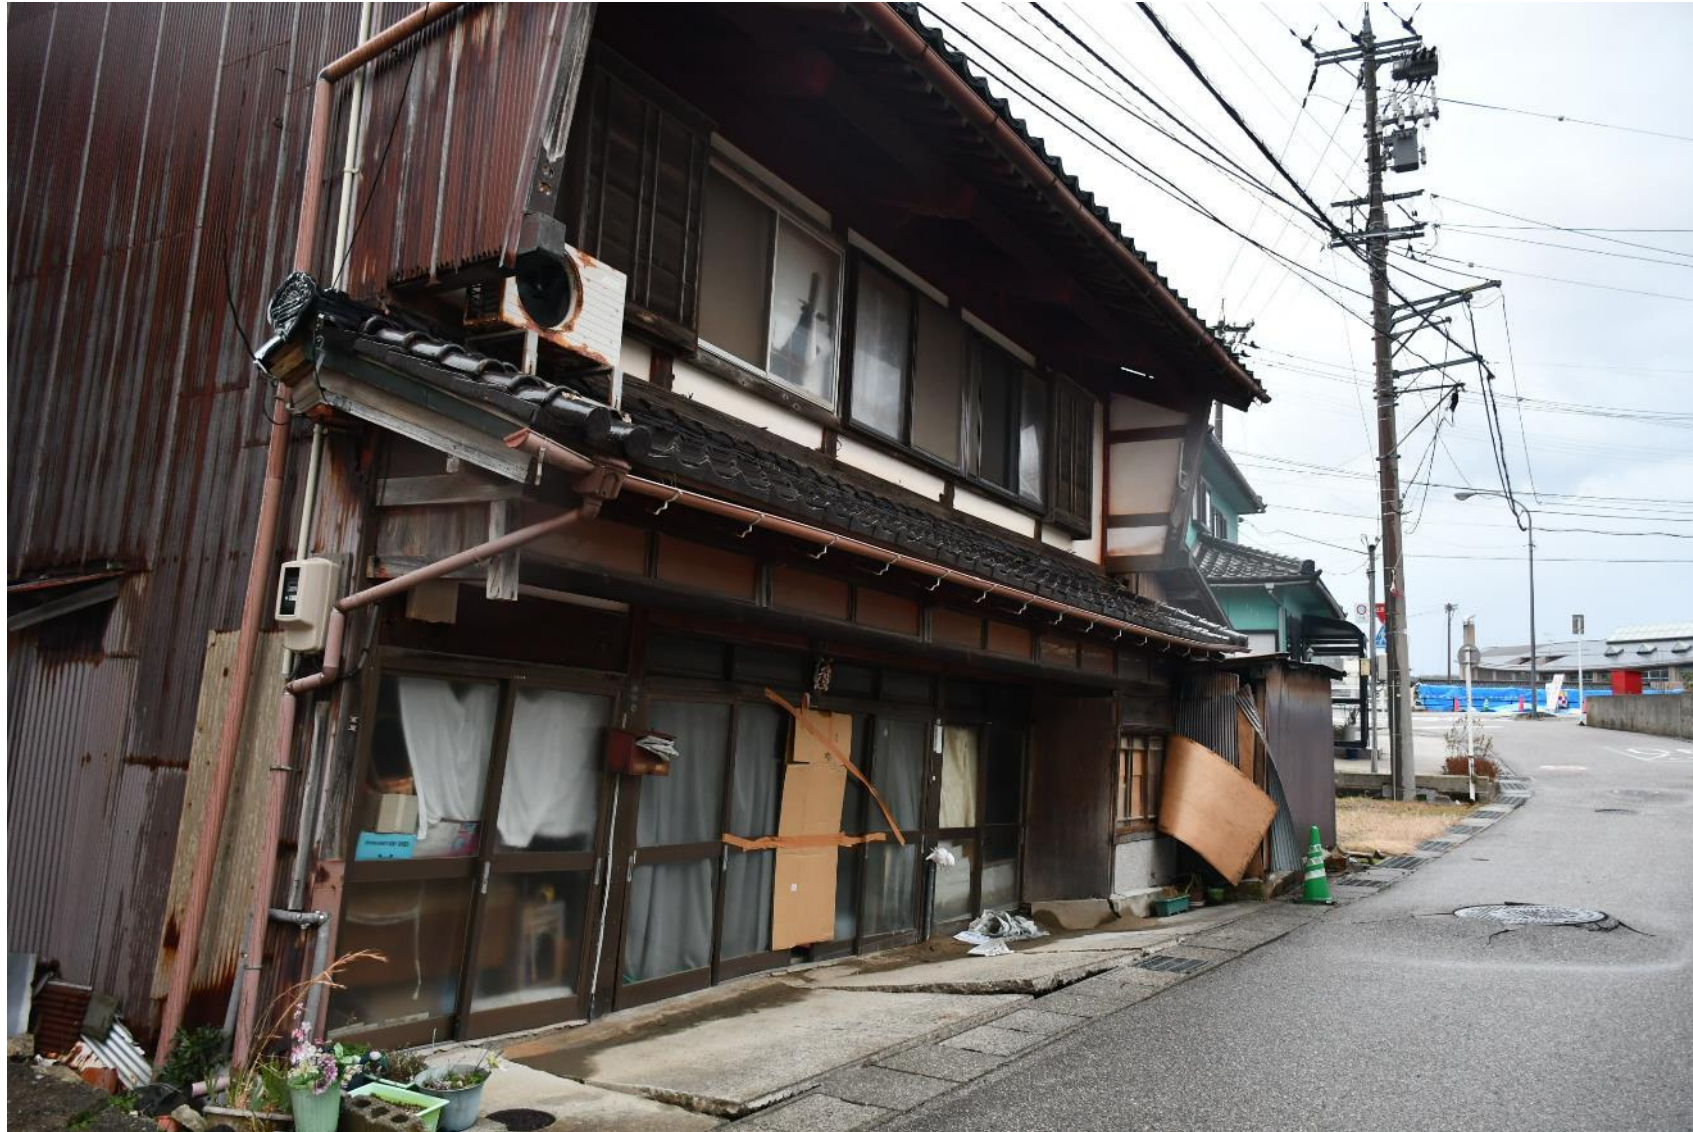
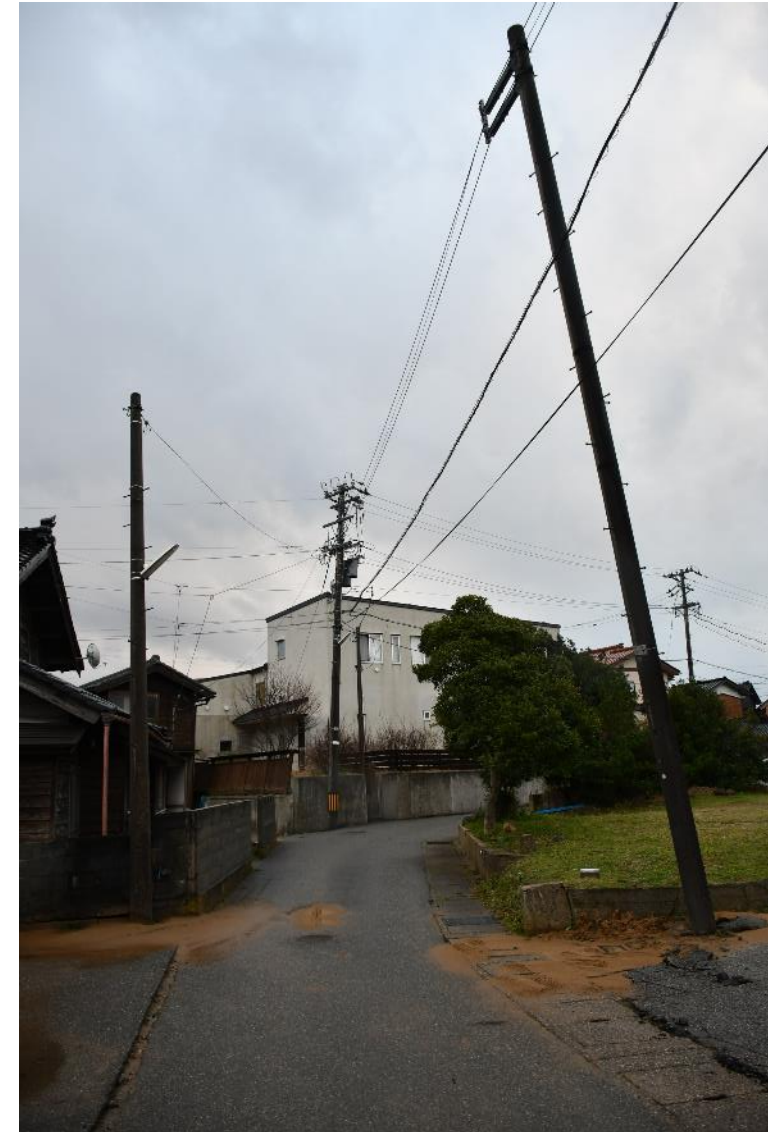
Subsidence of houses, utility poles due to liquefaction (Map①)

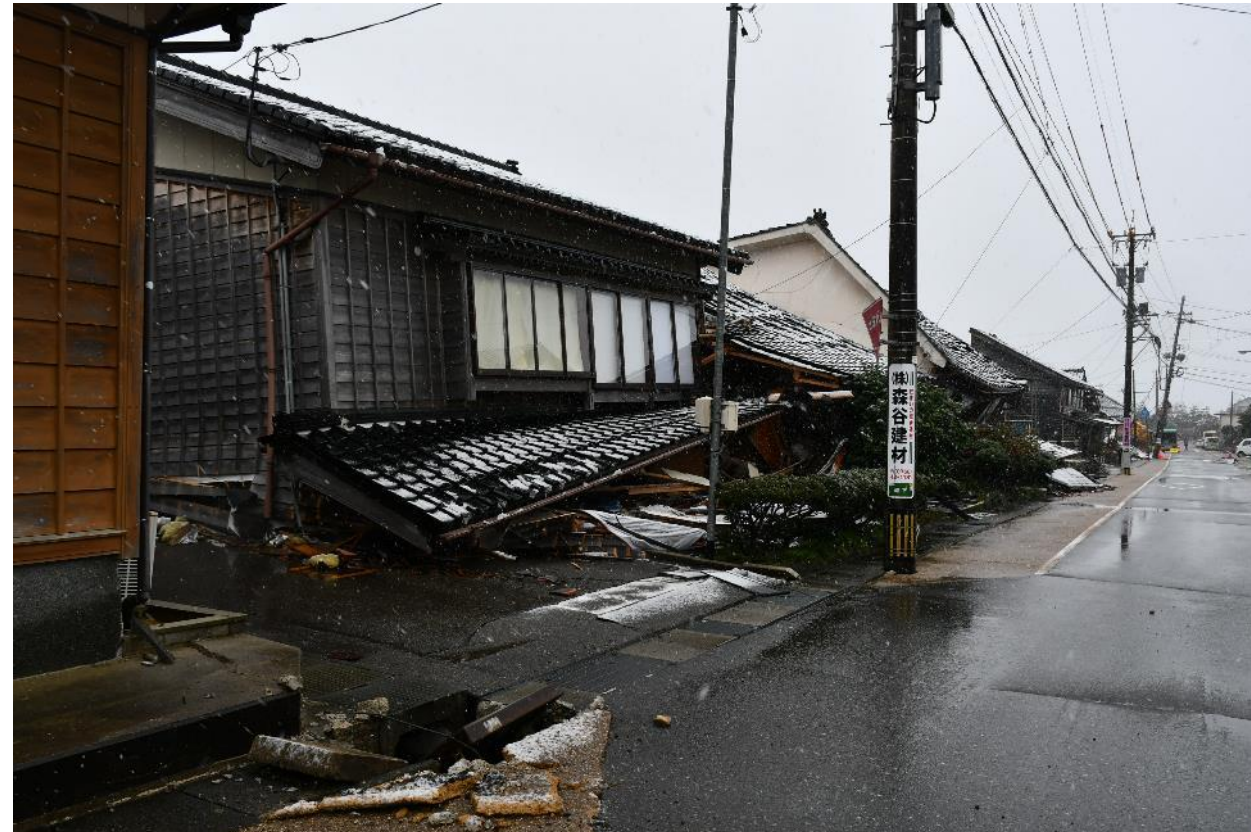
Collapse of wooden houses (Map①)

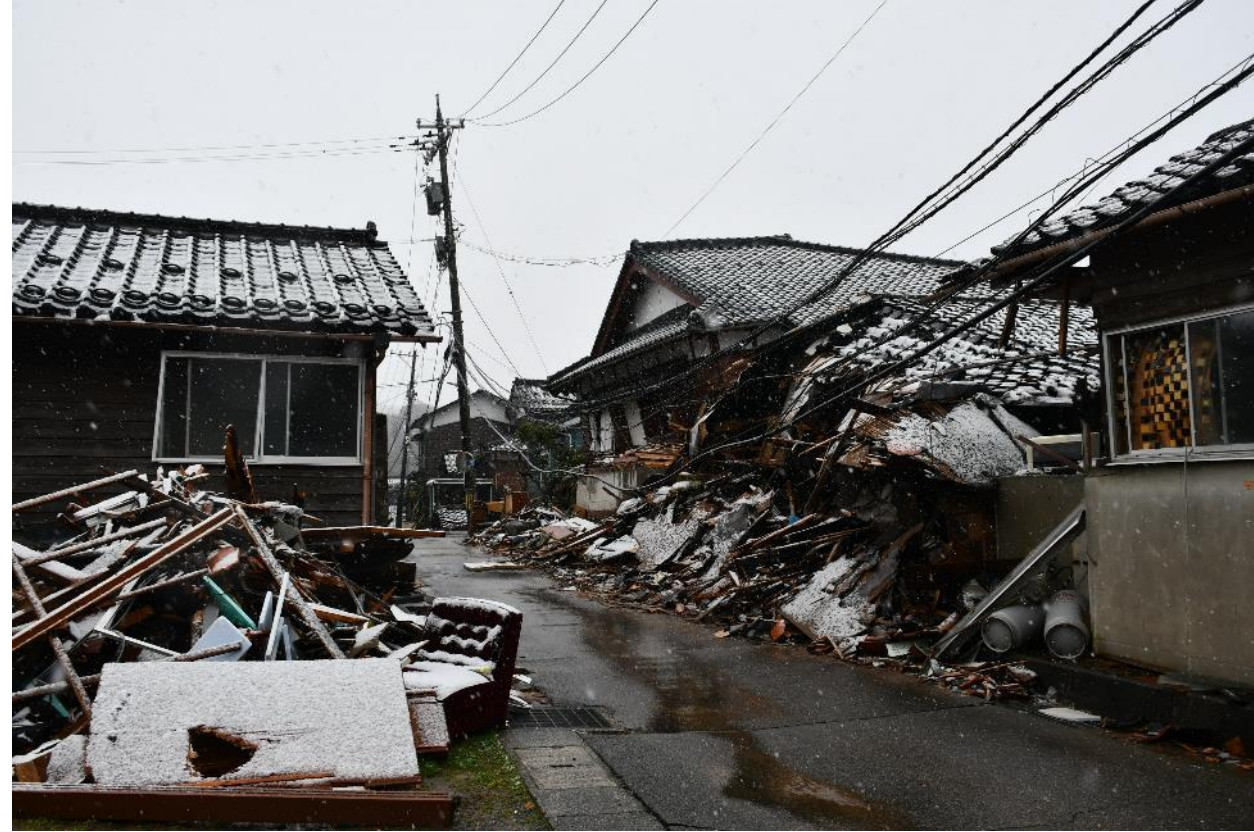
Collapse of wooden houses (Map①)
