# Quick report of preliminary reconnaissance of the 2024 Noto-hanto Earthquake in Japan —No.2—

Masakatsu Miyajima (Professor Emeritus, Kanazawa University)

Takao Hashimoto (Specially Appointed Professor, Kokushikan University)

Survey Period: 2024.1.12-1.15

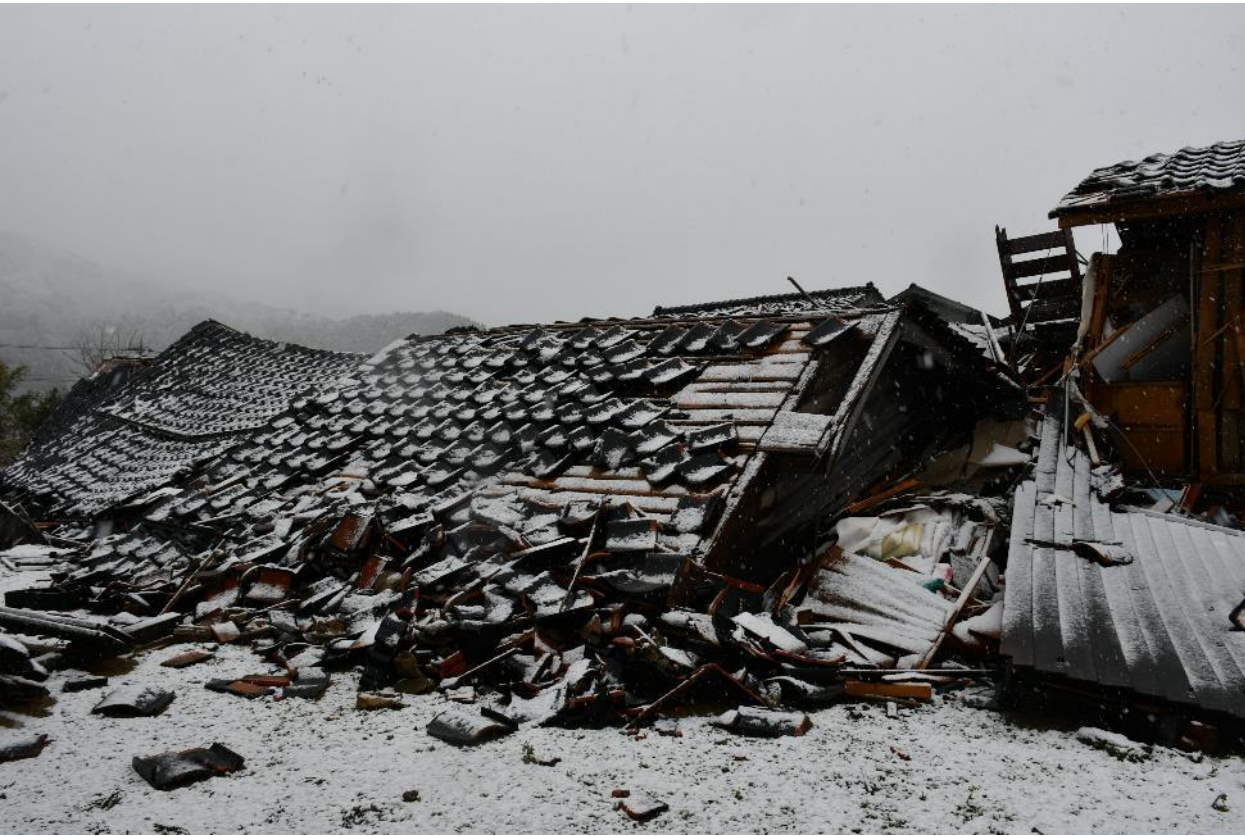
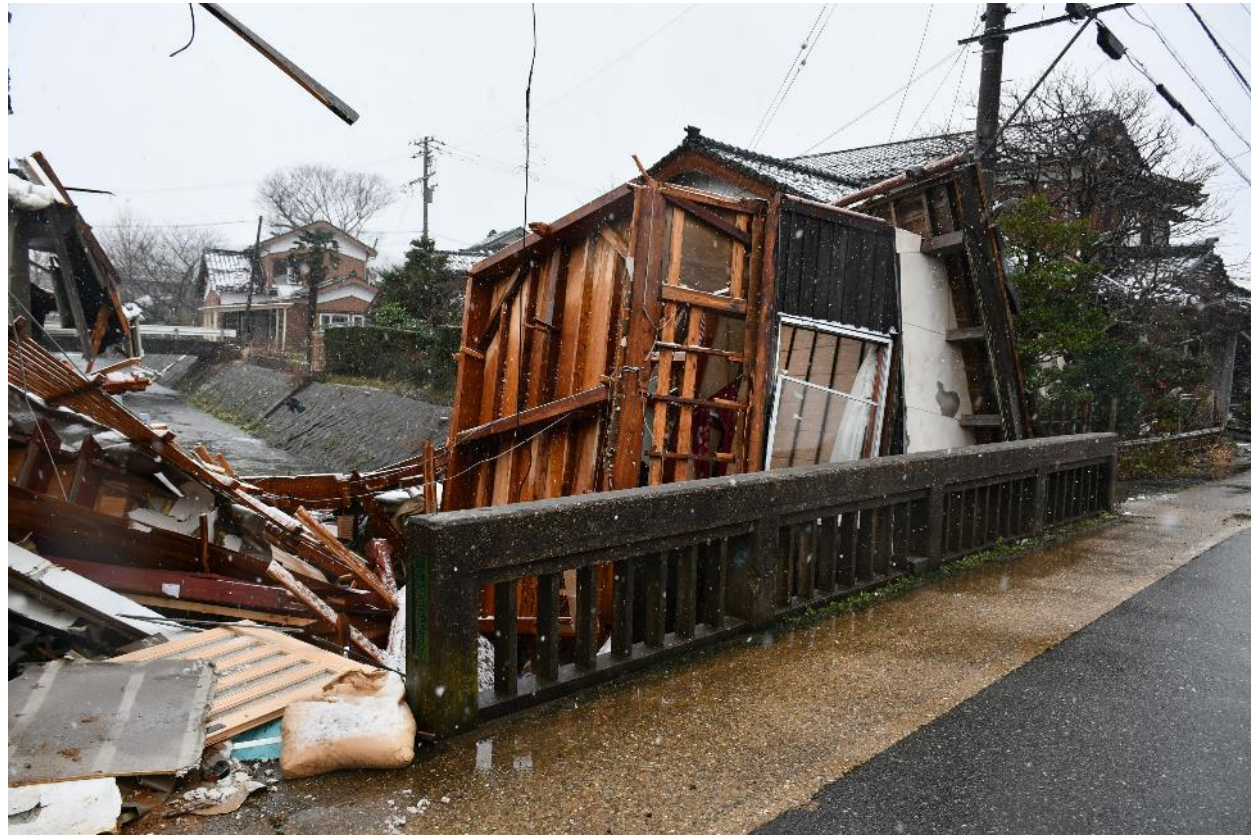
Collapse of wooden houses (Map①)

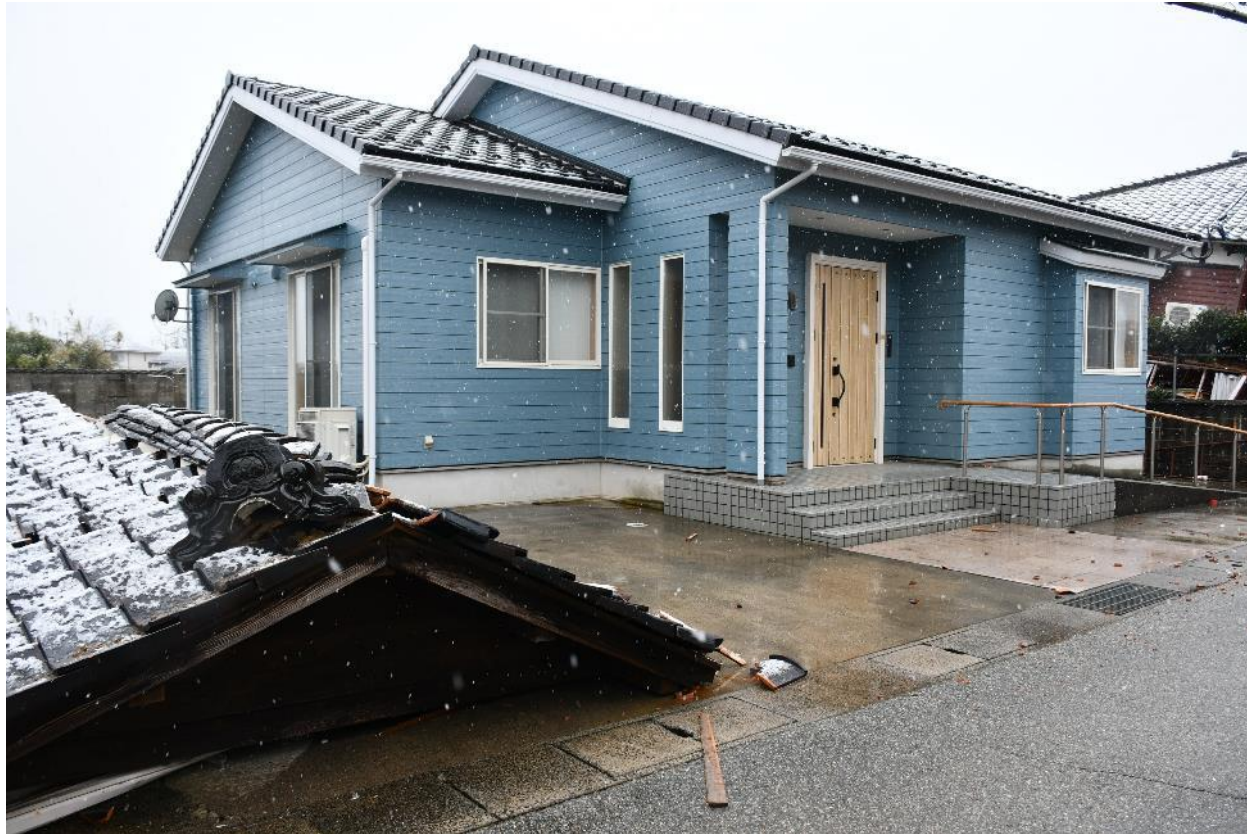
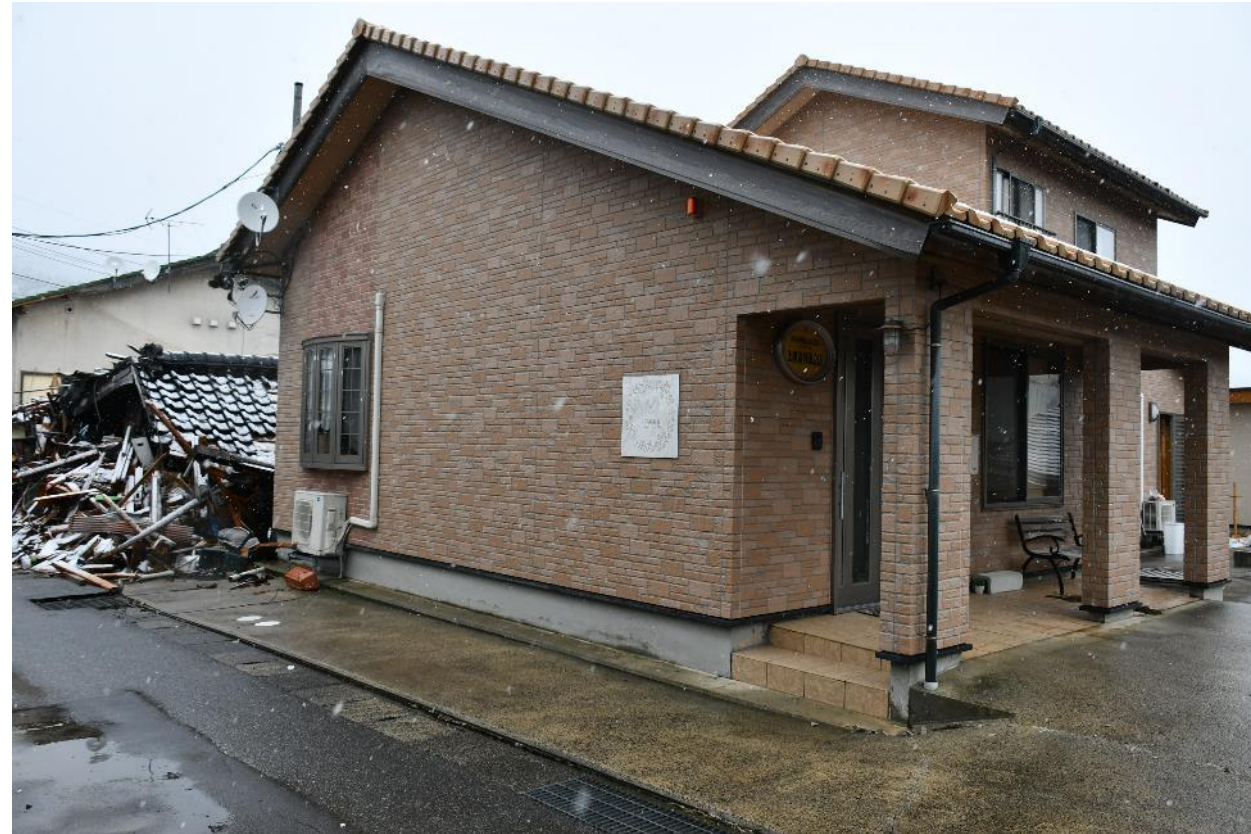
New houses were undamaged even in the affected area (Map①)

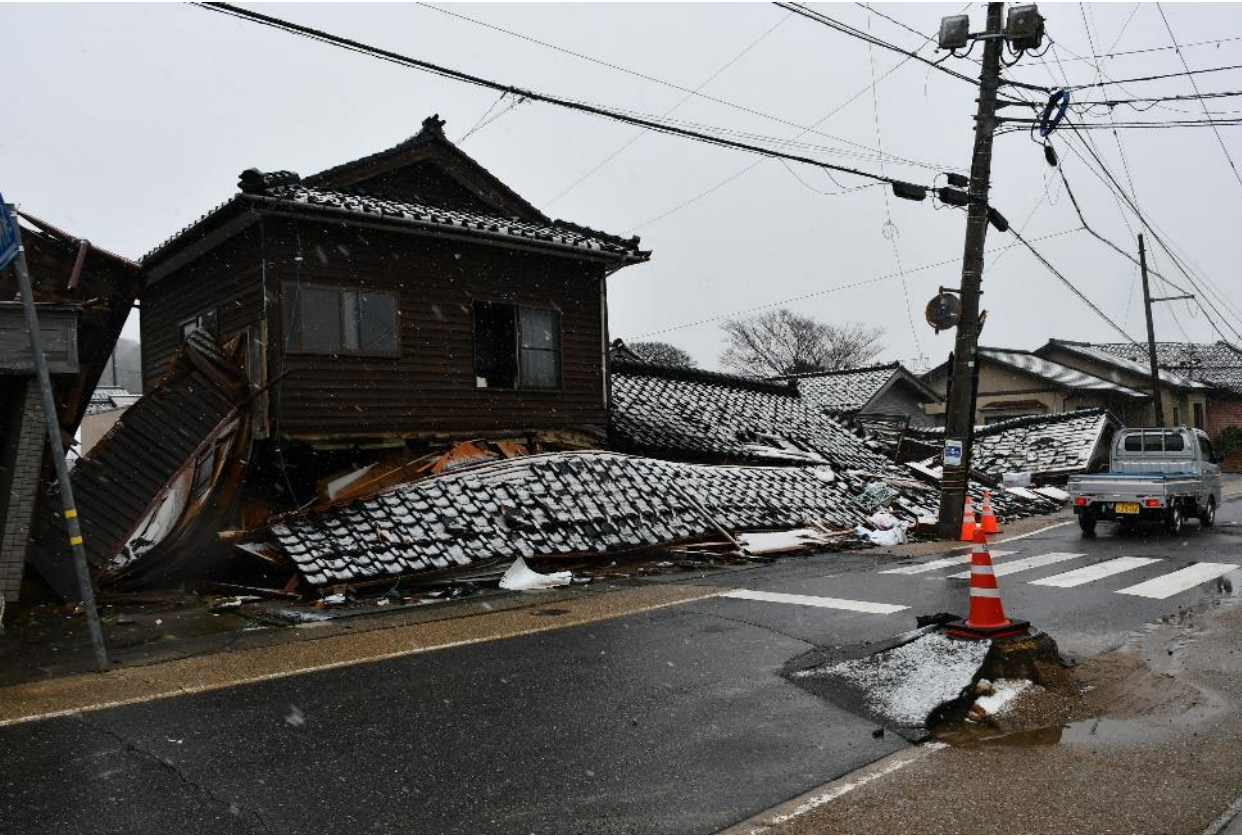
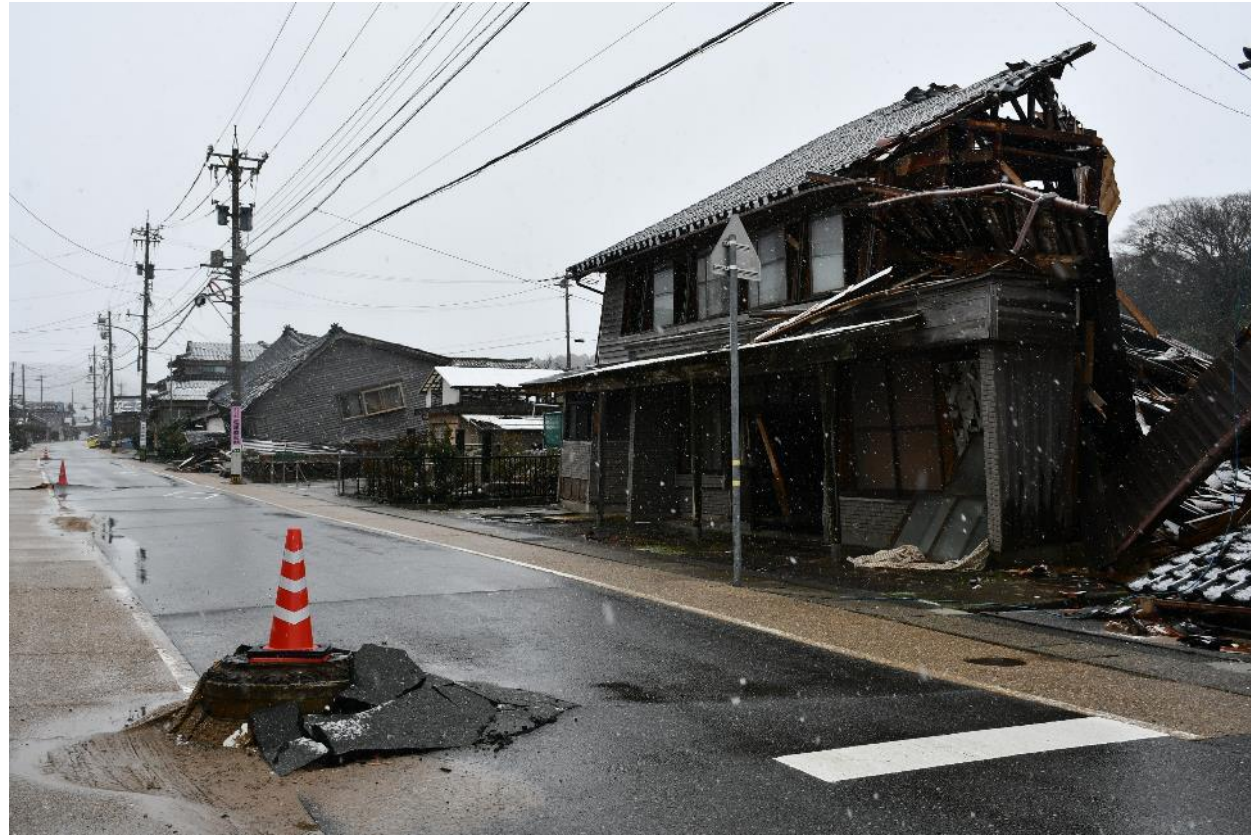
Uplift of manholes (Map②)

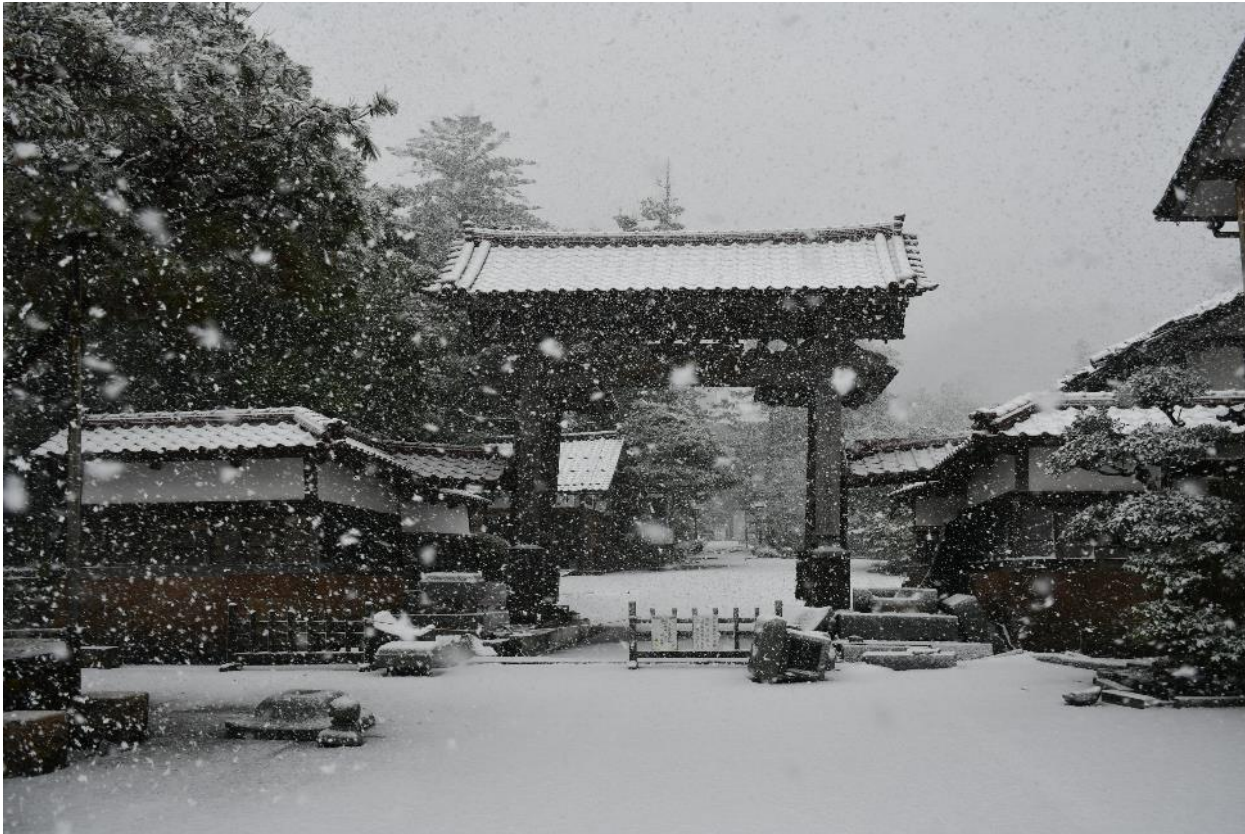
Extensive damage to Soujiji Temple (Map③)

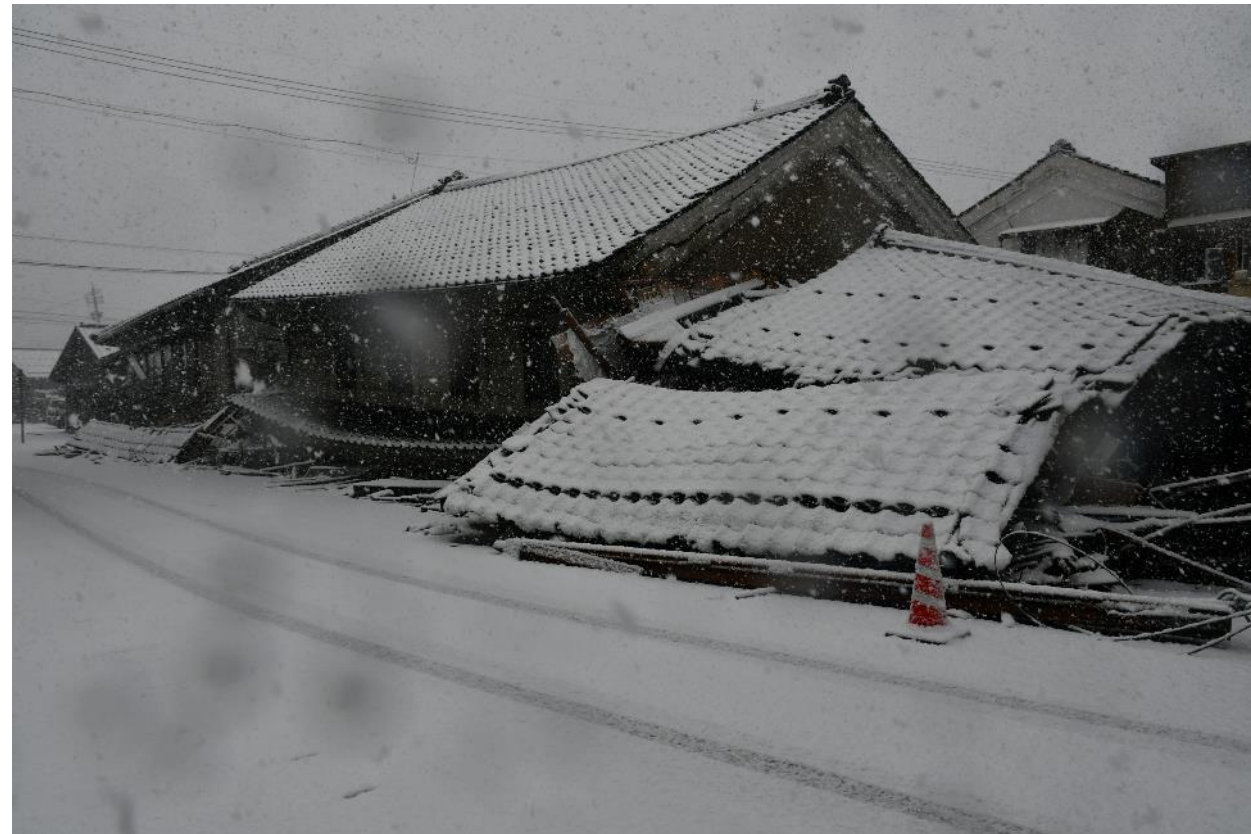
Collapse of wooden house (Map③)

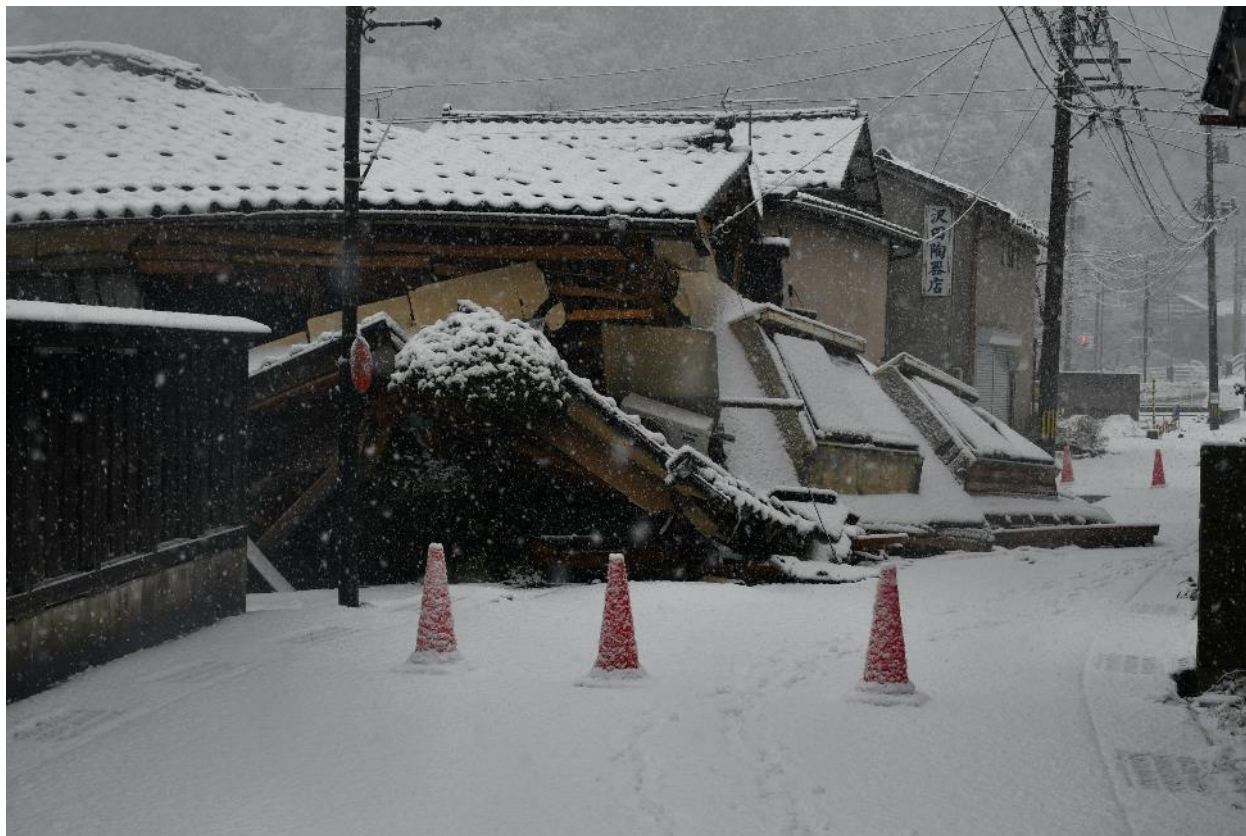
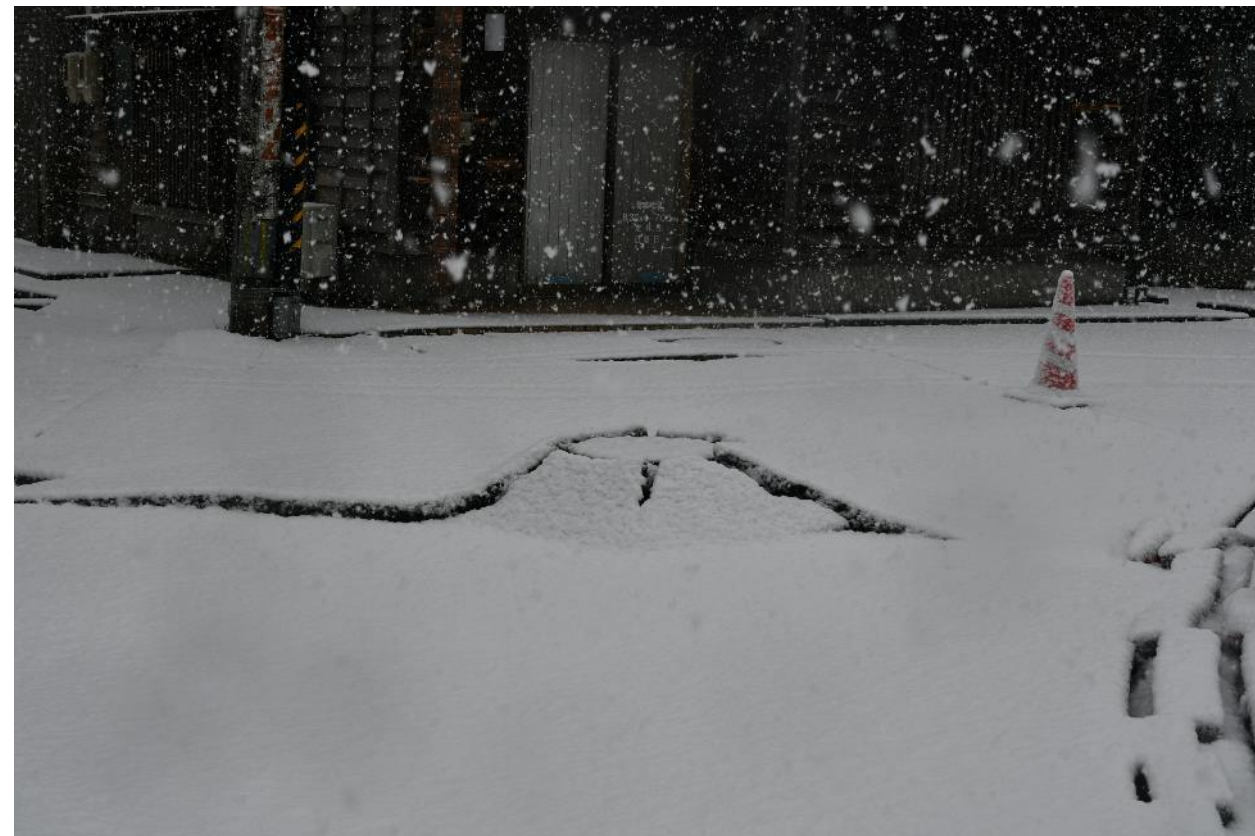
Traffic obstructions caused by collapsed houses and floating manholes (Map③)

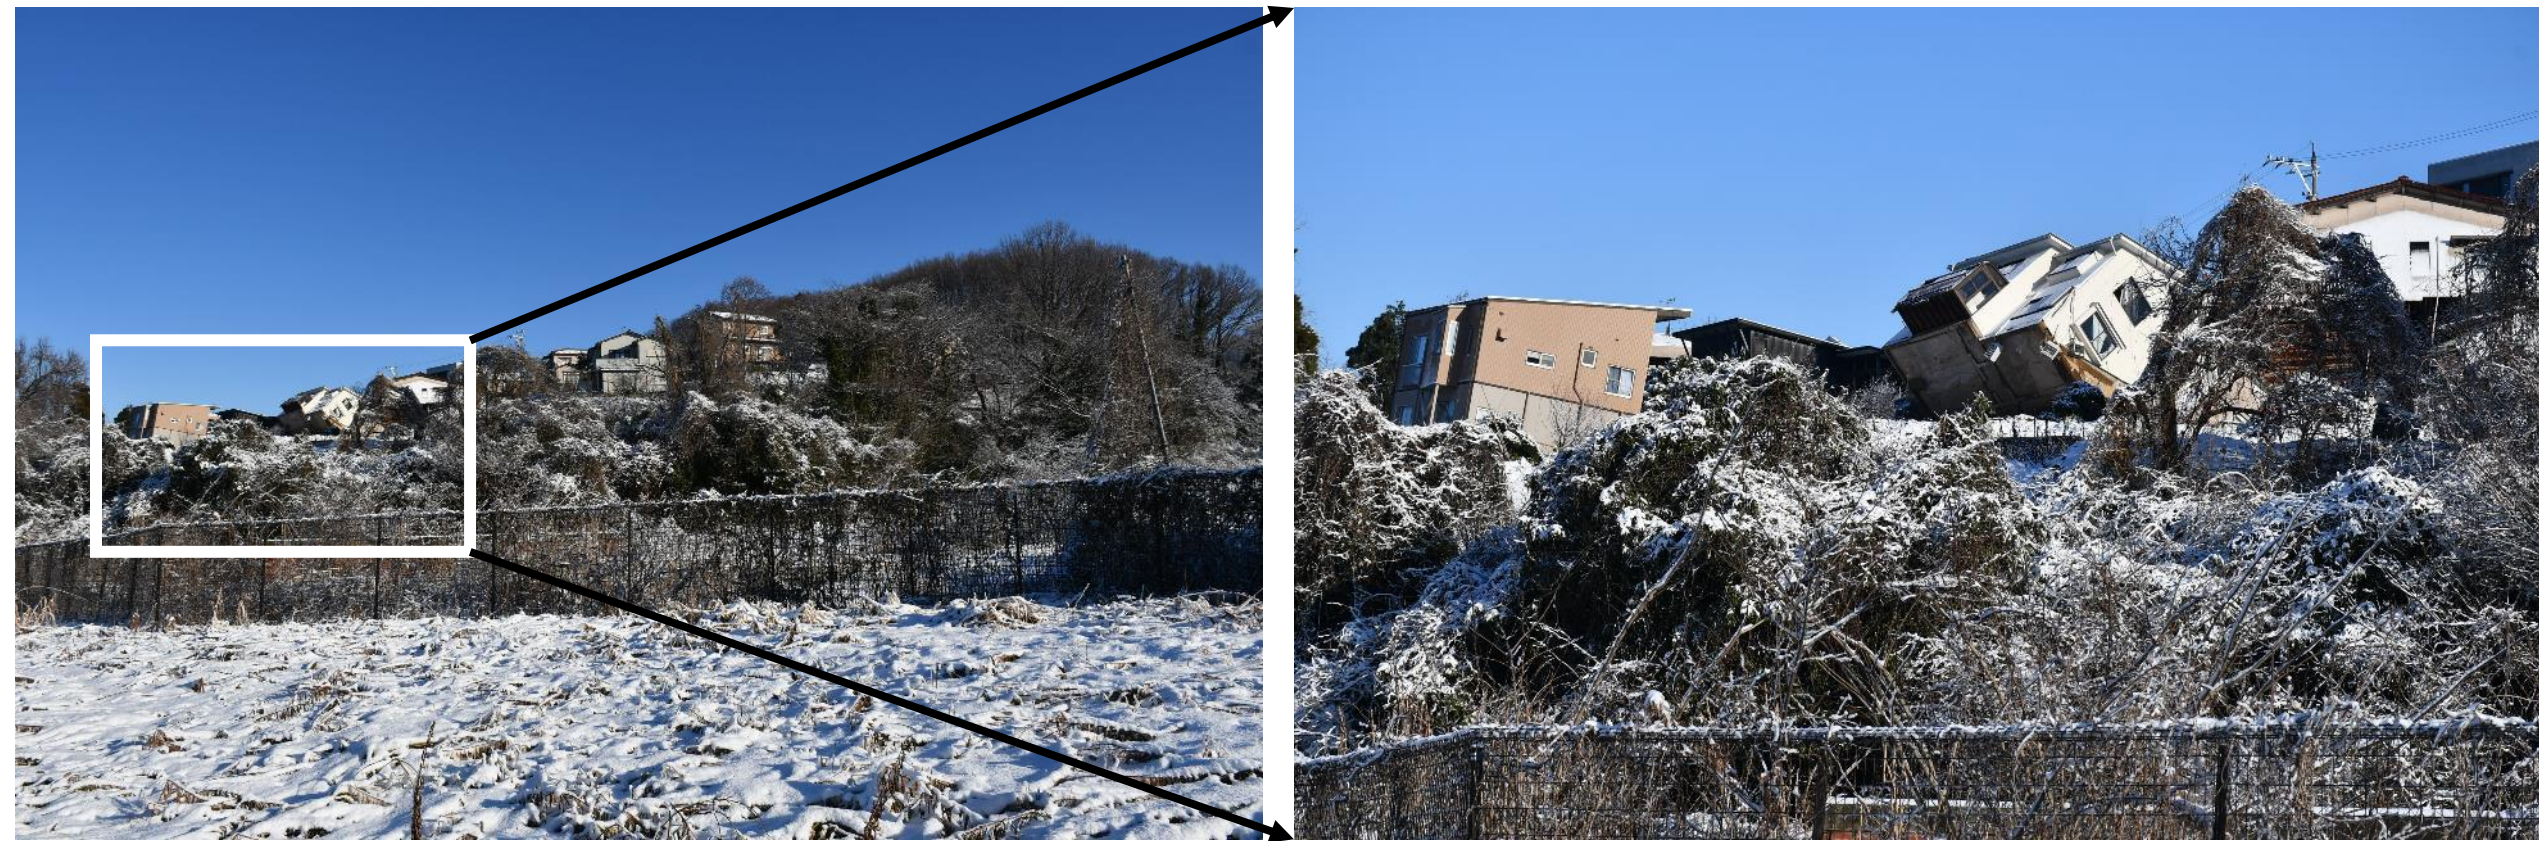
Damage to houses caused by landslides on embankment of developed residential areas (Map①)

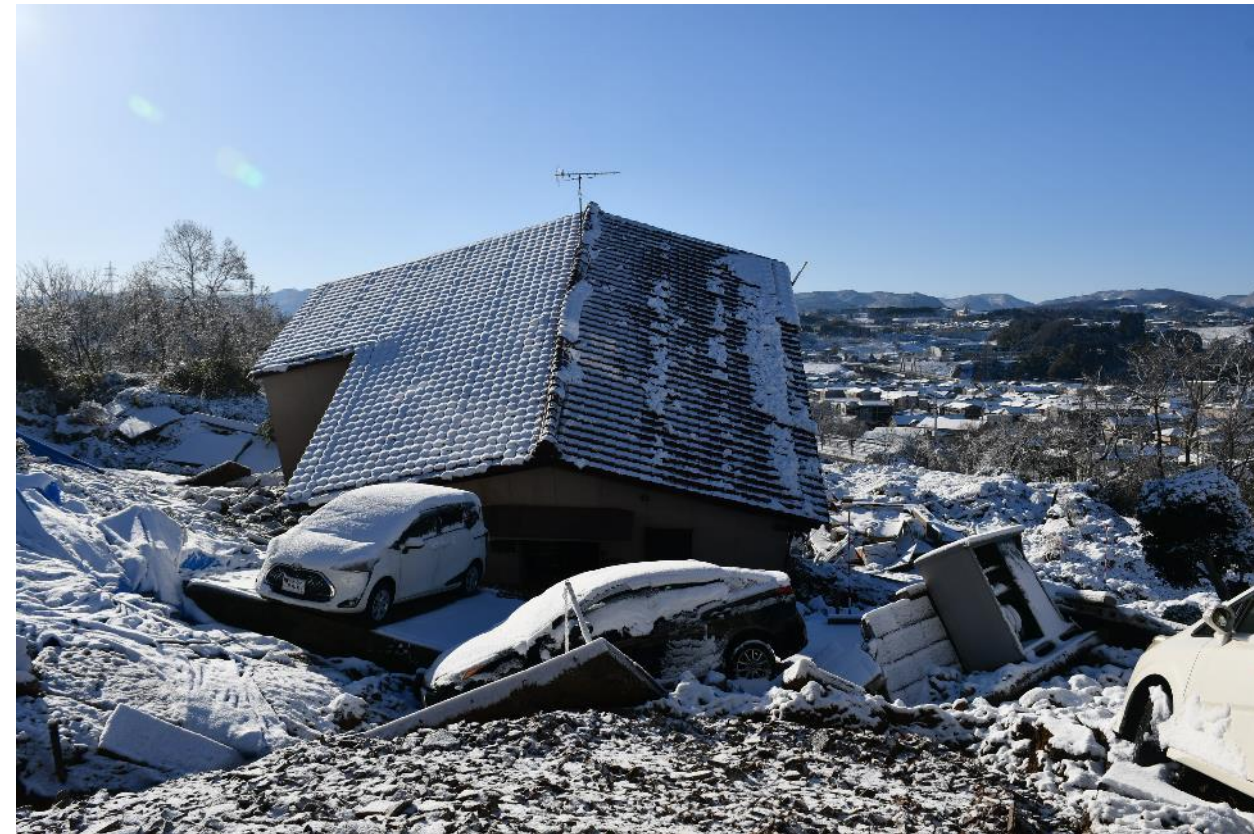
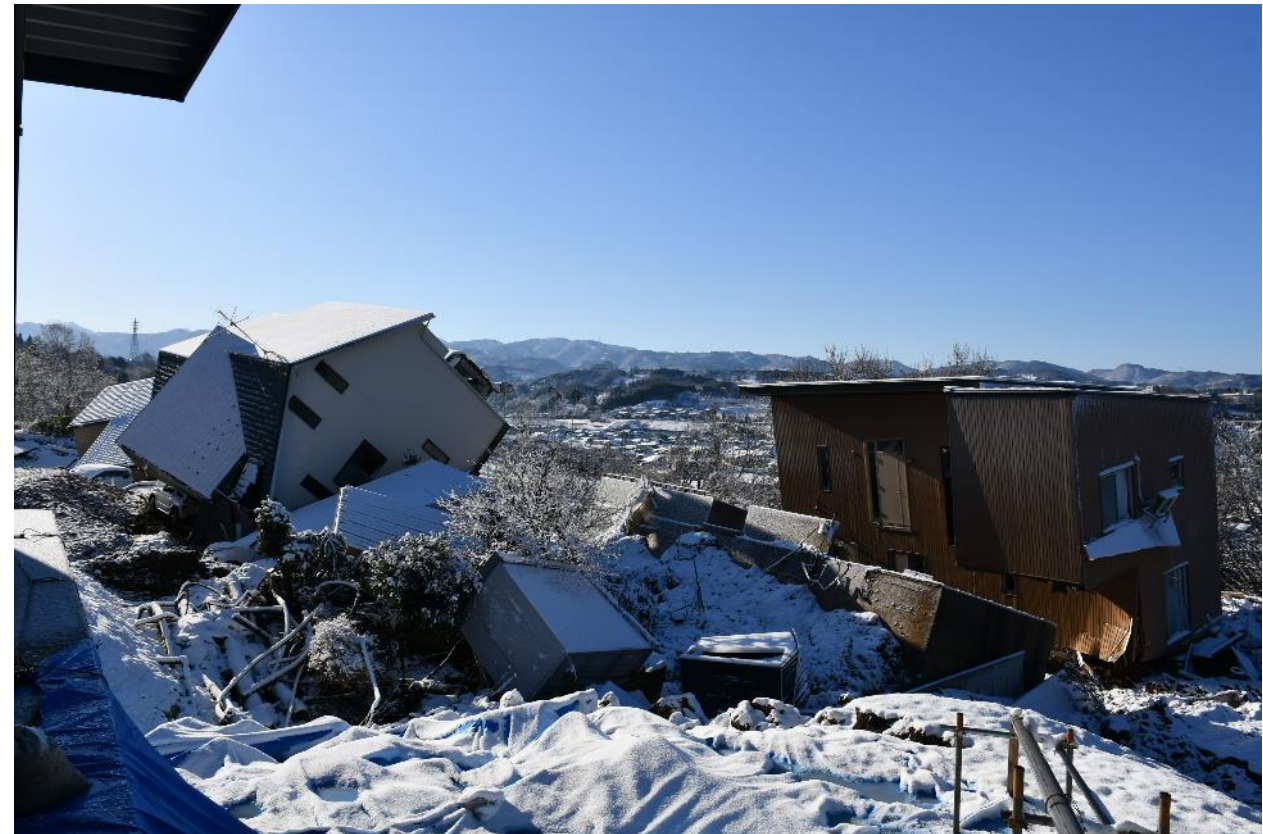
Damage to houses caused by landslides on embankment of developed residential areas (Map①)

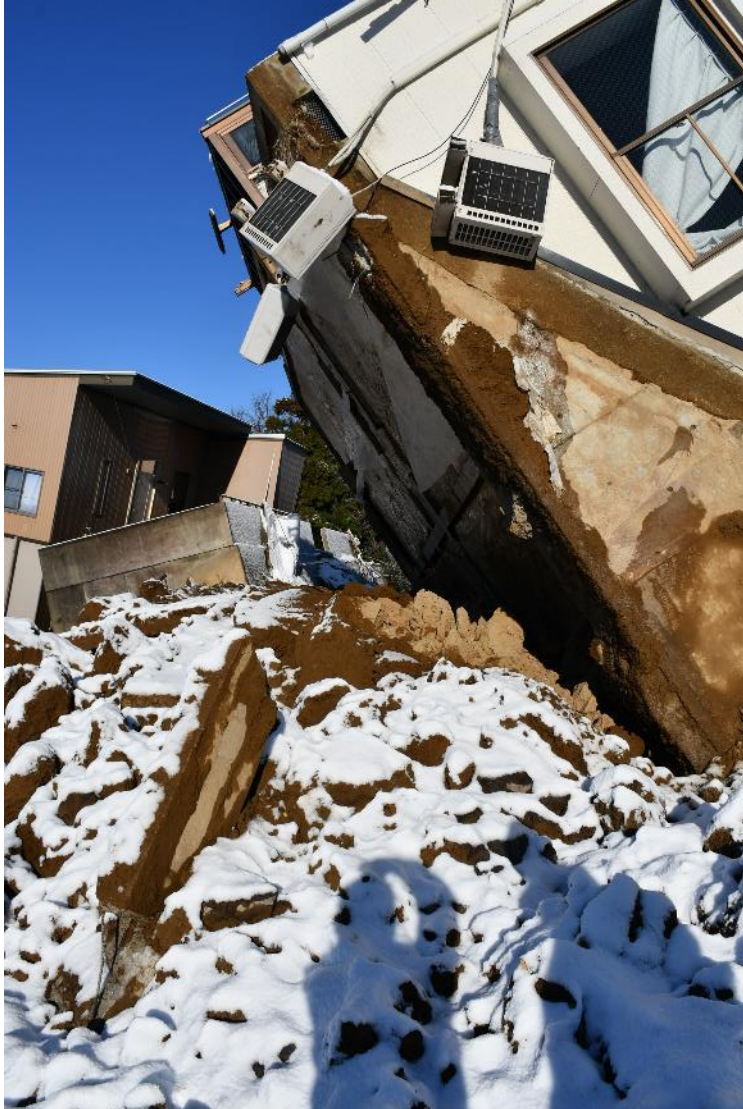
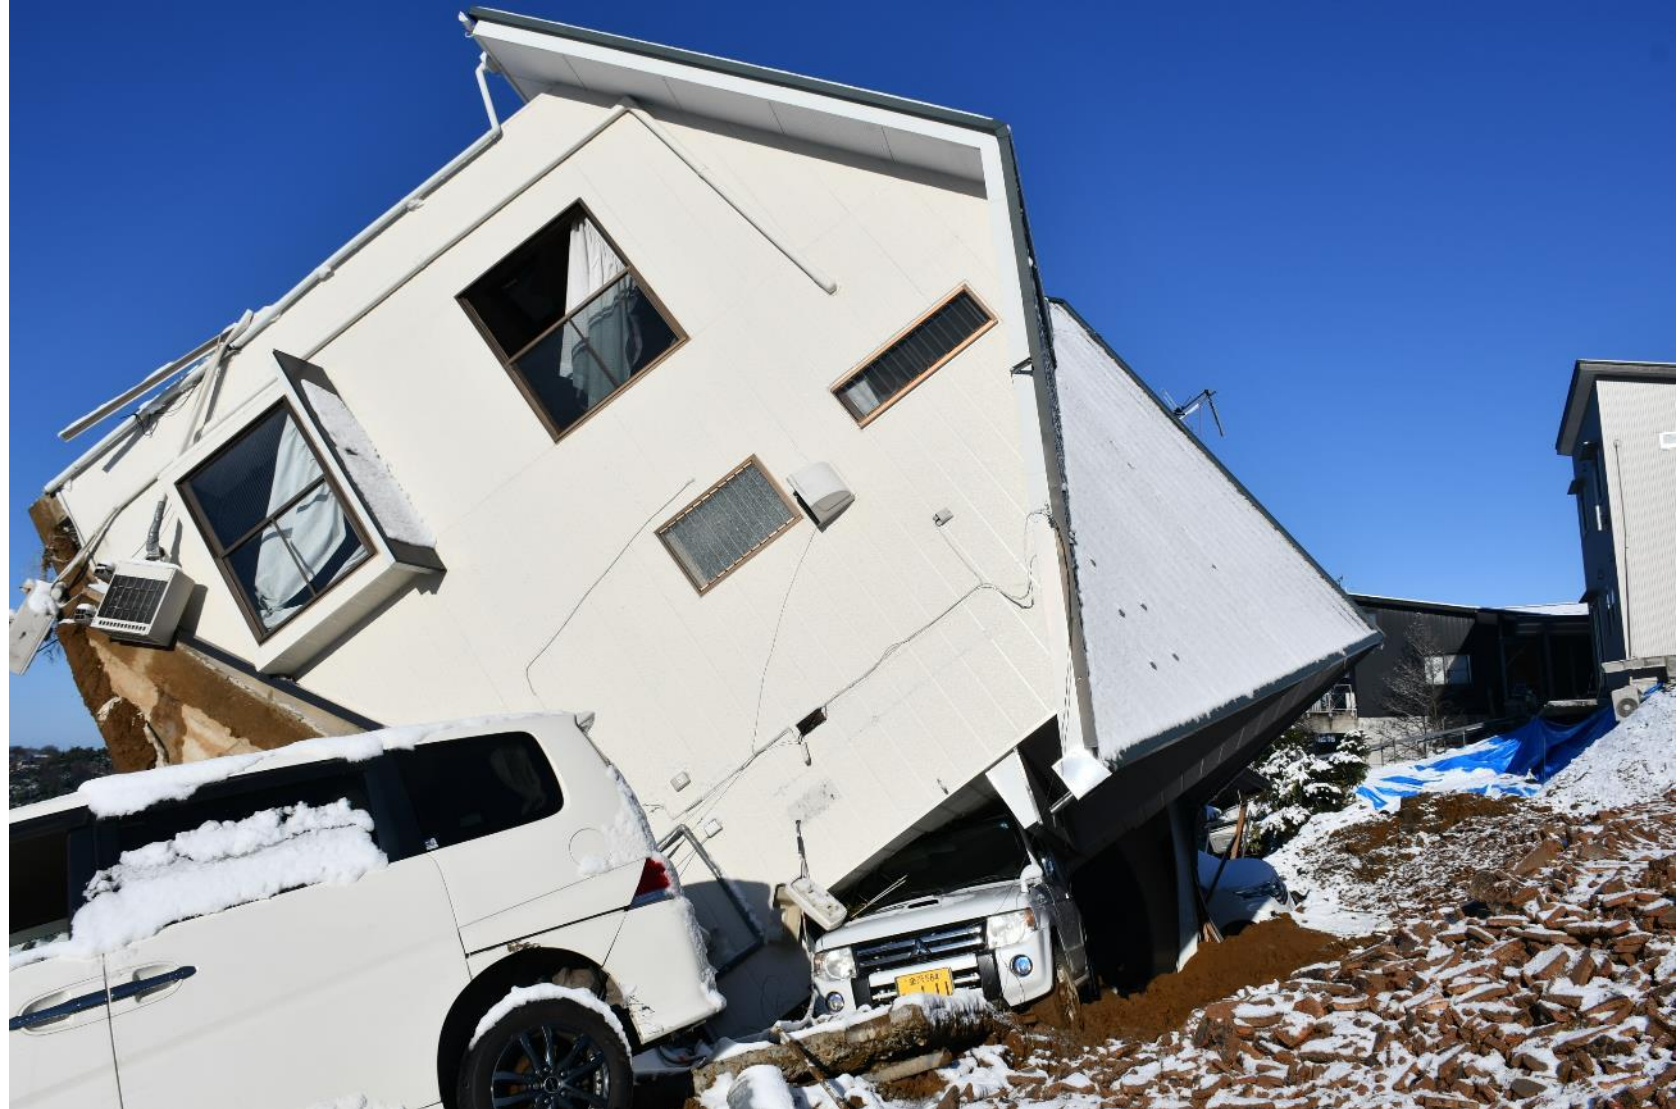
Damage to houses caused by landslides on embankment of developed residential areas (Map①)

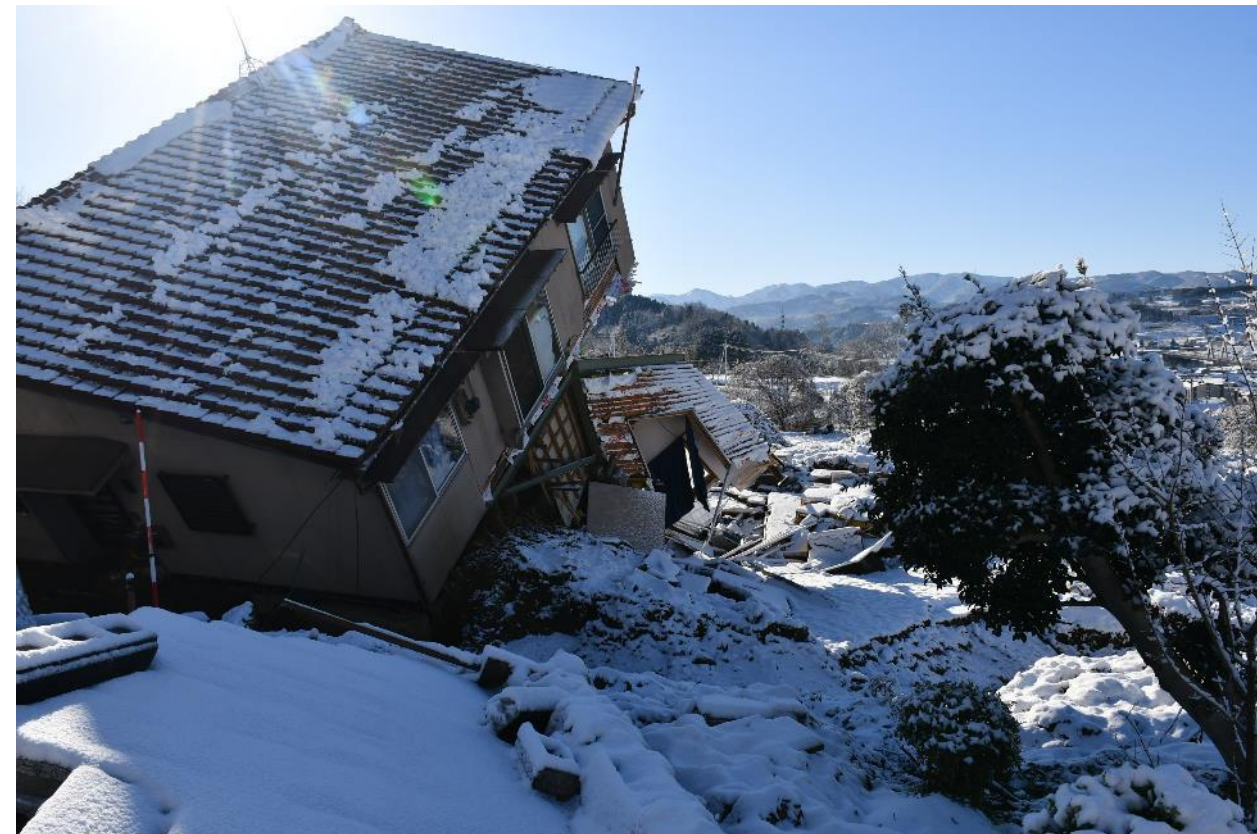
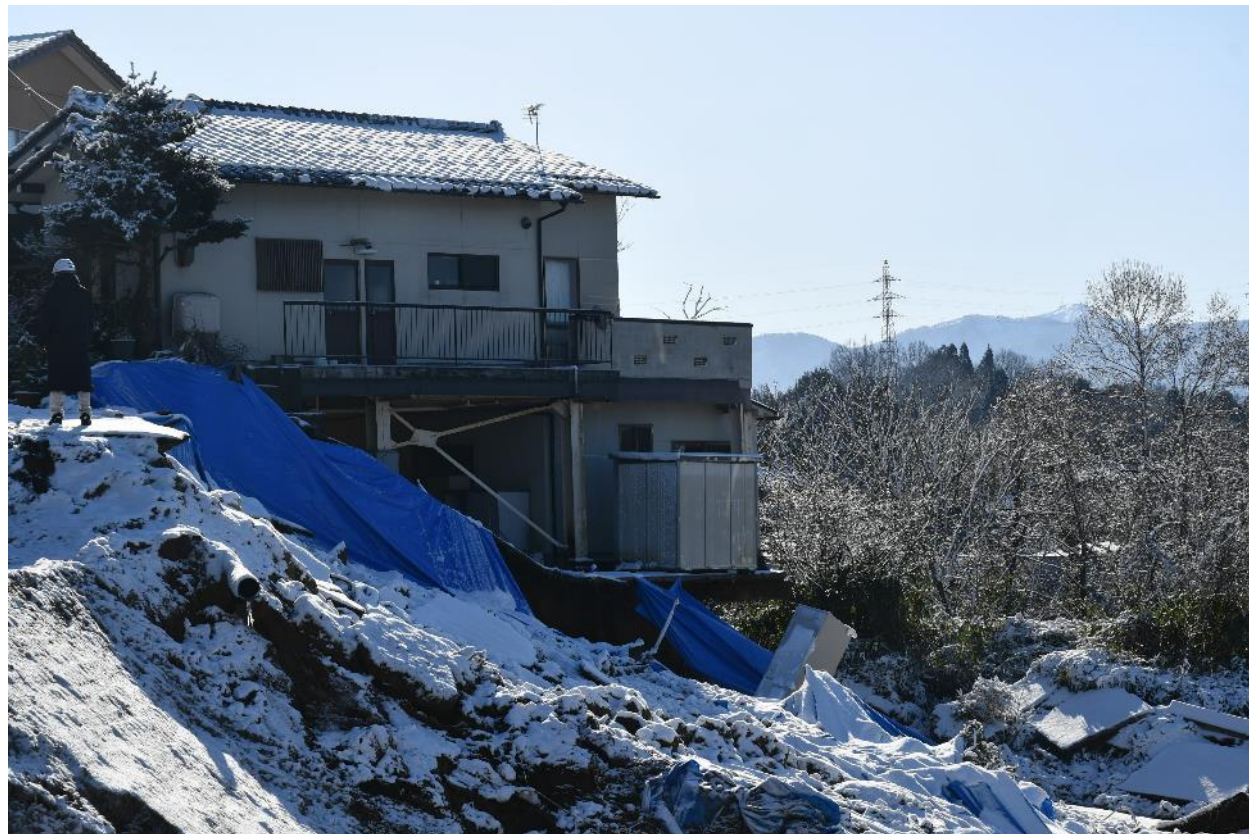
Damage to houses caused by landslides on embankment of developed residential areas (Map①)

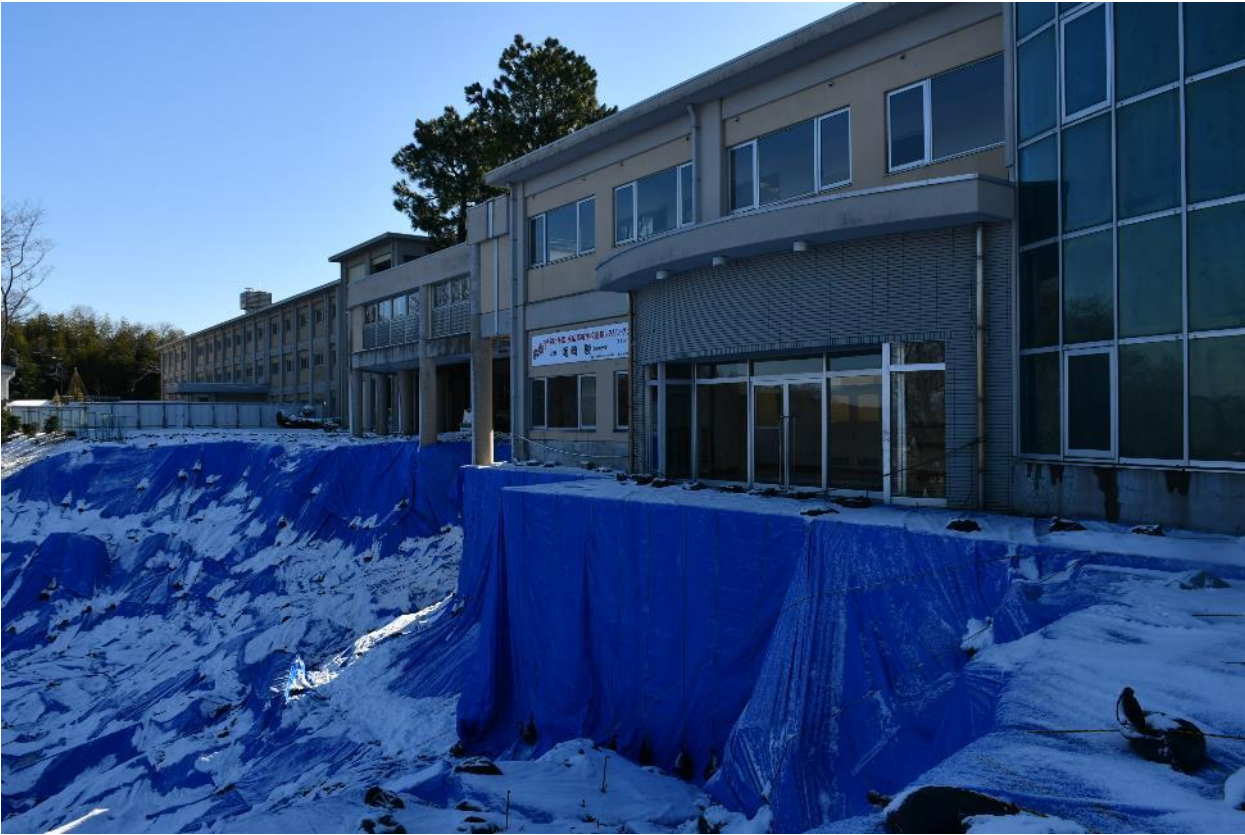
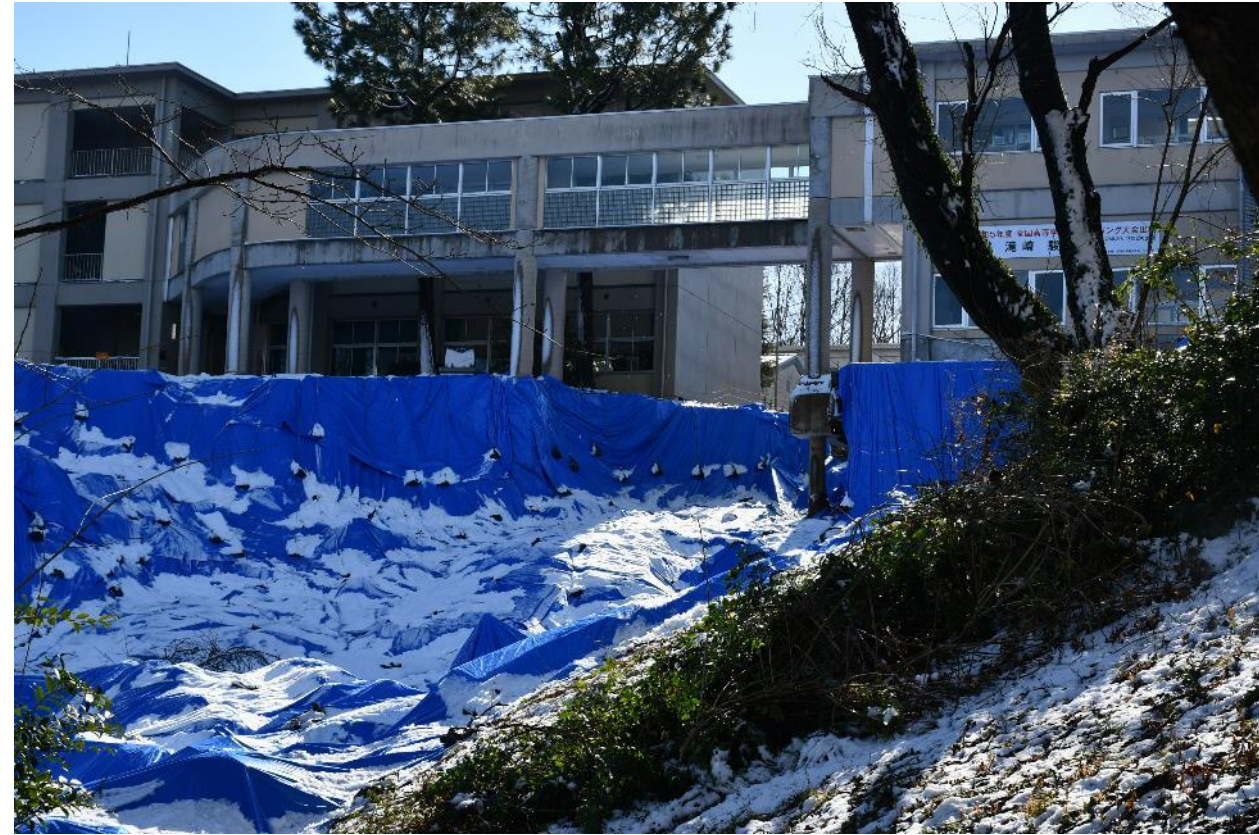
Slope failure on the high school grounds (Map②)
