# Quick report of preliminary reconnaissance of the 2024 Noto-hanto Earthquake in Japan —No.2—

Masakatsu Miyajima (Professor Emeritus, Kanazawa University)

Takao Hashimoto (Specially Appointed Professor, Kokushikan University)

Survey Period: 2024.1.12-1.15

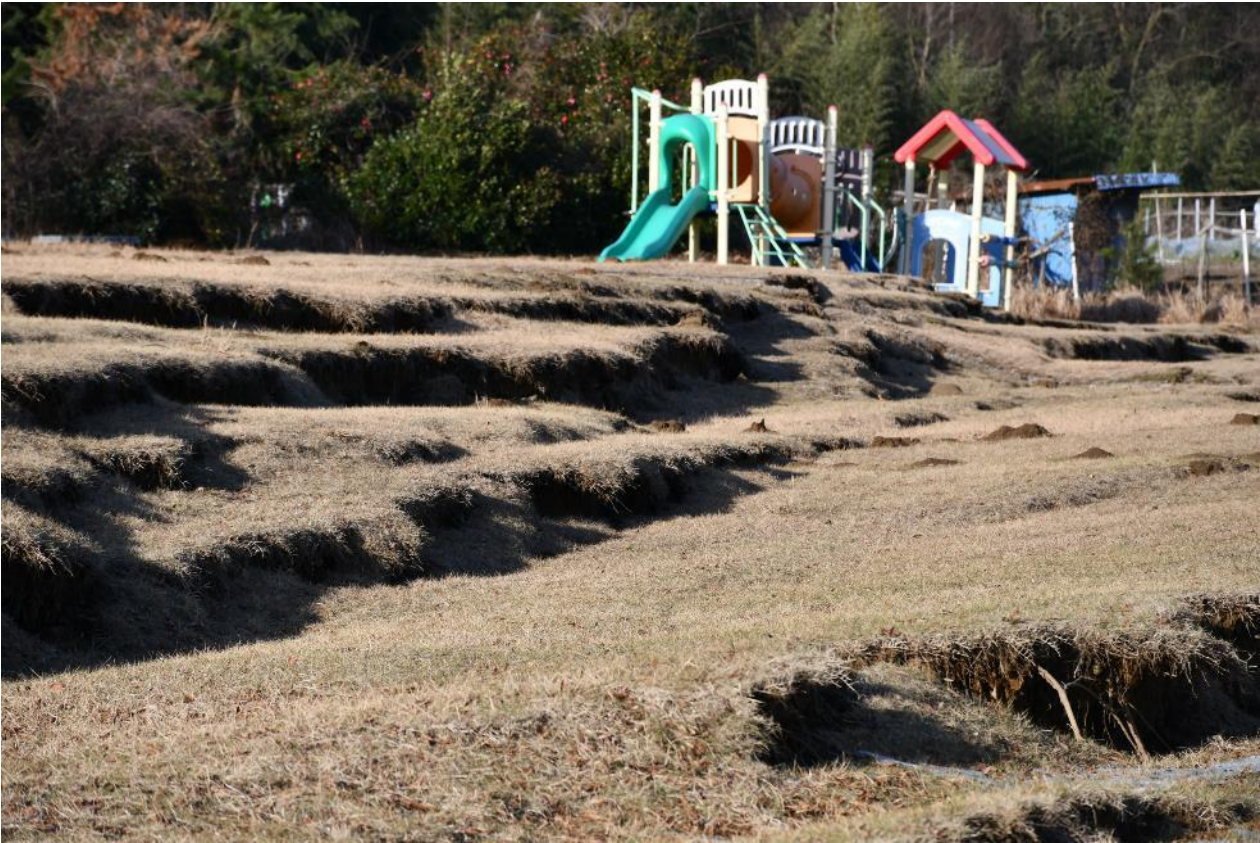
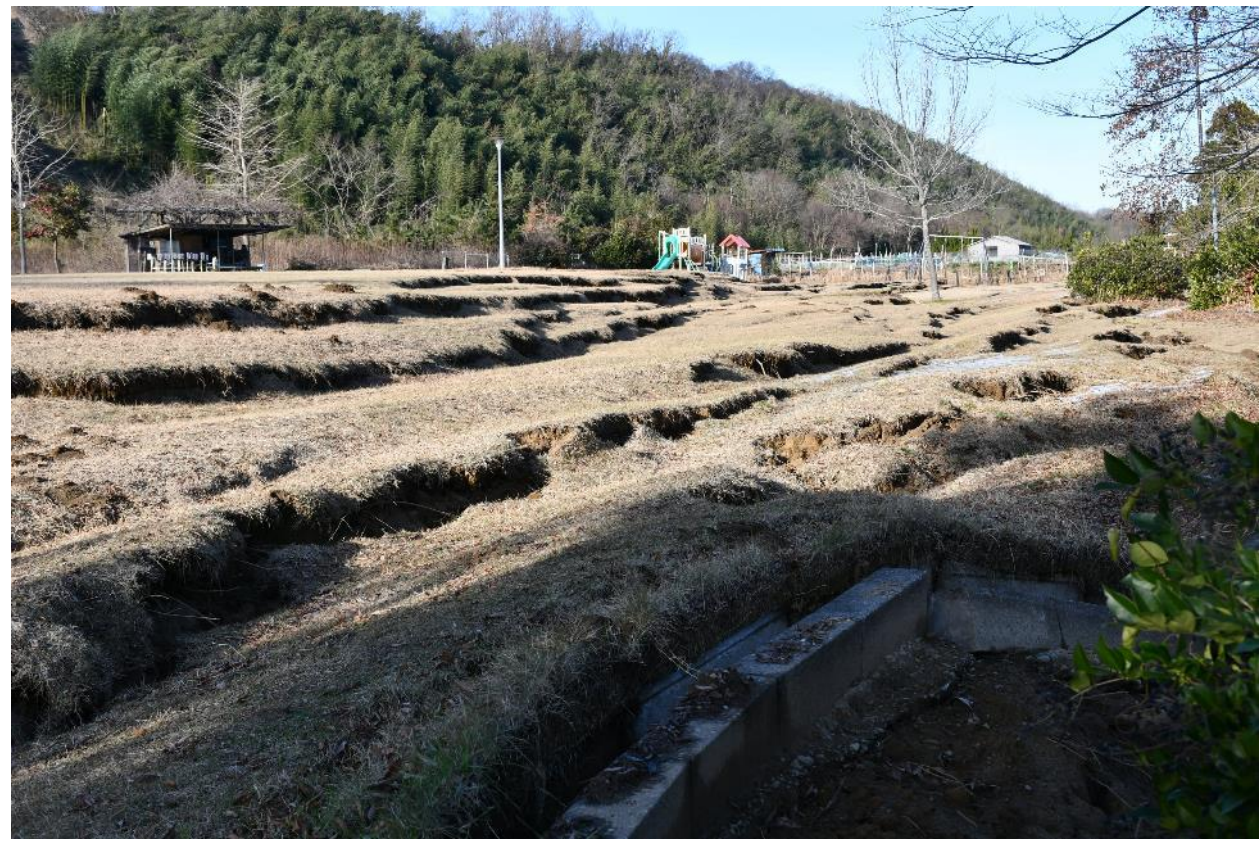
Ground deformation due to lateral flow (Map①)

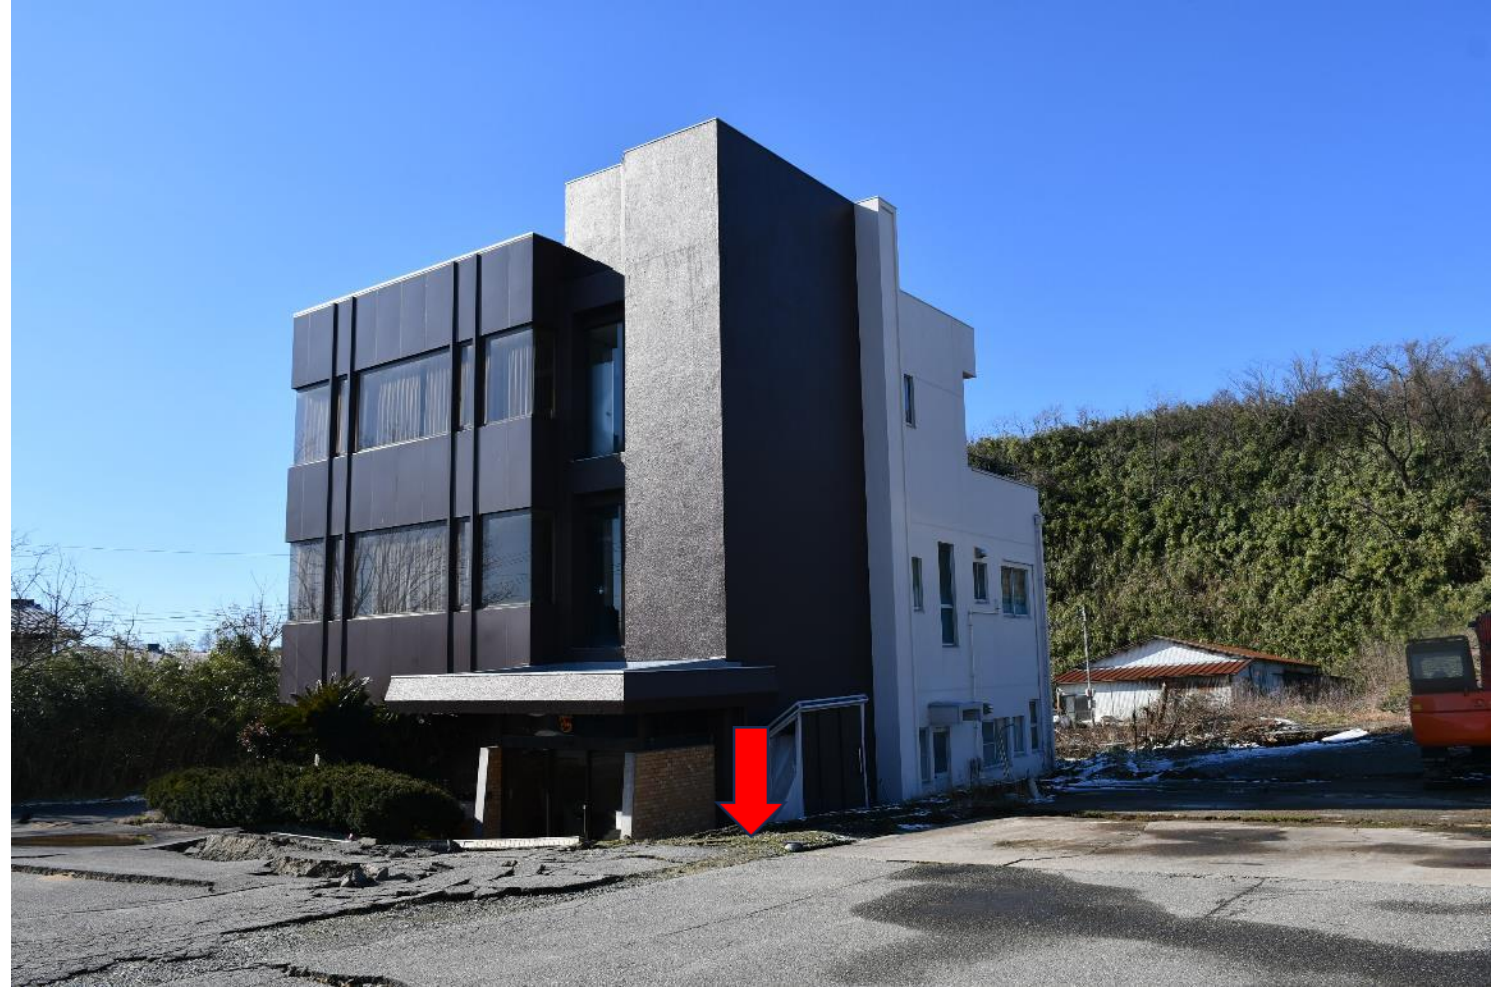
Subsidence of RC building due to liquefaction (Map②)

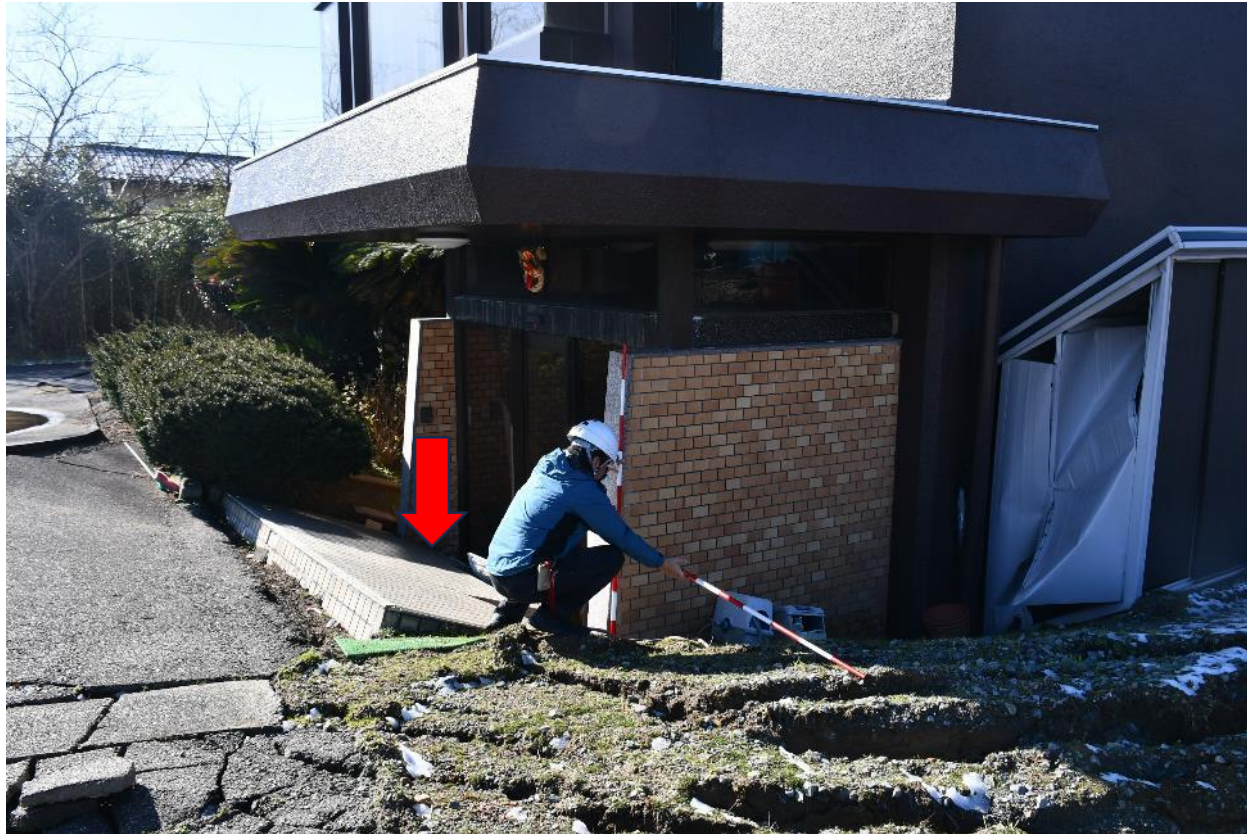
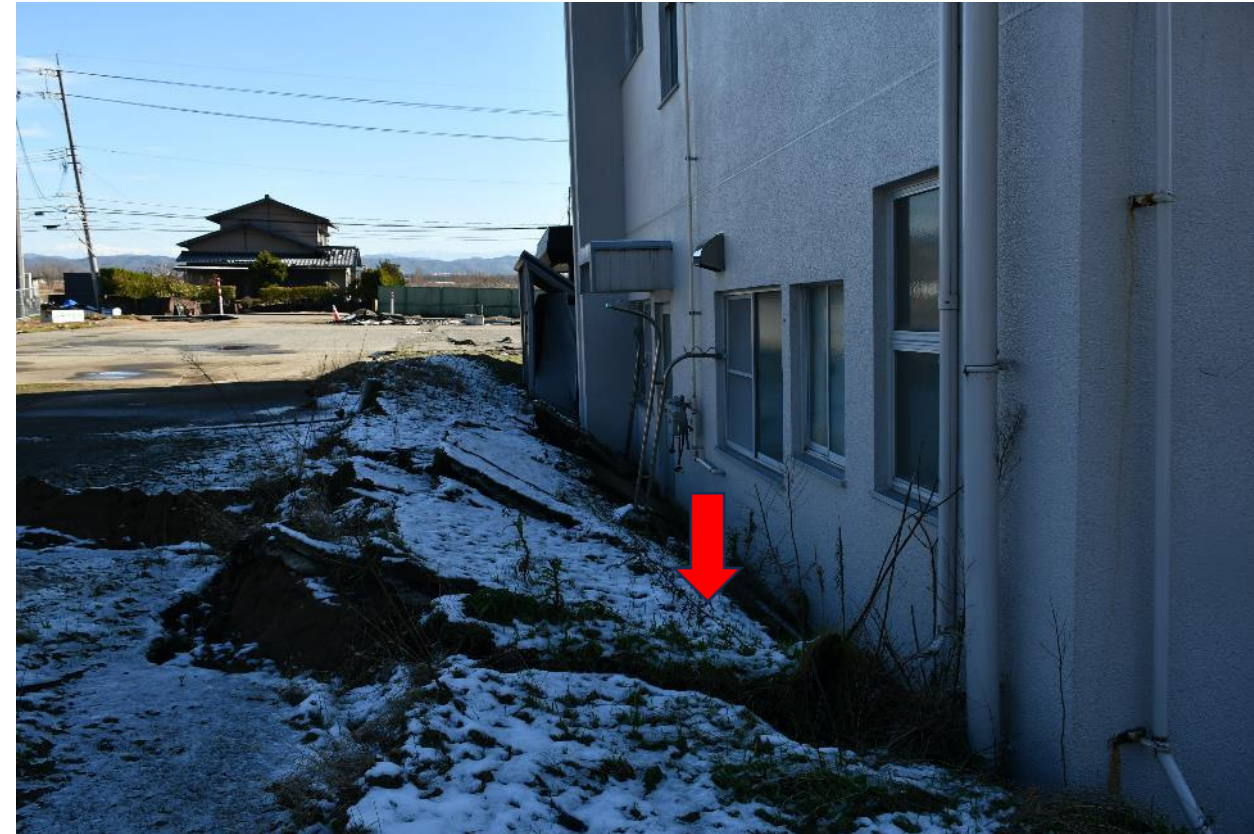
Subsidence of RC building due to liquefaction (Map②)

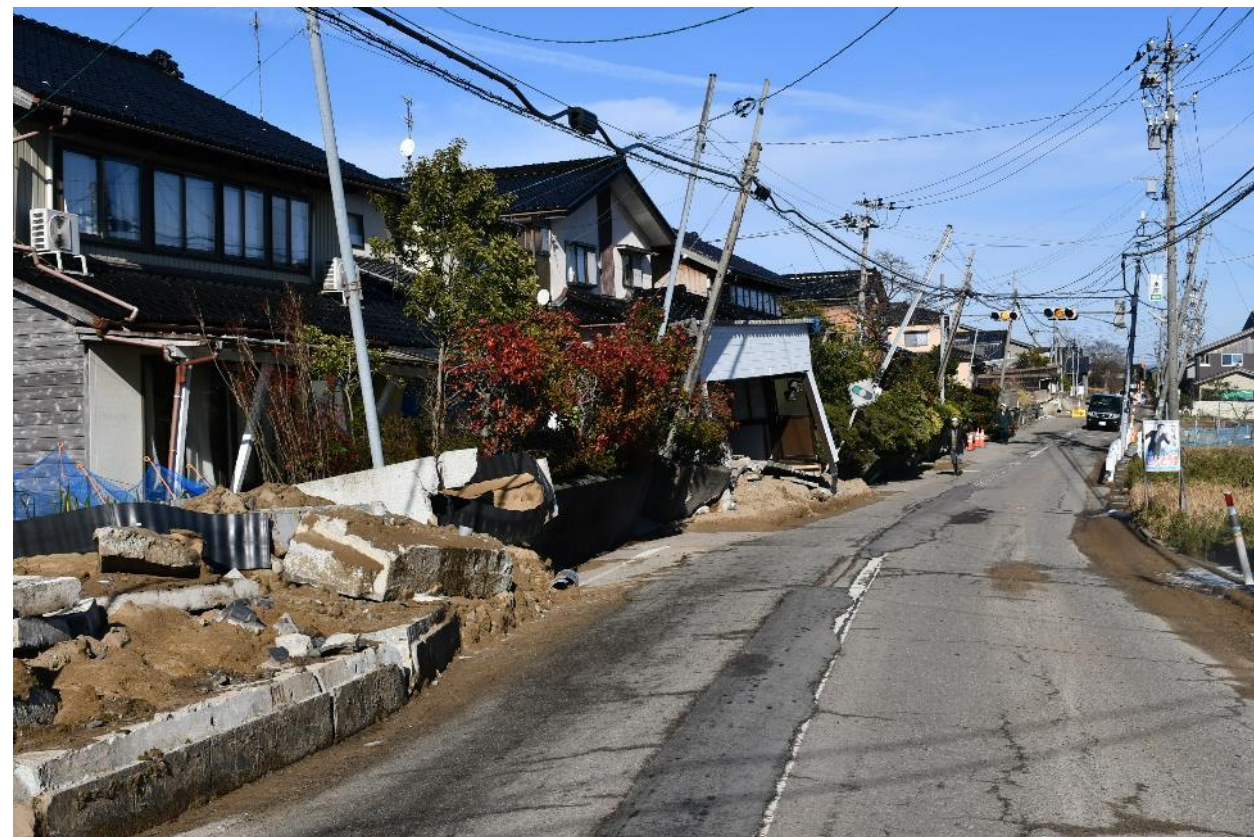
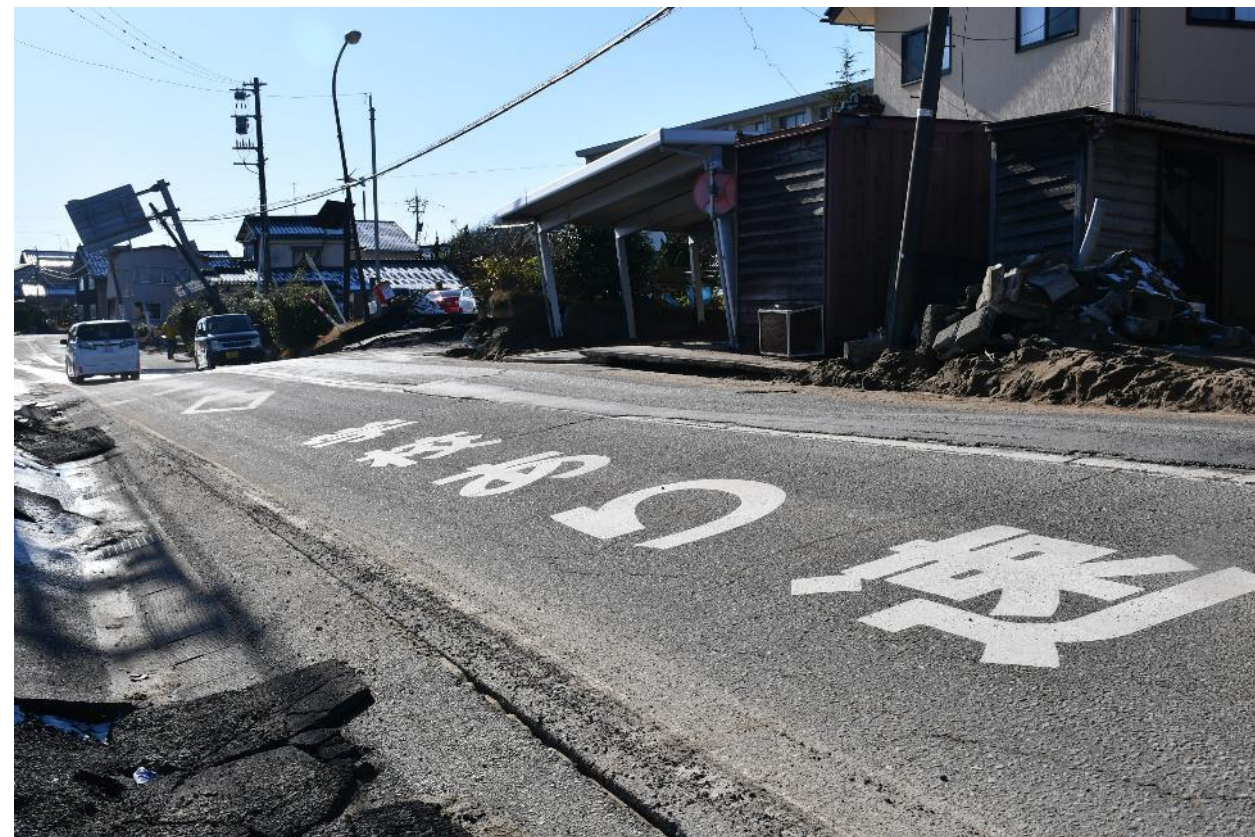
Meandering of the road due to lateral flow of liquefied ground (Map③)

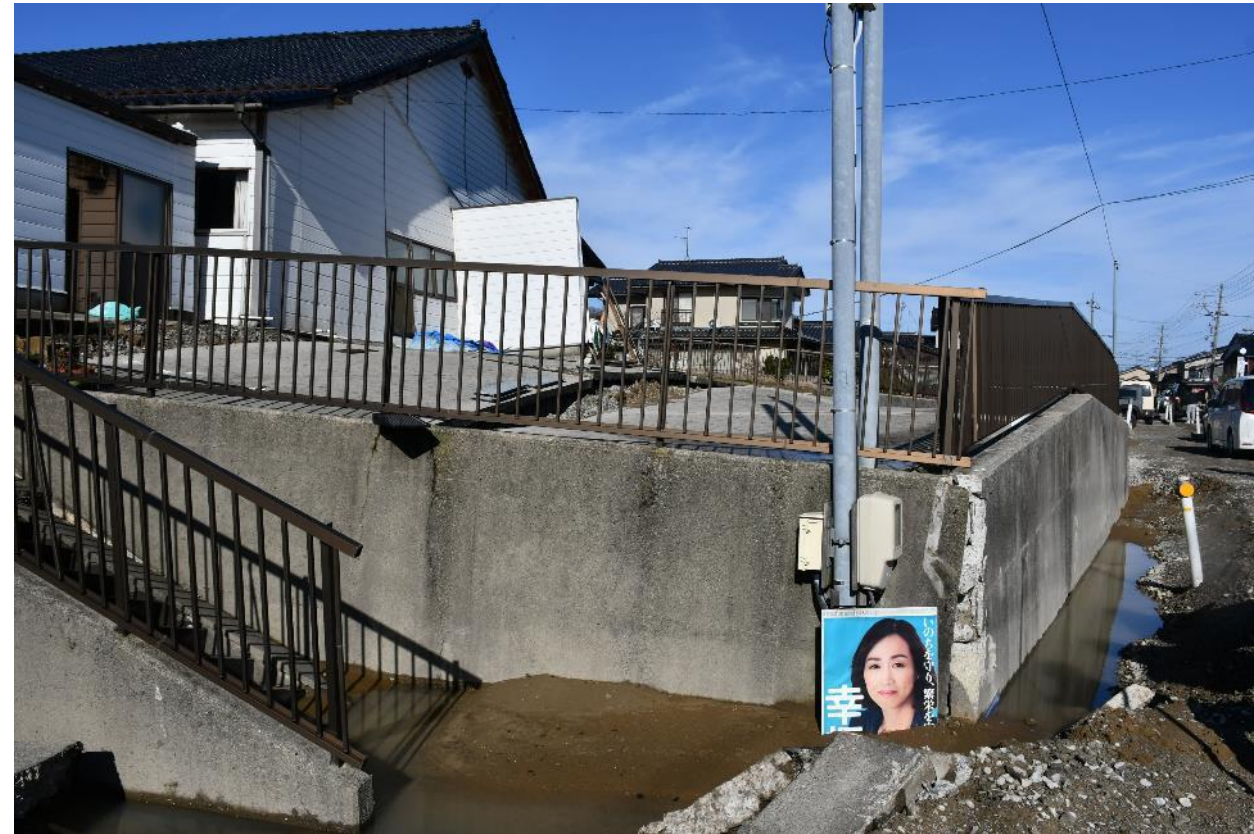
Lateral flow of liquefied ground in the dunes hinterland (Map③)

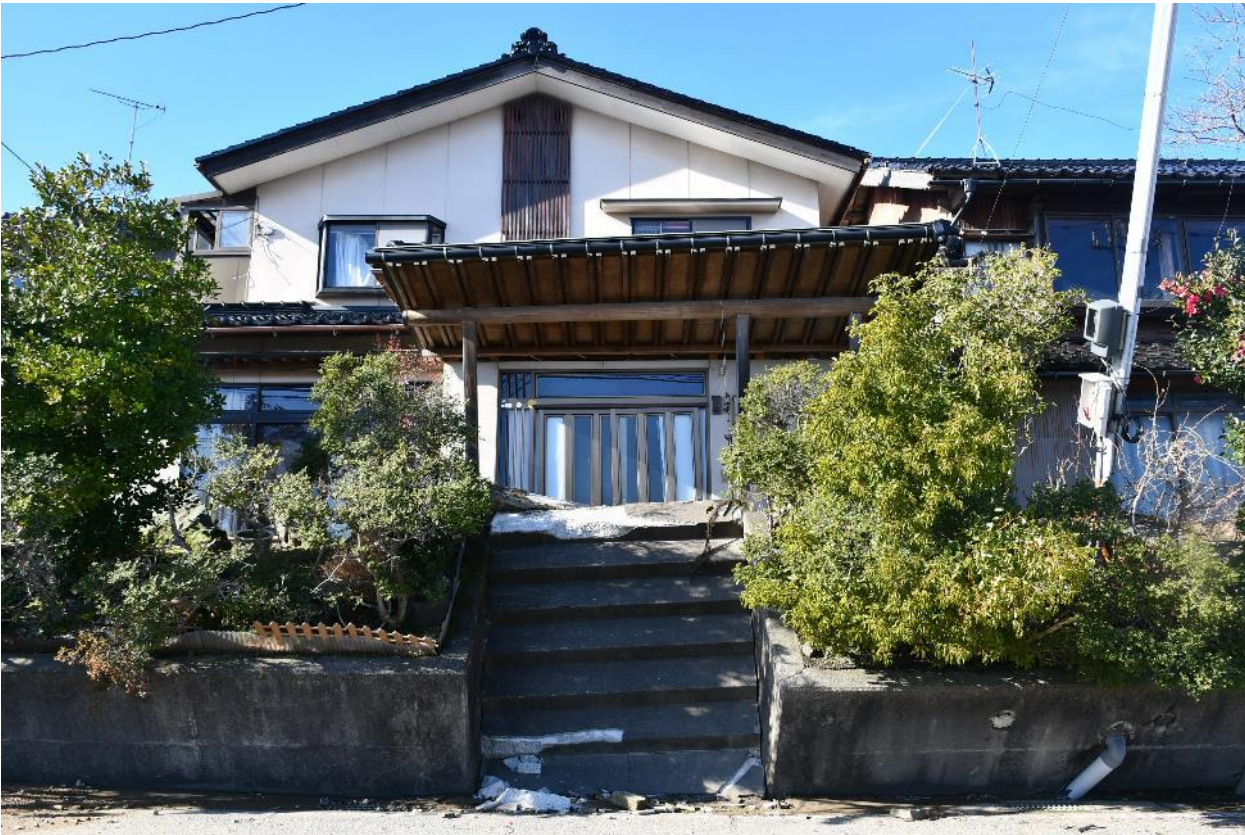
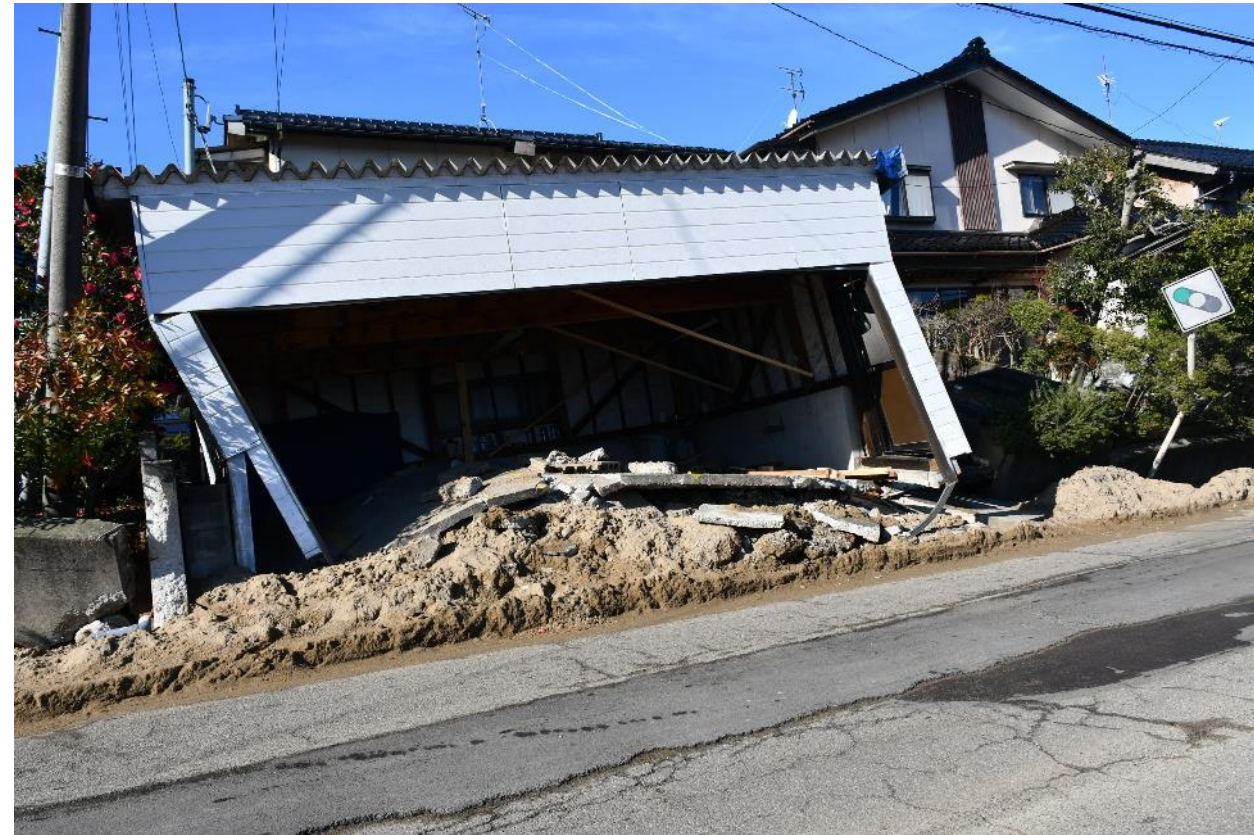
Lateral flow of liquefied ground in the dunes hinterland (Map③)

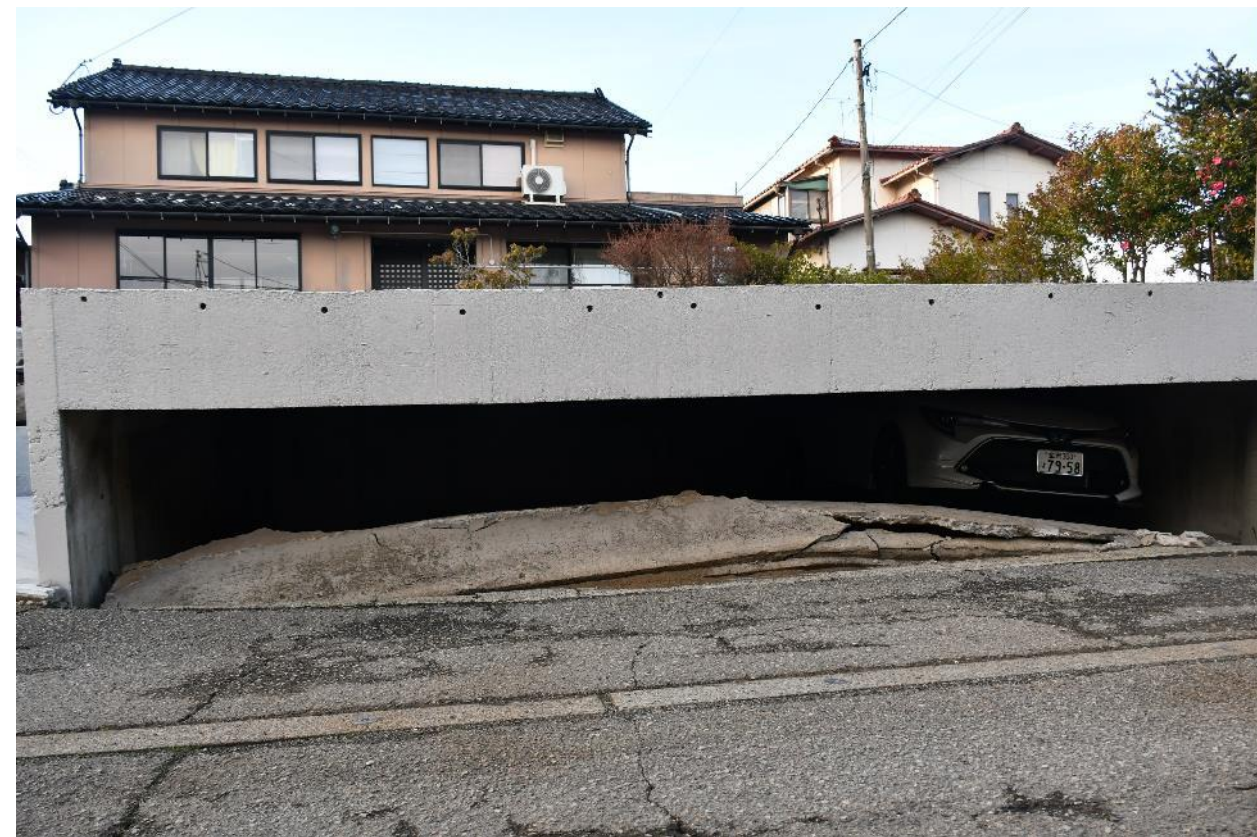
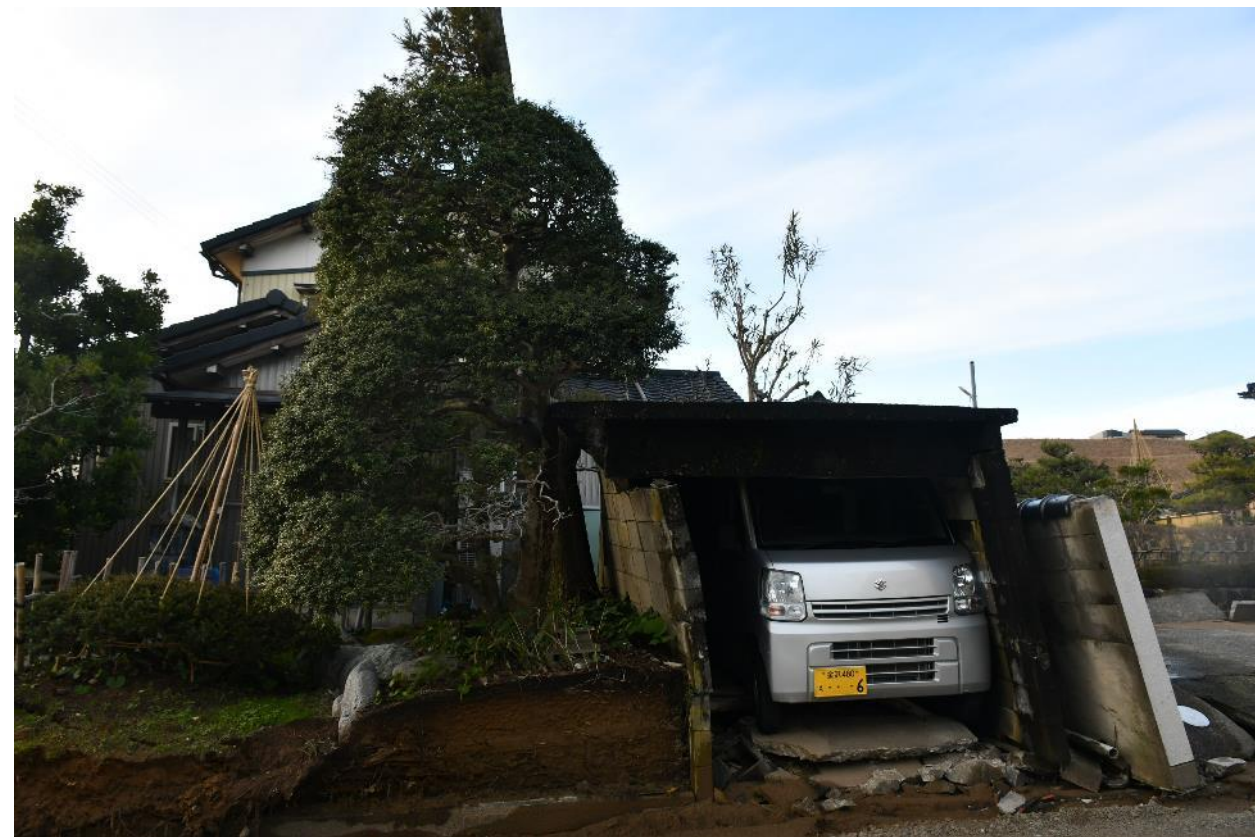
A car trapped in a deformed garage (Map③)

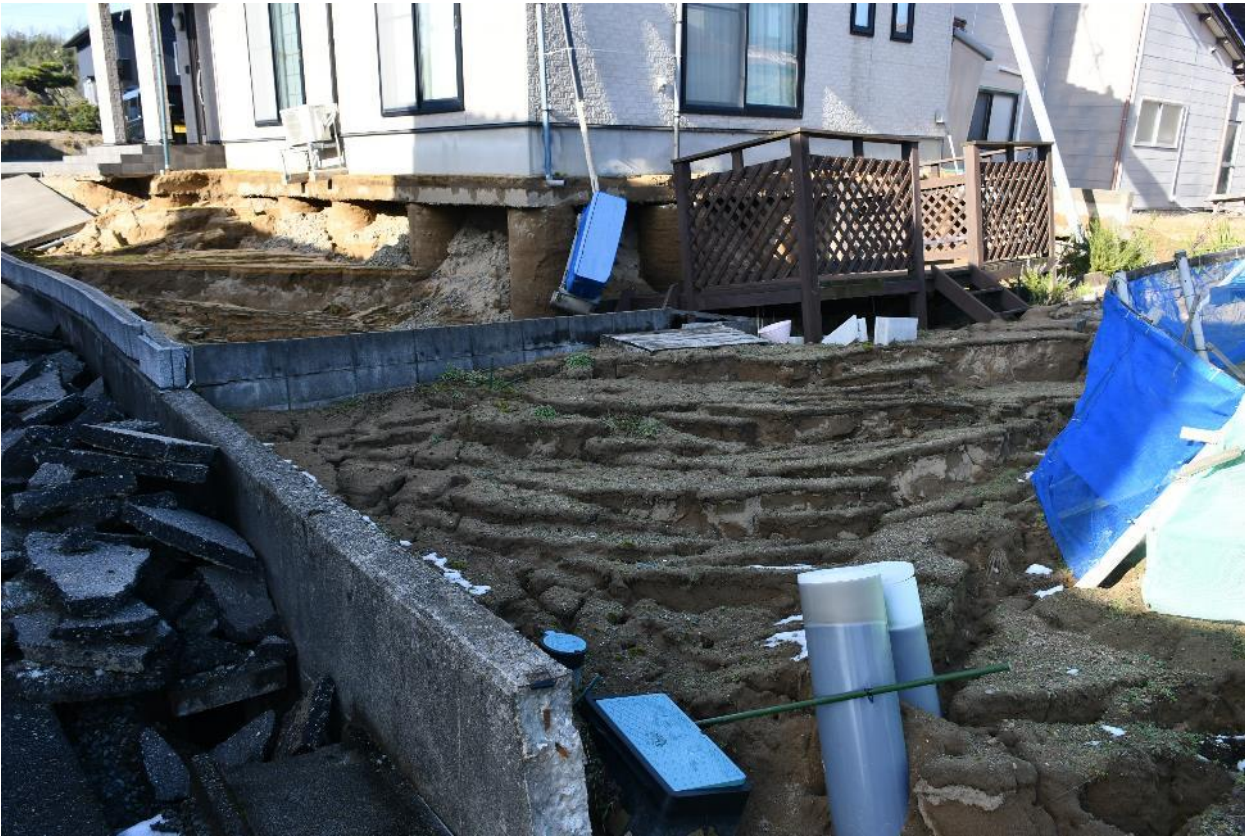
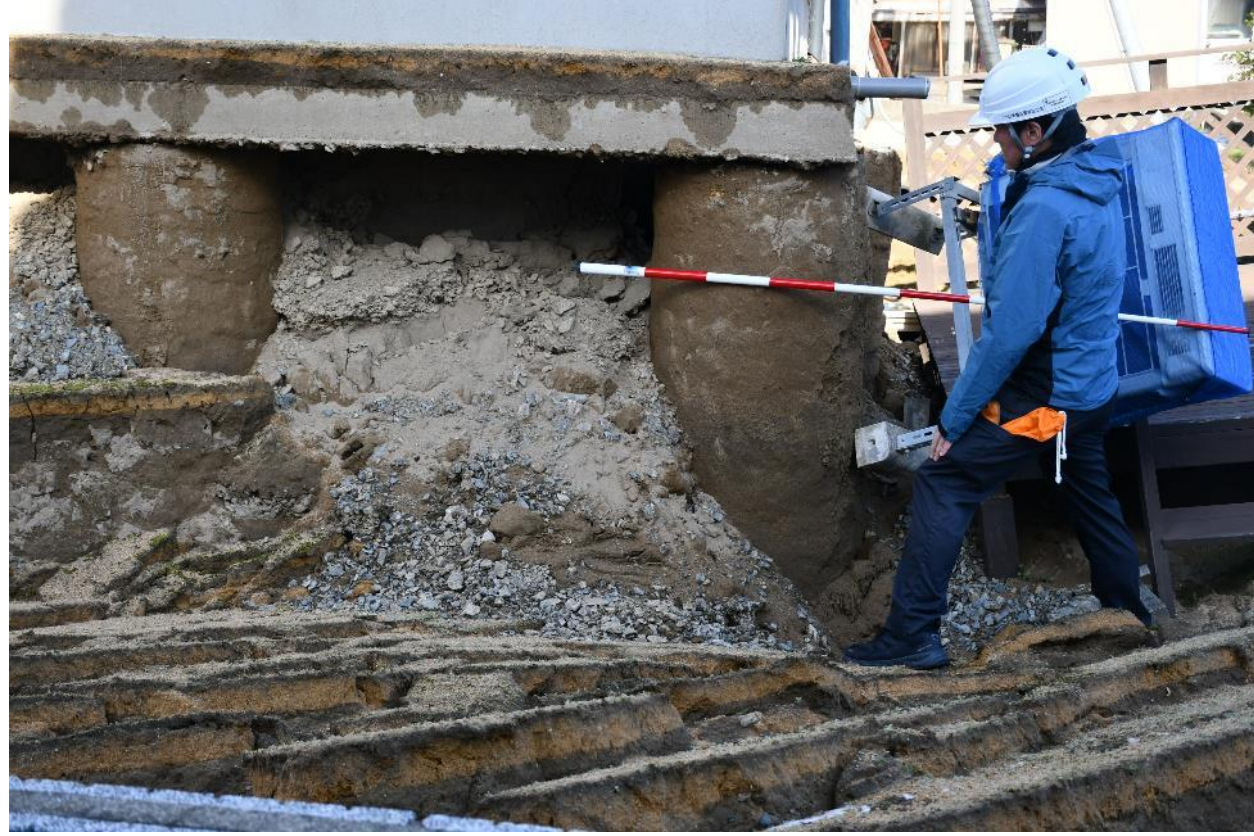
A house with ground improvement was no damage (Map③)

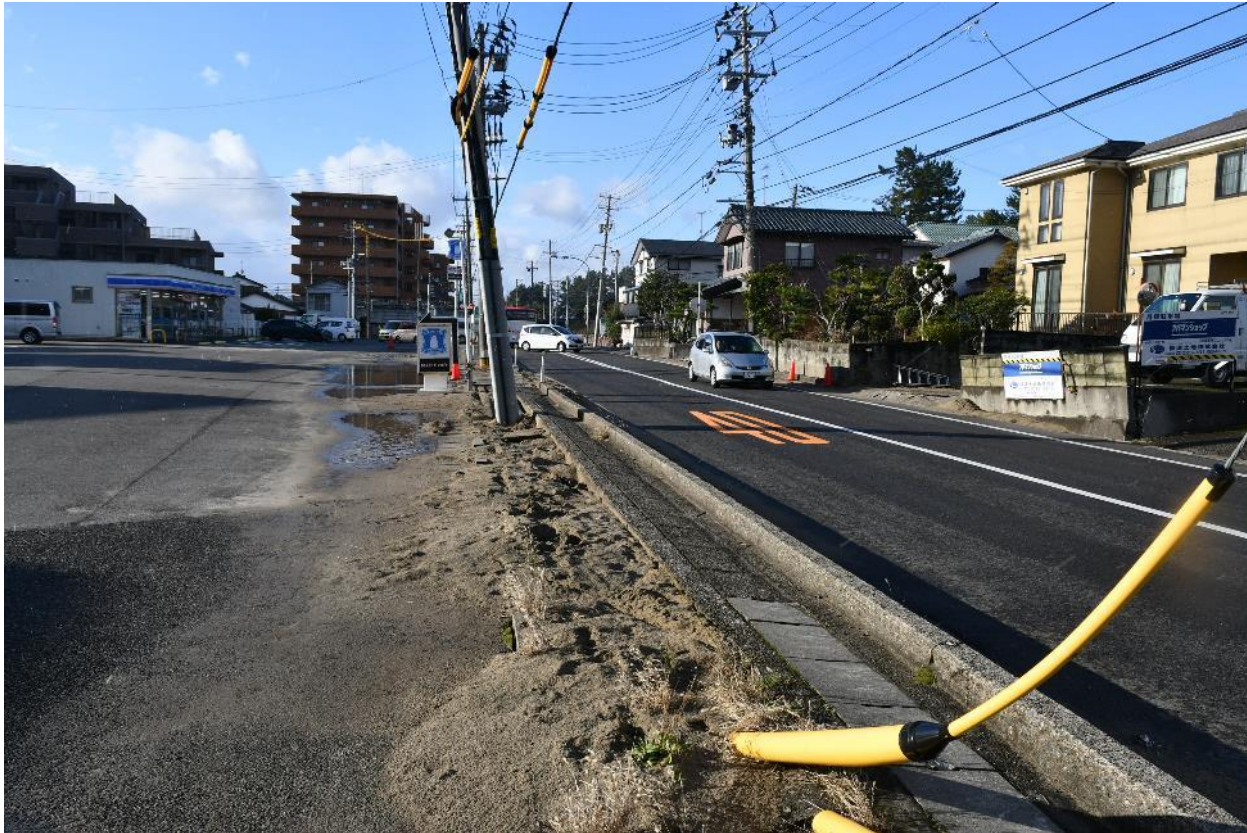
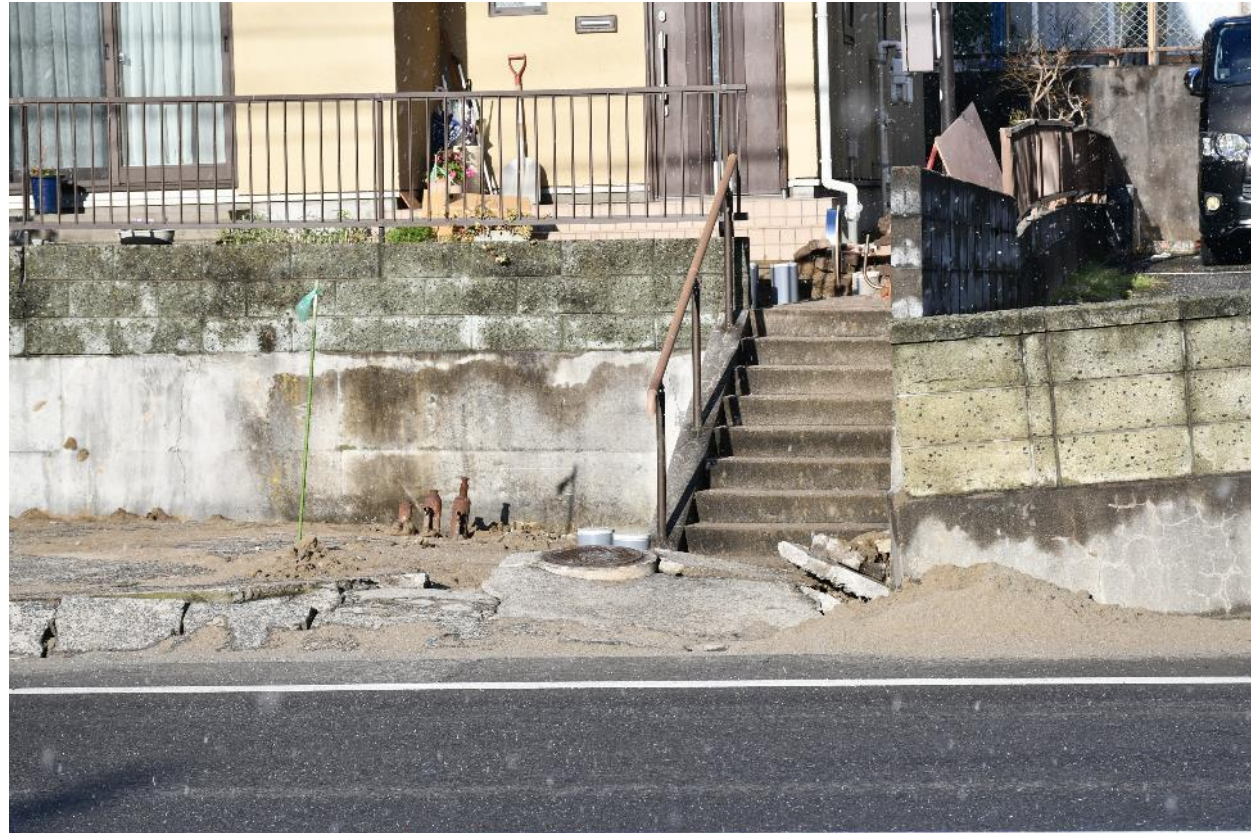
Lateral flow of liquefied ground in the dunes hinterland (Map①)

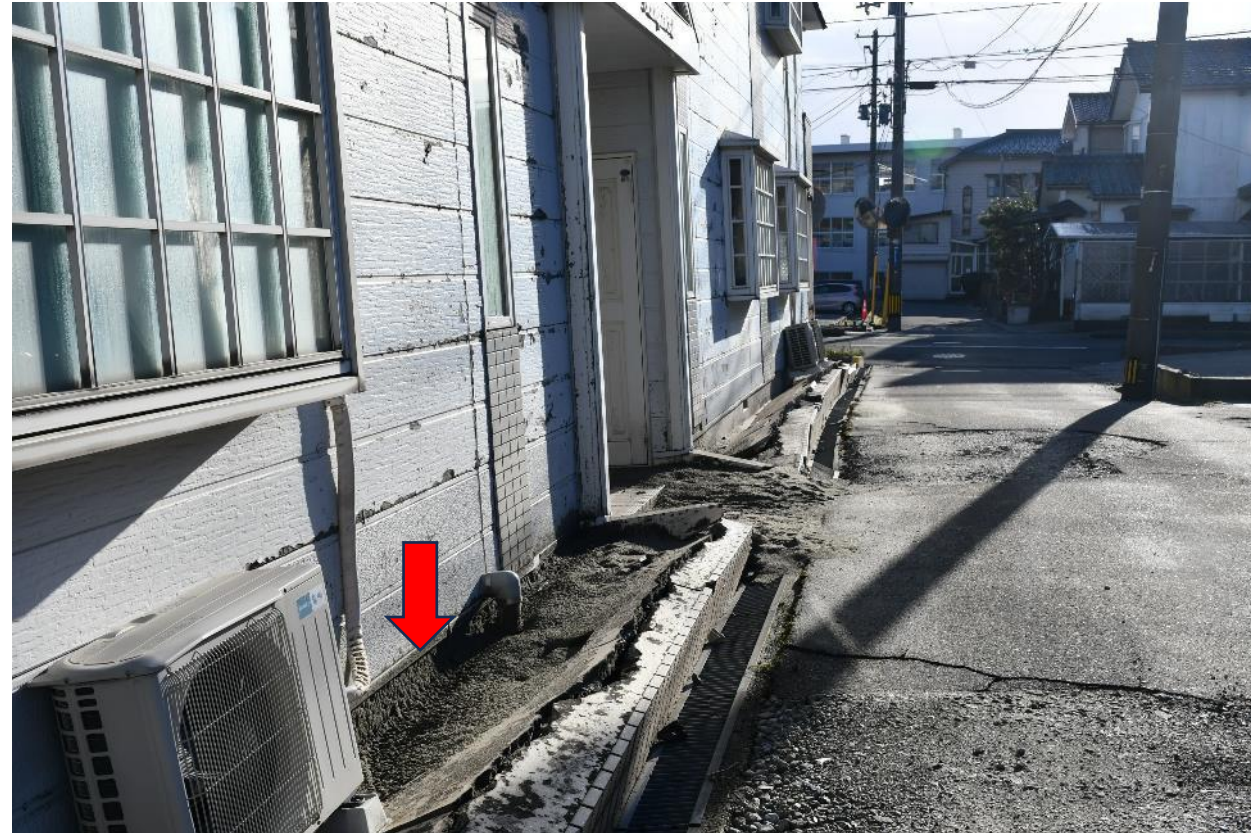
Subsidence and inclination of utility pole and apartments (Map①)

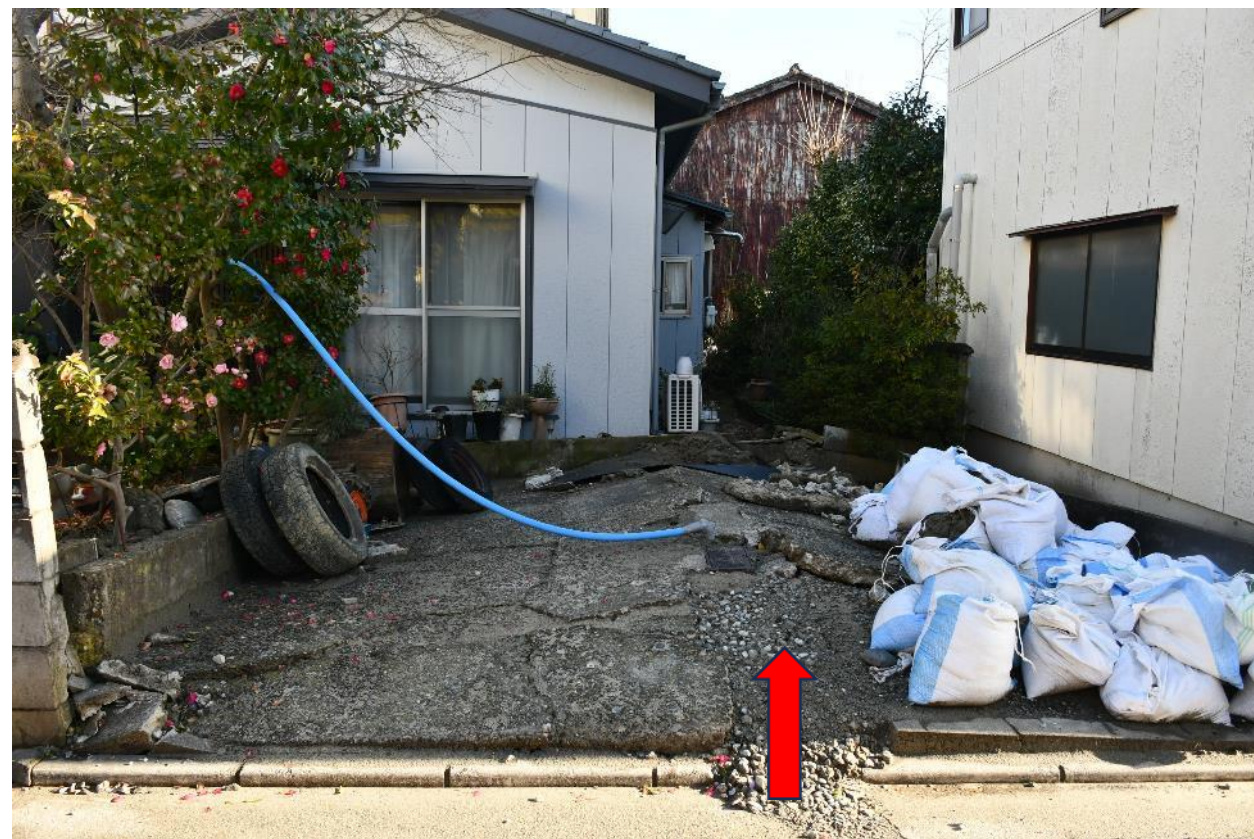
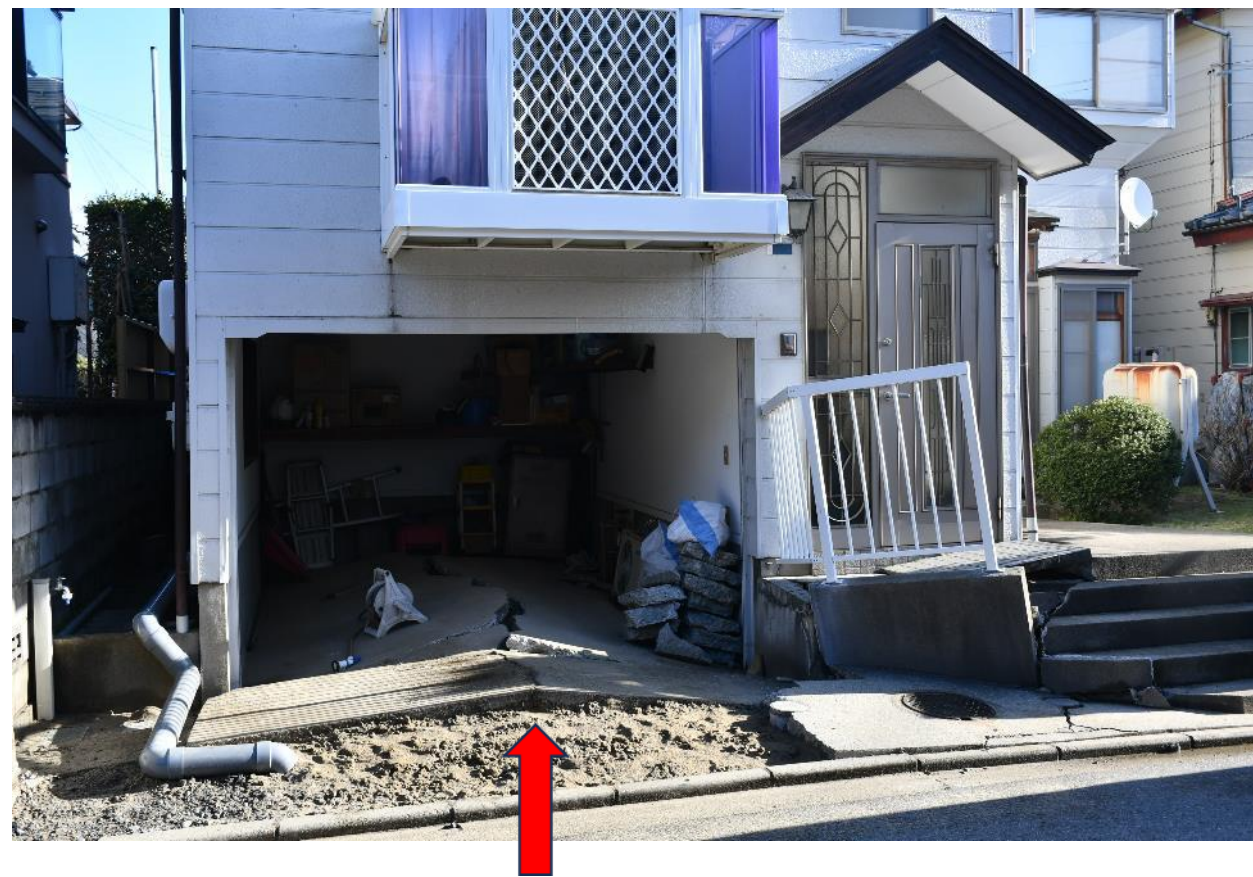
Uplift of the ground due to lateral flow (Map①)

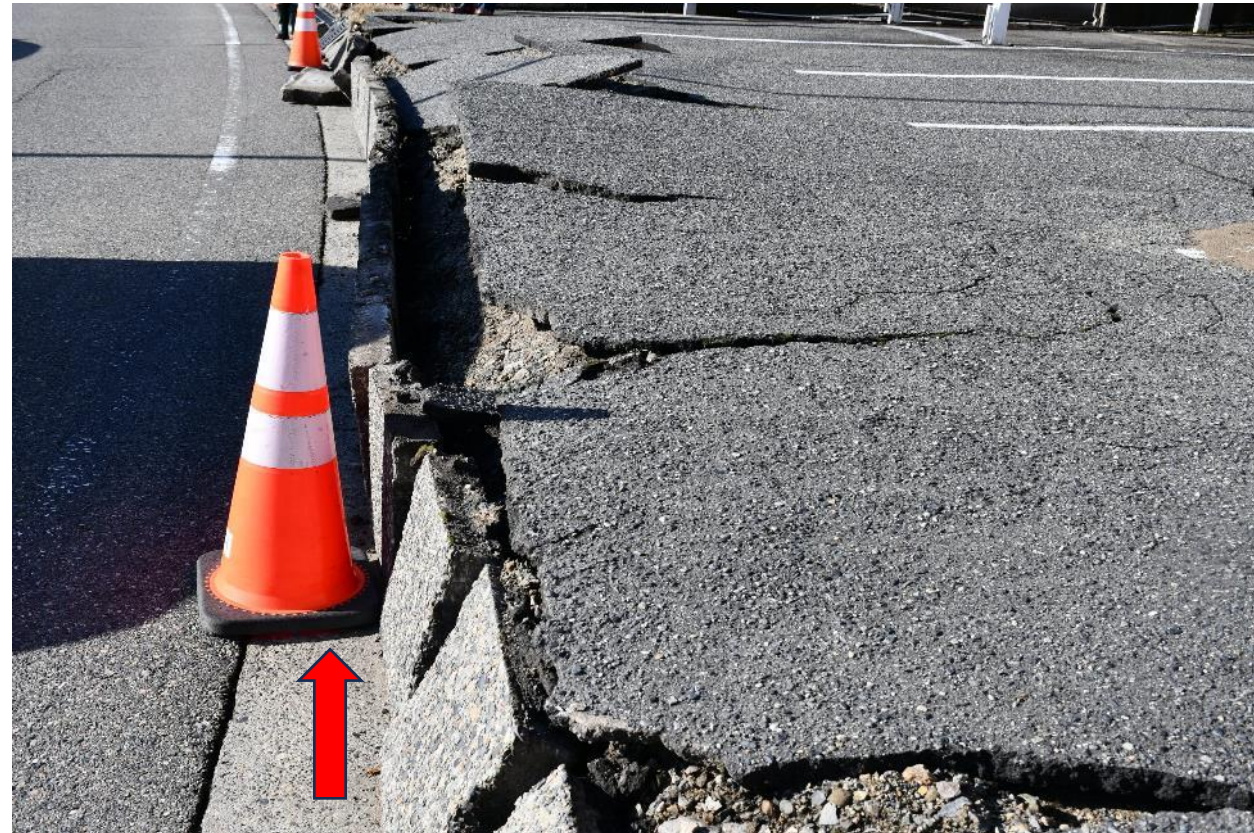
Uplift of the ground due to lateral flow (Map①)
