# Quick report of preliminary reconnaissance of the 2024 Noto-hanto Earthquake in Japan —No.2—

Masakatsu Miyajima (Professor Emeritus, Kanazawa University)

Takao Hashimoto (Specially Appointed Professor, Kokushikan University)

Survey Period: 2024.1.12-1.15

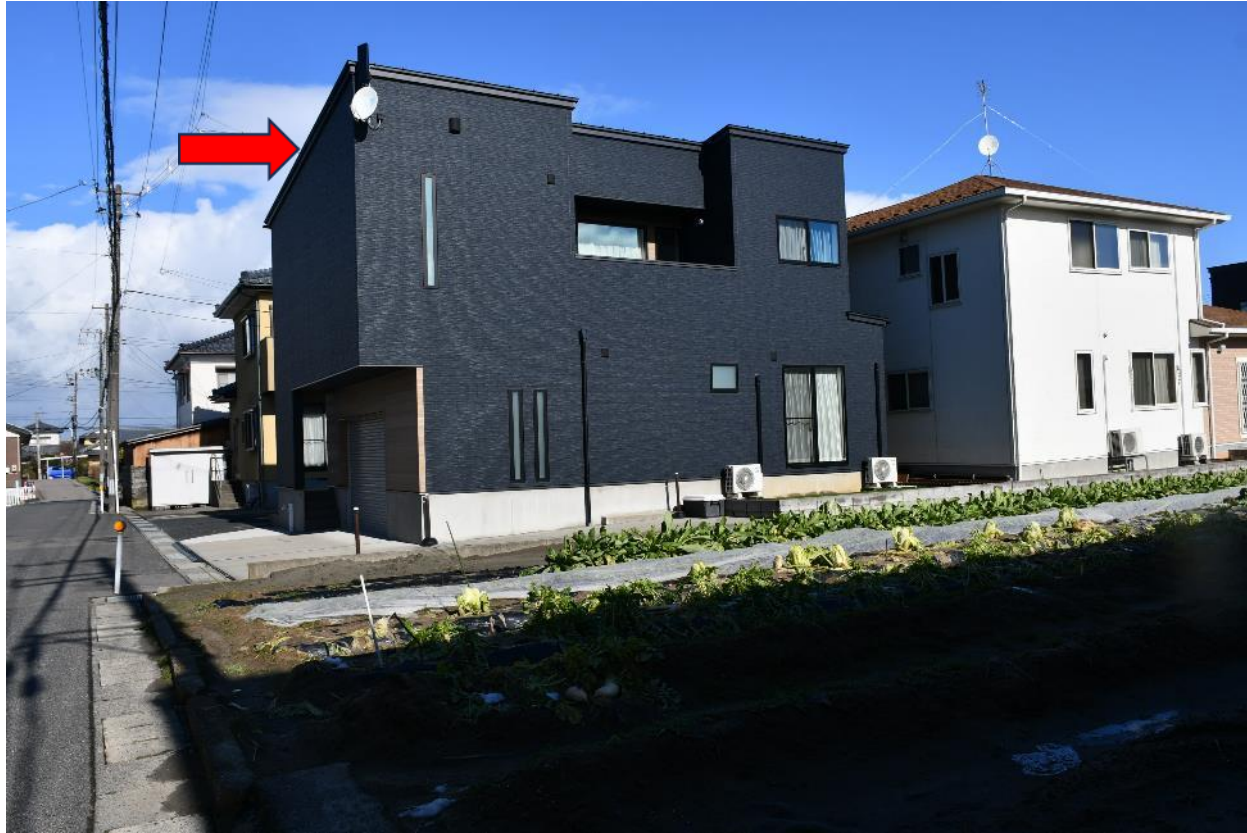
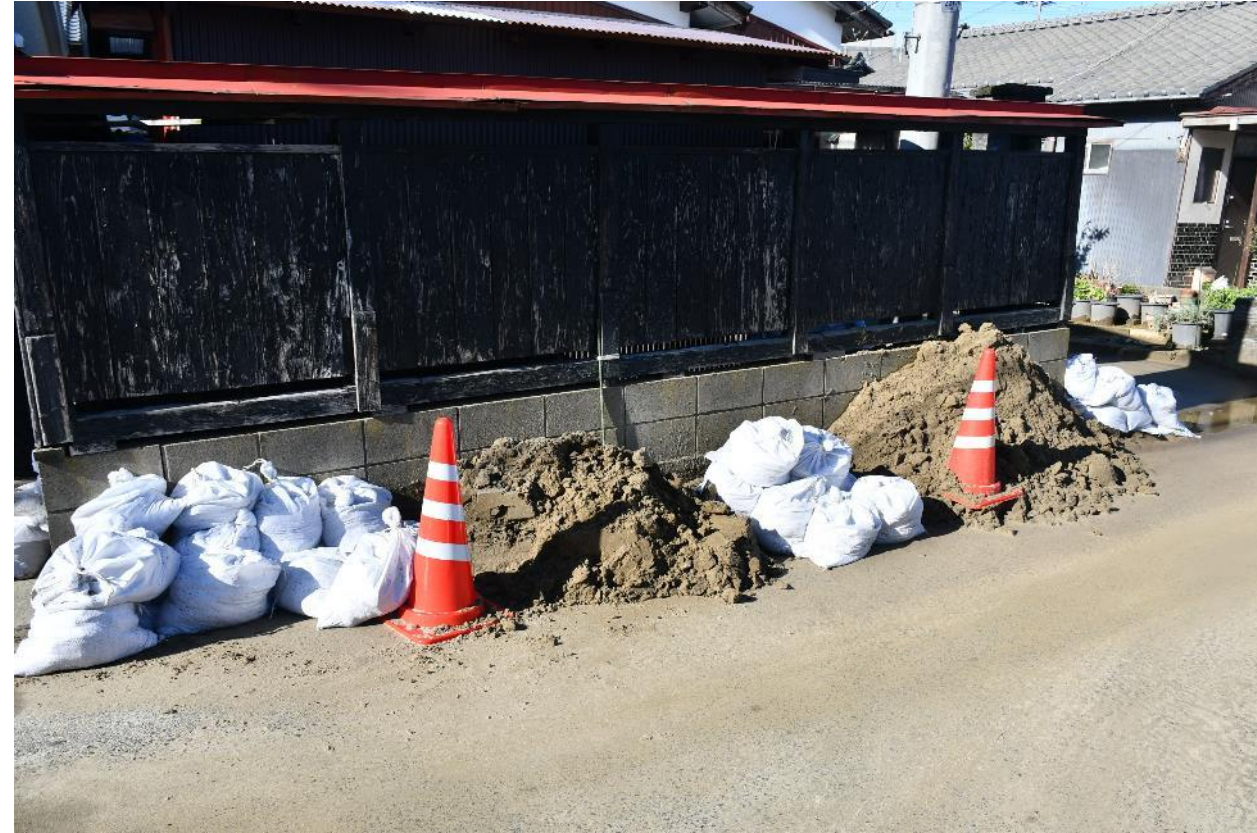
Inclination of houses and large amounts of ejected sand due to liquefaction on flat ground (Map②)
