# Quick report of preliminary reconnaissance of the 2024 Noto-hanto Earthquake in Japan —No.2—

Masakatsu Miyajima (Professor Emeritus, Kanazawa University)

Takao Hashimoto (Specially Appointed Professor, Kokushikan University)

Survey Period: 2024.1.12-1.15

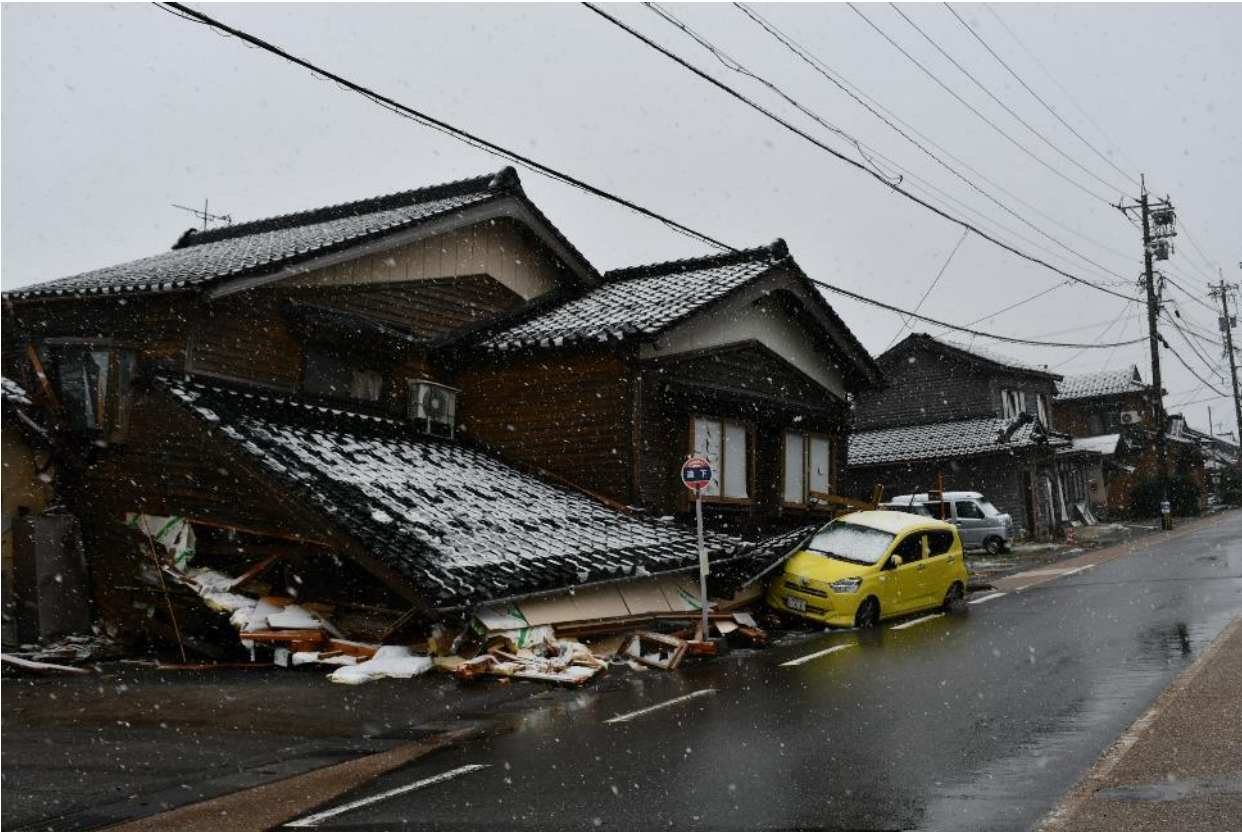
Collapse of wooden houses (Map①)

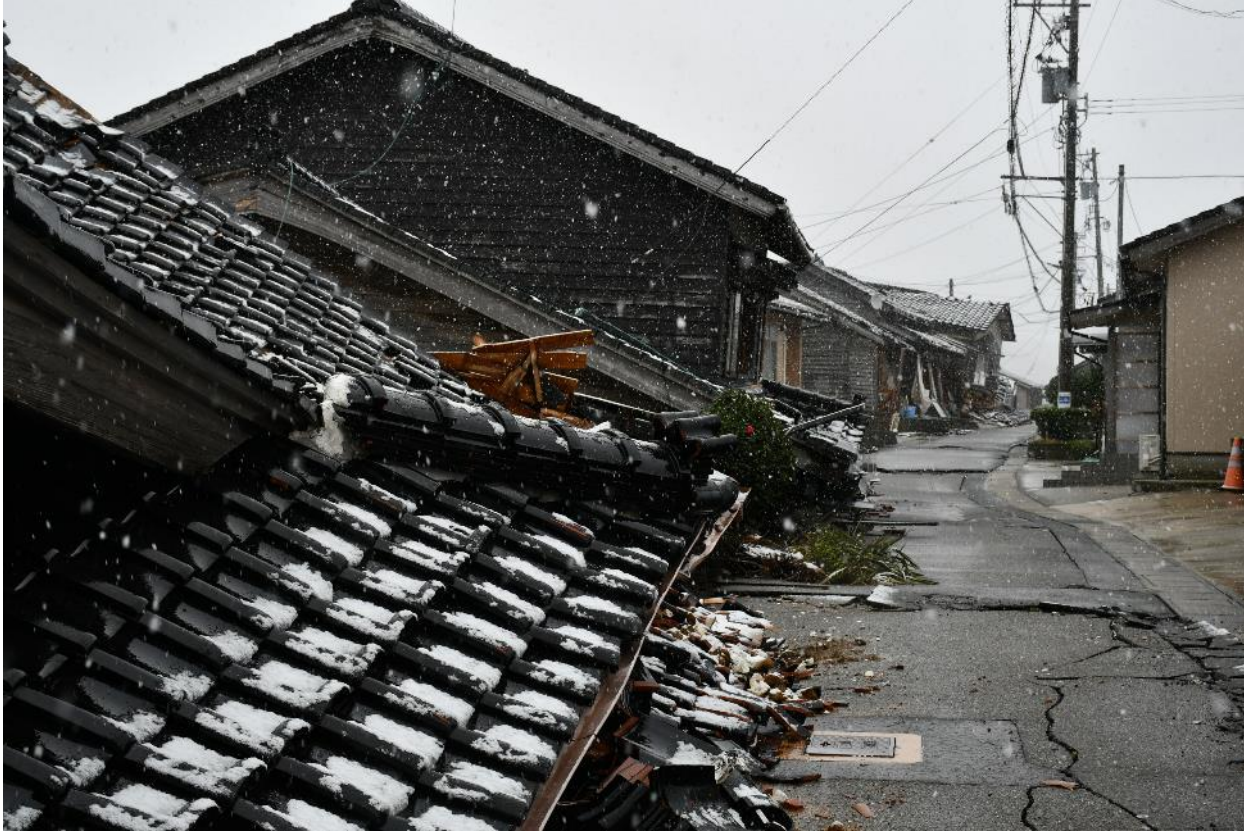
Collapse of wooden houses (Map①)

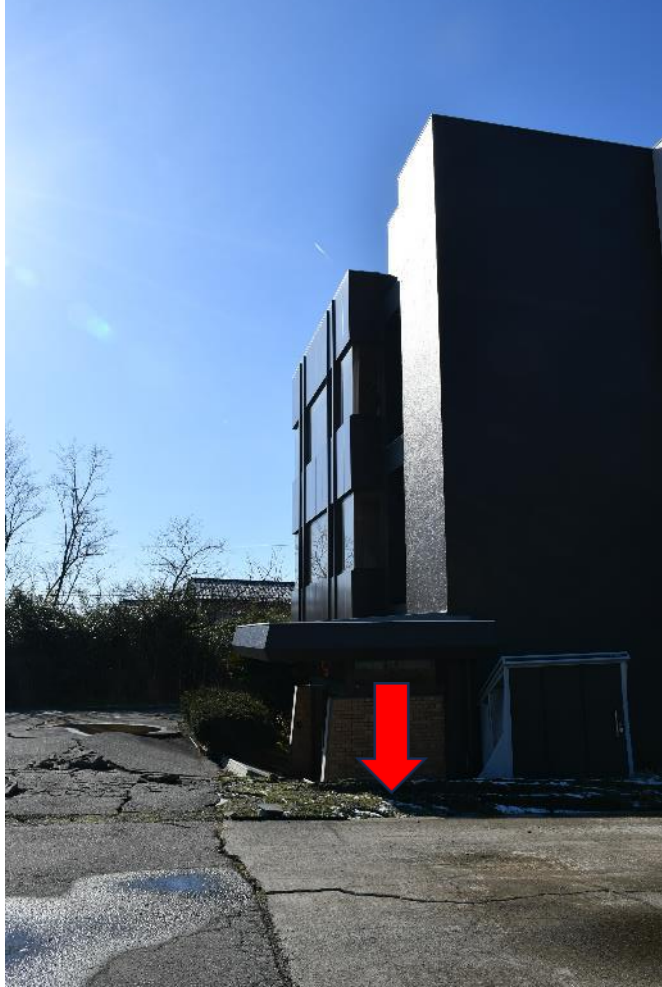
Subsidence of RC building due to liquefaction (Map②)

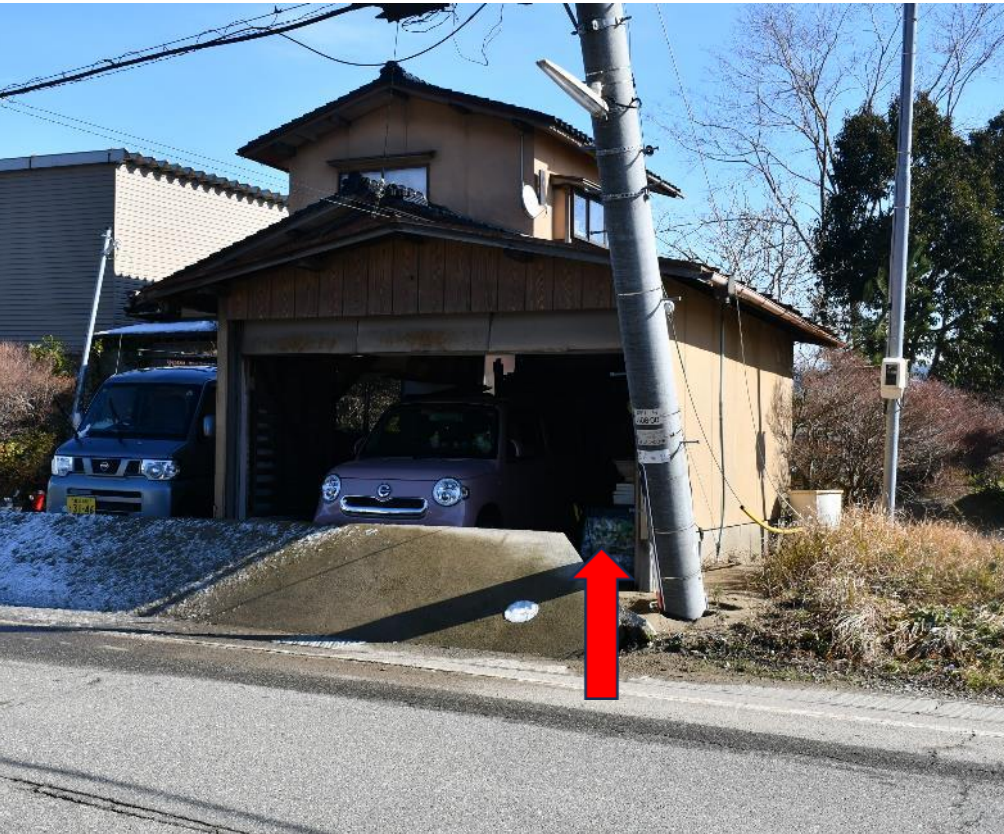
Lateral flow of liquefied ground in the dunes hinterland (Map③)

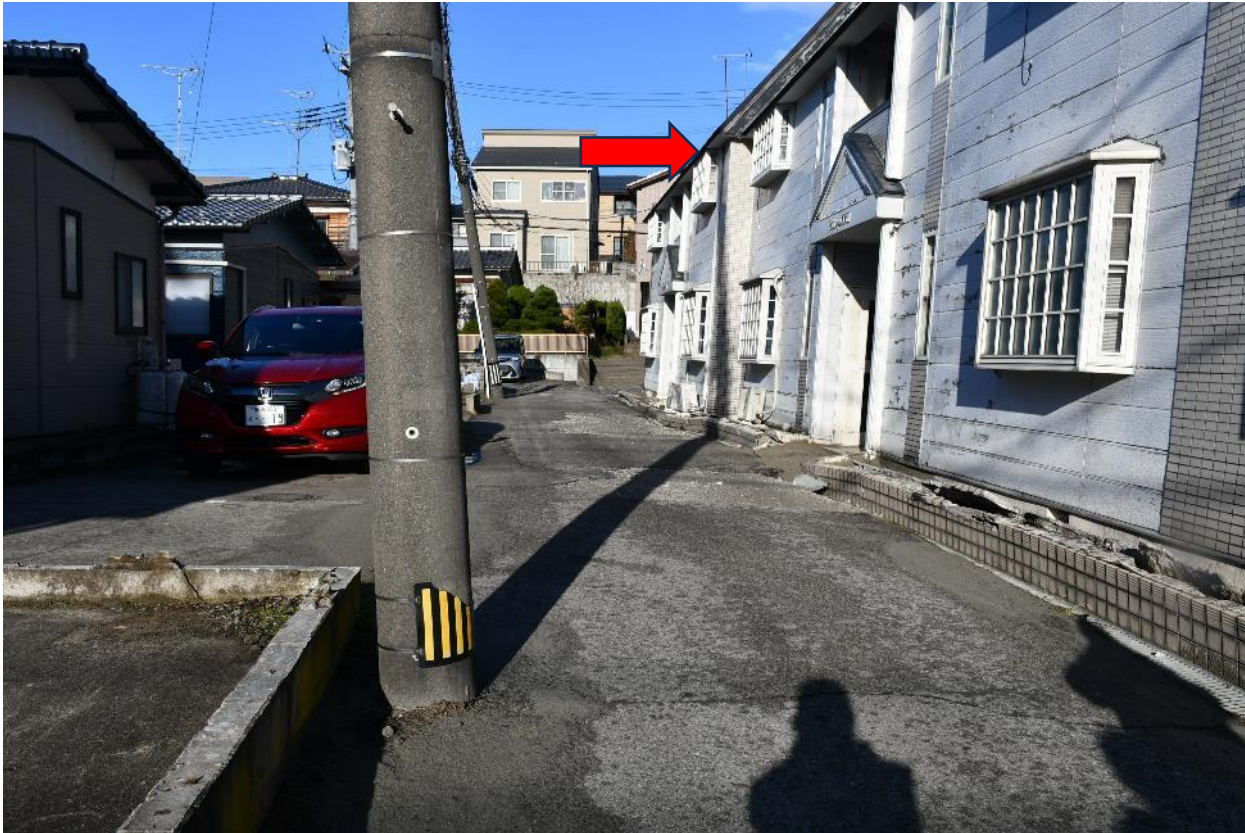
Subsidence and inclination of utility pole and apartments (Map①)

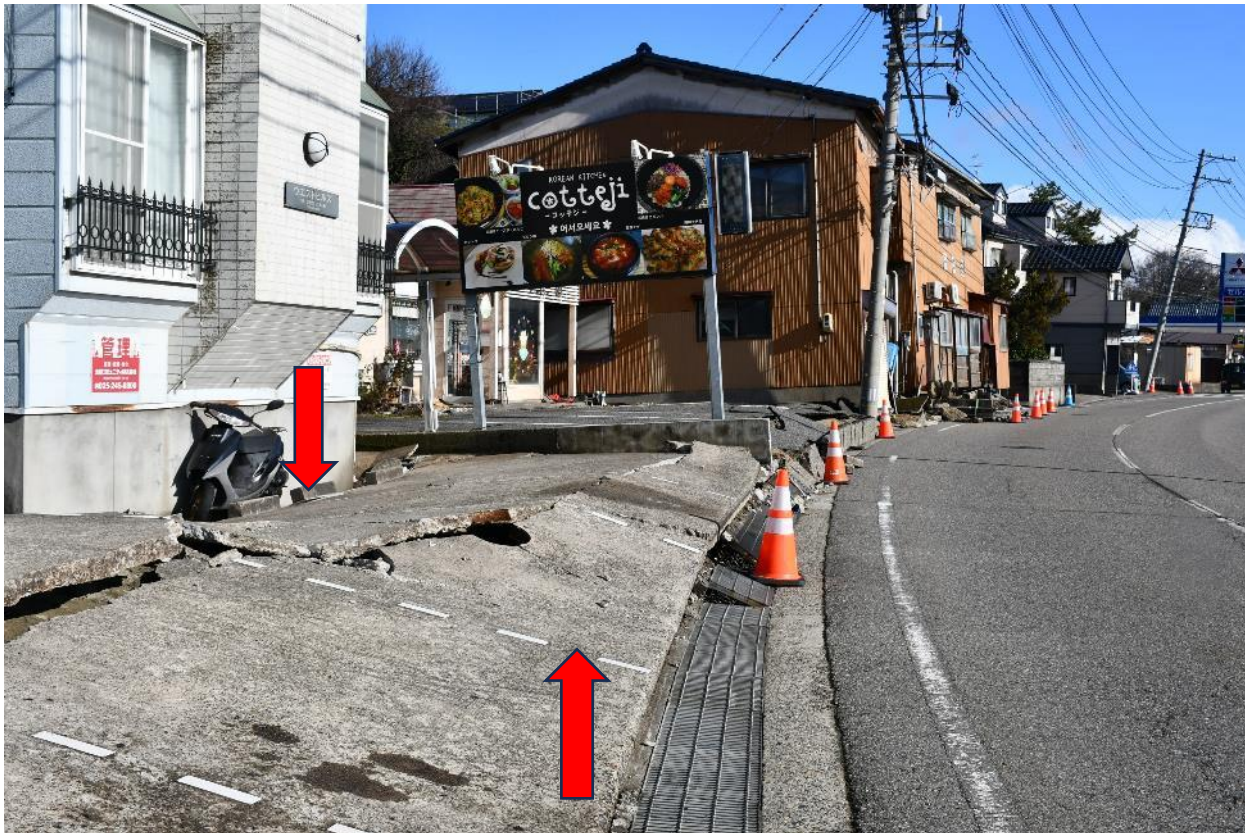
Uplift of the ground due to lateral flow (Map①)
